## ***TMS320F2837xS MCUs Silicon Revisions C, B***

This document describes the silicon updates to the functional specifications for the TMS320F2837xS microcontrollers (MCUs).

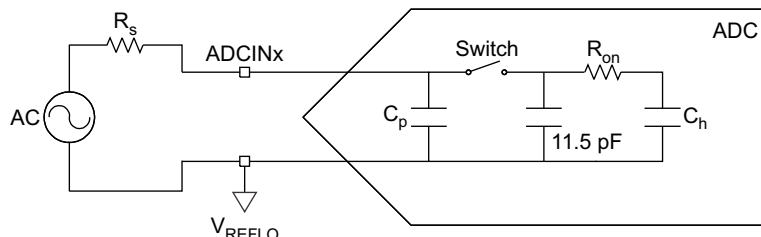
**Figure 3. Single-Ended Input Model**

The ADC input model should be used to select the sample-and-hold (S+H) duration for each ADC input. For the revisions affected, if the currently converting channel is an even-numbered channel and the previously converted channel was an odd-numbered channel (or vice versa), then the 12-bit input model will not accurately predict ADC input performance. Under these conditions, an additional capacitance should be added to the model. This capacitance has a value of 11.5 pF and should be placed between the S+H switch and  $R_{on}$  as shown in [Figure 3](#).

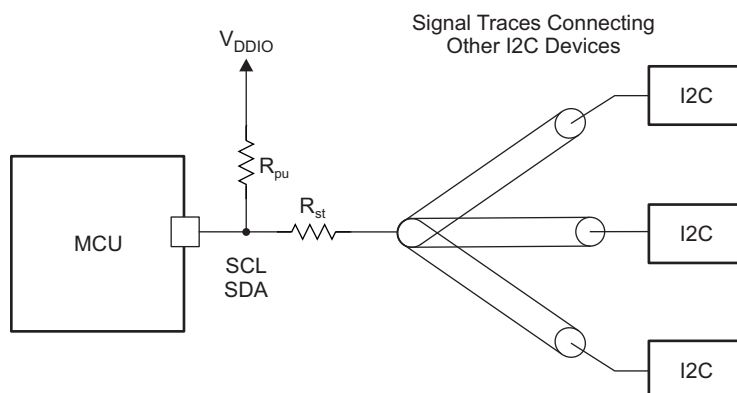
**Figure 7. Placement of Series Termination Resistor and Pullup Resistor**

The SDA and SCL outputs are implemented with push-pull 3-state output buffers rather than open-drain output buffers as required by I2C. While it is possible for the push-pull 3-state output buffers to behave as open-drain outputs, an internal timing skew issue causes the outputs to drive a logic-high for a duration of 0–5 ns before the outputs are disabled. The unexpected high-level pulse will only occur when the SCL or SDA outputs transition from a driven low state to a high-impedance state and there is sufficient internal timing skew on the respective I2C output.

This short high-level pulse injects energy in the I2C signals traces, which causes the I2C signals to sustain a period of ringing as a result of multiple transmission line reflections. This ringing should not cause an issue on the SDA signal because it only occurs at times when SDA is expected to be changing logic levels and the ringing will have time to damp before data is latched by the receiving device. The ringing may have enough amplitude to cross the SCL input buffer switching threshold several times during the first few nanoseconds of this ringing period, which may cause clock glitches. This ringing should not cause a problem if the amplitude is damped within the first 50 ns because I2C devices are required to filter their SCL inputs to remove clock glitches. Therefore, it is important to design the PCB signal traces to limit the duration of the ringing to less than 50 ns. One possible solution is to insert series termination resistors near the SCL and SDA terminals to attenuate transmission line reflections.

This issue may also cause the SDA output to be in contention with the slave SDA output for the duration of the unexpected high-level pulse when the slave begins its ACK cycle. This occurs because the slave may already be driving SDA low before the unexpected high-level pulse occurs. The glitch that occurs on SDA as a result of this short period of contention does not cause any I2C protocol issue but the peak current applies unwanted stress to both I2C devices and potentially increases power supply noise. Therefore, a series termination resistor located near the respective SDA terminal is required to limit the current during the short period of contention.

Insert series termination resistors on the SCL and SDA signals and locate them near the SCL and SDA terminals. The SCL and SDA pullup resistors should also be located near the SCL and SDA terminals. The placement of the series termination resistor and pullup resistor should be connected as shown in [Figure 7](#).

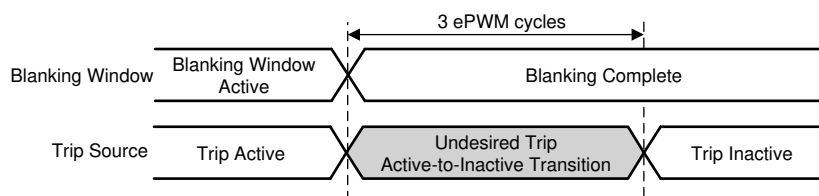
**Figure 8. Undesired Trip Event and Blanking Window Expiration**

The blanking window is typically used to mask any PWM trip events during transitions which would be false trips to the system. If an ePWM trip event remains active for less than three ePWM clocks after the end of the blanking window cycles, there can be an undesired glitch at the ePWM output.

Figure 8 illustrates the time period which could result in an undesired ePWM output.
