## USB251xB/xBi Family Silicon Errata

The USB251xB/xBi family devices that you have received conform functionally to the current Device Data Sheet (DS00001692A), except for the anomalies described in this document.

**Note:** This document summarizes all silicon errata issues of the current silicon revision (**A2**).

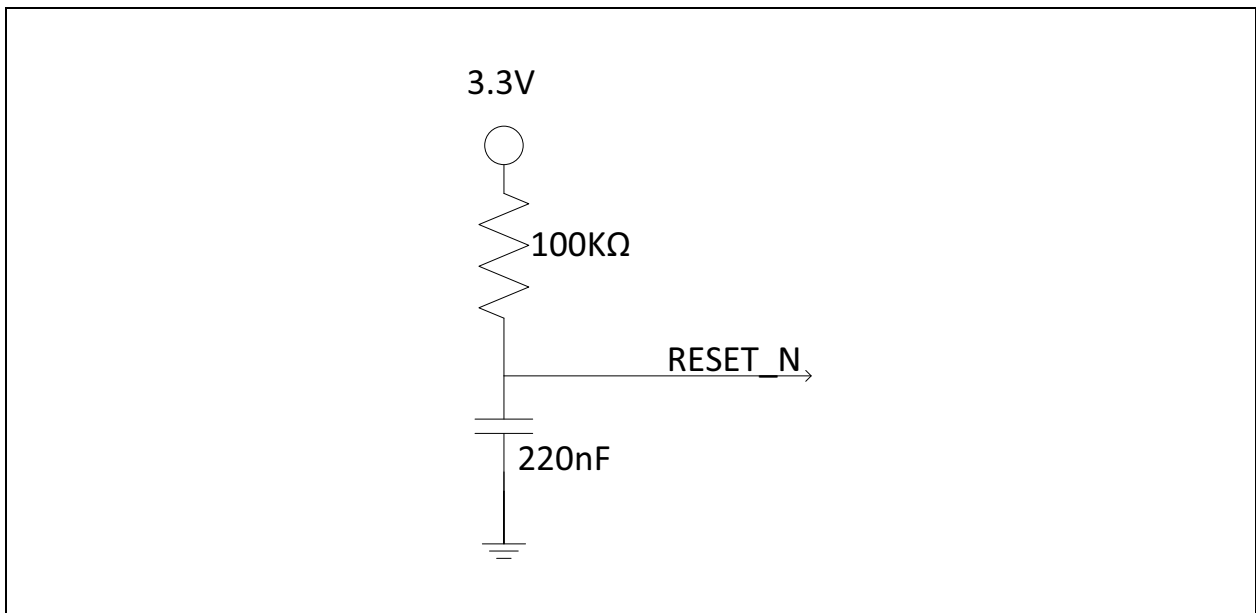
**FIGURE 1: RC CIRCUIT DIAGRAM**

When the Hub is powering up, the DP pin is asserted before other internal logic has started. When the internal logic does start, it can cause a low pulse on the SMBus and DP pins.

The USB protocol can handle a glitch on DP, so no user impact on the USB lines. The SMBus glitch can impact the state machine of the SMBus Controller.

Keep the RESET\_N pin low during POR to remove this glitch. Control RESET\_N through a digital controller or an RC circuit by connecting a 100K $\Omega$  pull-up resistor to 3.3V and a 220nF capacitor to ground. See RC circuit diagram below.
