## XC3S1000 and XC3S1000L FPGA Errata and Deviations from Spartan-3/3L Data Sheet

DS099-E05 (v2.5) December 14, 2006

Errata Notice

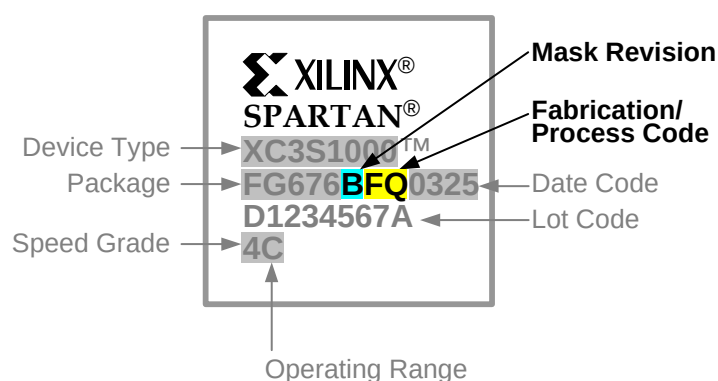
Figure 1: Spartan-3 FPGA from UMC 200 mm facility with "FQ" Fabrication/Process Code Marking

This issue potentially affects some applications where the VCCINT power supply is the last supply to reach its Power-On Reset (POR) voltage threshold. This issue only affects devices with the “FQ” fabrication/process code, as indicated in [Table 4](#).

**OPTION 1:** Use Spartan-3 FPGAs fabricated from the 300 mm production facility or specially-screened FPGAs from the 200 mm production facility.

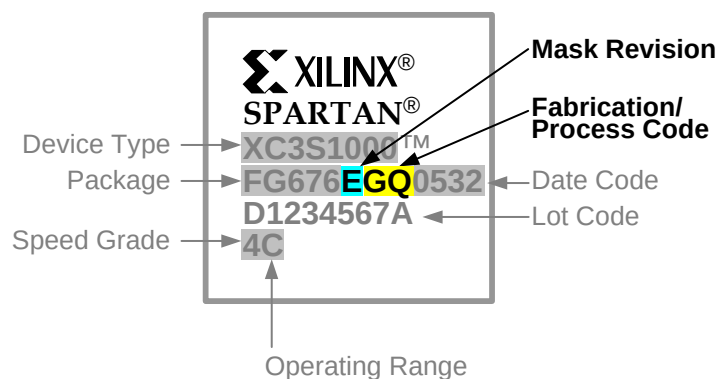
Figure 2: Spartan-3 FPGA from UMC 300 mm facility with "GQ" Fabrication/Process Code Marking

This issue only applies to those designs using the Readback feature on the XC3S1000 or XC3S1000L FPGAs shown in [Table 5](#) with a “GQ” Fabrication/Process Code marking, as shown in [Figure 2](#).

XC3S1000 FPGAs with an “FQ” Fabrication/Process Code marking fully support the Readback feature. Similarly, XC3S1000 or XC3S1000L FPGAs with an “EGQ” Mask/Fabrication/Process Code marking and with a Date Code of “0532” or later fully support Readback.

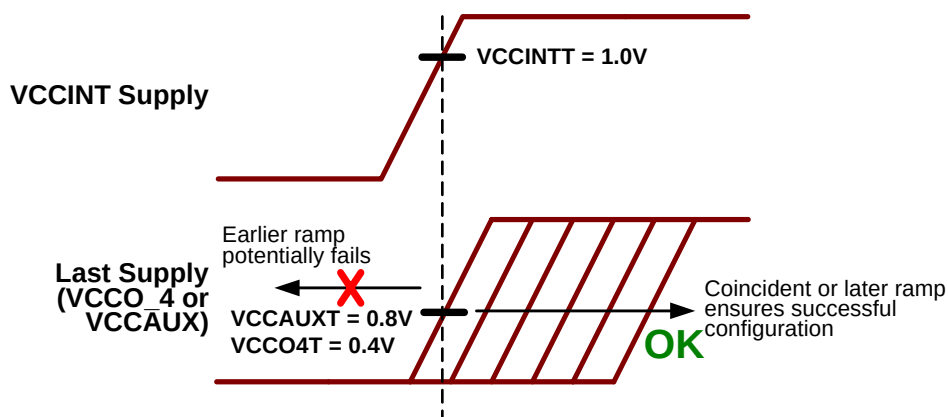
In the potentially failing condition, the VCCINT supply must be the last supply to reach its valid POR voltage and the ramp rate must be slower than 500  $\mu$ S. When the FPGA fails to configure, the INIT\_B remains Low and the FPGA ignores the PROG\_B program pin. Even with the worst identified power sequence, actual failures only occur on a small percentage of devices, typically measured in parts per million. The issue is more pronounced at cold temperatures.

Figure 3: Requirements when VCCINT is not the Last Supply

VCCINT must reach its maximum POR threshold ( $V_{CCINTT} = 1.0V$ ) before or coincident with VCCAUX reaching its minimum threshold ( $V_{CCAUXT} = 0.8V$ ). This supply sequence and threshold relationship is illustrated in [Figure 3](#).

Alternatively, VCCINT must reach its maximum POR threshold ( $V_{CCINTT} = 1.0V$ ) before or coincident with VCCO\_4 supplying I/O bank 4 reaching its minimum threshold ( $V_{CCO4T} = 0.4V$ ). This supply sequence and threshold relationship is also illustrated in [Figure 3](#).

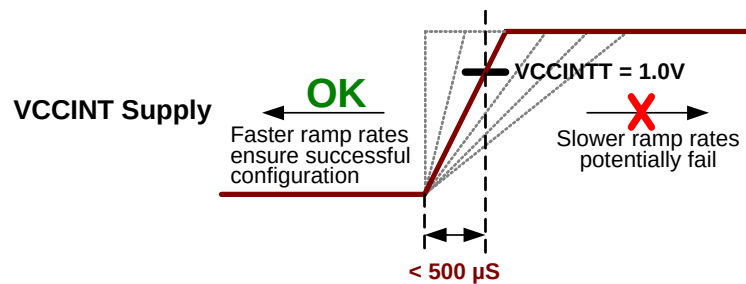
Figure 4: Use Faster VCCINT Ramp Rate if VCCINT is Last Supply

**OPTION 3:** In a system that requires that the VCCINT supply is last in the power-up sequence, ensure that it ramps to its maximum POR threshold voltage ( $V_{CCINTT} = 1.0V$ ) in less than  $< 500 \mu S$ , as shown in [Figure 4](#).

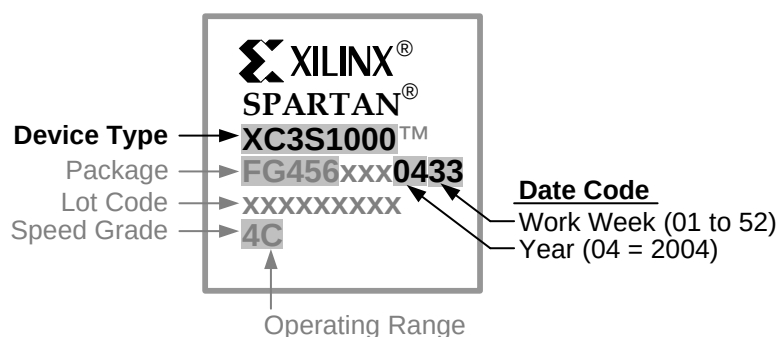
These new bitstream settings are now the default settings starting with Xilinx ISE 6.3i, Service Package 1, available for download from the Xilinx web site after September 13, 2004. XC3S1000 FPGAs are tested using these new bitstream settings beginning with date codes "0433", corresponding to Work Week 33 of 2004. [Figure 5](#) shows an example top marking for a Spartan-3 FPGA. The relevant fields to identify an affected device are highlighted and include the **Device Type** and the **Date Code**.

Figure 5: Example Spartan-3 Package Markings

**Please regenerate any Spartan-3 FPGA configuration bitstreams** created using software versions prior to Xilinx ISE 6.3i development software, Service Pack 1. By updating the bitstream, the application can use any existing or future production Spartan-3 FPGA device.
