## XC3S1500 and XC3S1500L FPGA Errata and Deviations from Spartan-3 FPGA Data Sheet

EN089 (DS099-E06) (v2.6) June 24, 2008

Errata Notice

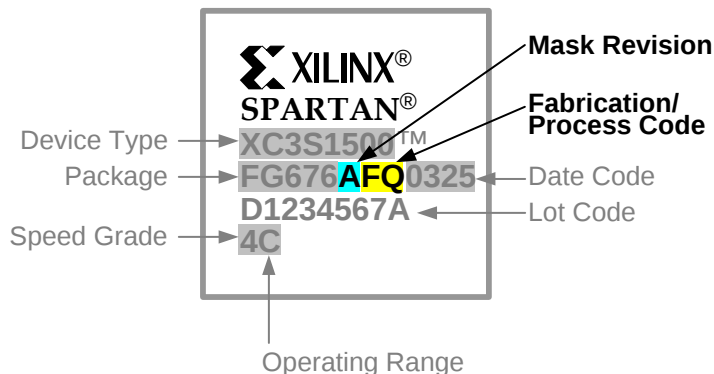
Figure 1: Spartan-3 FPGA from UMC 200 mm facility with “FQ” Fabrication/Process Code Marking

This issue only affects the XC3S1500 FPGAs shown in [Table 4](#), marked with the “AFQ” mask/fab/process code as shown in [Figure 1](#).

This issue only affects the XC3S1500 FPGAs shown in [Table 6](#), marked with the “AFQ” mask/fab/process code as shown in [Figure 1](#).

This issue only affects the XC3S1500 FPGAs shown in [Table 7](#), marked with the "AFQ" mask/fab/process code as shown in [Figure 1](#).

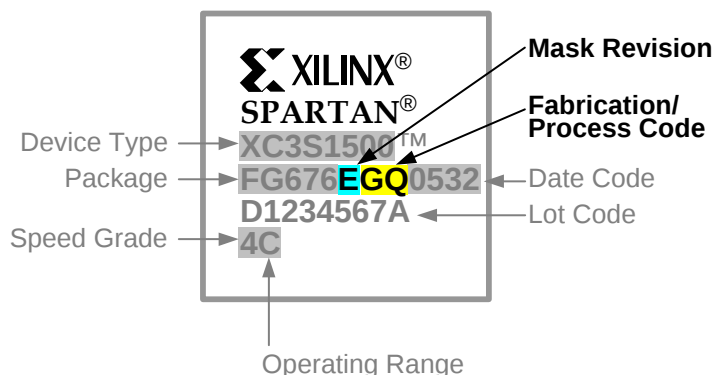
Figure 2: Spartan-3 FPGA from UMC 300 mm facility with “GQ” Fabrication/Process Code Marking

This issue only applies to those designs using the Readback feature on the XC3S1500 or XC3S1500L FPGAs shown in [Table 8](#) with an "AGQ" mask/fab/process code marking, or "EGQ" before date code 0532, as shown in [Figure 2](#).

This issue is corrected on XC3S1500L FPGAs and on XC3S1500 FPGAs with a “BGQ” or “EGQ” mask/fab/process code marking, as shown in [Figure 2](#).

This issue is corrected on XC3S1500L FPGAs and XC3S1500 FPGAs with a “BGQ” or “EGQ” mask/fab/process code marking, as shown in [Figure 2](#).

This issue is corrected on XC3S1500L FPGAs and XC3S1500 FPGAs with a "BGQ" or "EGQ" mask/fab/process code marking, as shown in [Figure 2](#).

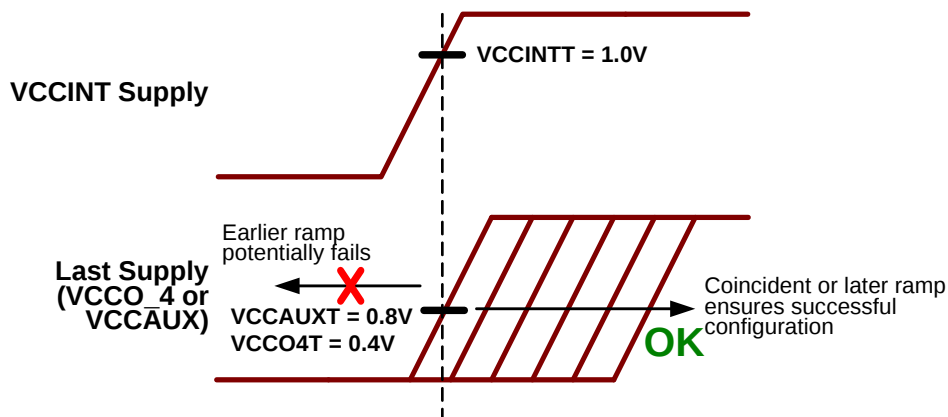
Figure 3: Requirements when VCCINT is not the Last Supply

VCCINT must reach its maximum POR threshold ( $V_{CCINTT} = 1.0V$ ) before or coincident with VCCAUX reaching its minimum threshold ( $V_{CCAUXT} = 0.8V$ ). This supply sequence and threshold relationship is illustrated in [Figure 3](#).

Alternatively, VCCINT must reach its maximum POR threshold ( $V_{CCINTT} = 1.0V$ ) before or coincident with VCCO\_4 supplying I/O bank 4 reaching its minimum threshold ( $V_{CCO4T} = 0.4V$ ). This supply sequence and threshold relationship is also illustrated in [Figure 3](#).

**OPTION 2:** Use a power-on sequence where VCCINT is not the last supply to reach its POR threshold level.
