These errata apply **ONLY** to Spartan-3 XC3S200 FPGAs, including both production devices and engineering samples. These errata **DO NOT** apply to any other Spartan-3 FPGA. If using a different Spartan-3 FPGA, check for errata specific to that device.

These errata only apply to the XC3S200 FPGA as shown in [Table 1](#). Both engineering sample (ES) and production silicon (no ES marking) are affected. The [errata details](#) may further limit the class of devices affected by a specific issue.

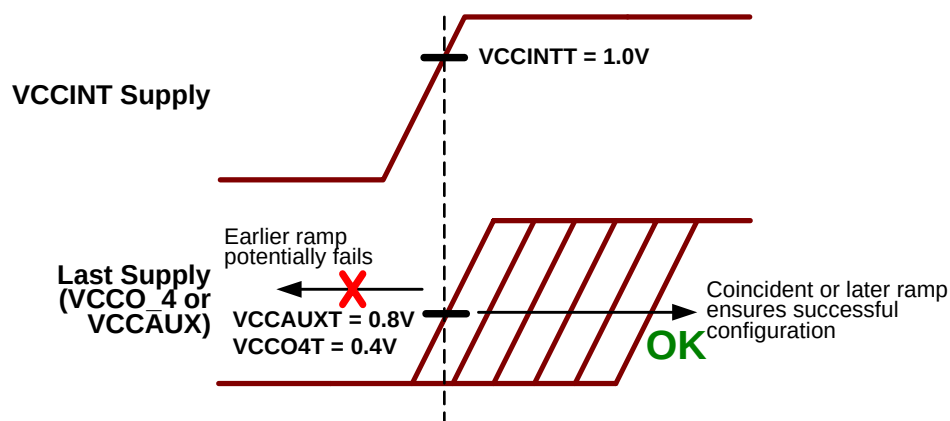
Figure 3: Requirements when VCCINT is not the Last Supply

Three voltage-supply inputs—VCCINT, VCCAUX and the VCCO supply to Bank 4—control the behavior of the Spartan-3 Power On Reset (POR) circuit. When applying power, a Power-On Reset (POR) circuit within the FPGA monitors each of these three rails. Once the voltages on each of the three rails exceed their respective POR thresholds, the POR circuit allows the FPGA to continue with its configuration process.

In the potentially failing condition, the VCCINT supply must be the last supply to reach its valid POR voltage and the ramp rate must be slower than 500  $\mu$ S. When the FPGA fails to configure, the INIT\_B remains Low and the FPGA ignores the PROG\_B program pin. Even with the worst identified power sequence, actual failures only occur on a small percentage of devices, typically measured in parts per million. The issue is more pronounced at cold temperatures.

**OPTION 2:** Use a power-on sequence where VCCINT is not the last supply to reach its POR threshold level.

VCCINT must reach its maximum POR threshold ( $V_{CCINTT} = 1.0V$ ) before or coincident with VCCAUX reaching its minimum threshold ( $V_{CCAUXT} = 0.8V$ ). This supply sequence and threshold relationship is illustrated in [Figure 3](#).

Alternatively, VCCINT must reach its maximum POR threshold ( $V_{CCINTT} = 1.0V$ ) before or coincident with VCCO\_4 supplying I/O bank 4 reaching its minimum threshold ( $V_{CCO4T} = 0.4V$ ). This supply sequence and threshold relationship is also illustrated in [Figure 3](#).
