Thank you for your interest in the Xilinx XC3S700A FPGA device engineering samples. Although Xilinx has made every effort to ensure the highest possible quality, these devices are subject to the limitations described in this errata notification.

**Table 1: XC3S700A Devices Affected by These Errata**

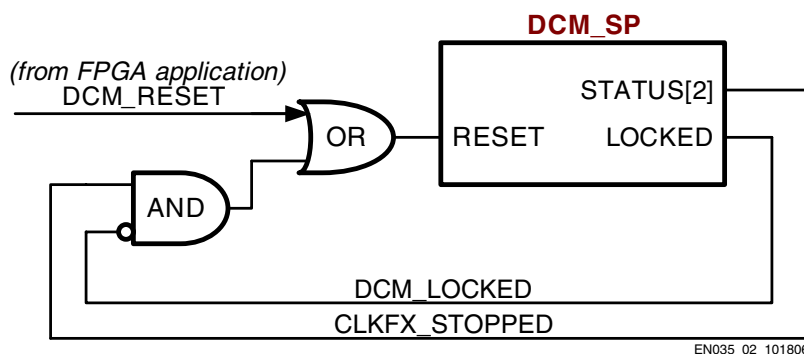
Figure 2: DCM DFS Lock Failure Workaround

### DCM Digital Frequency Synthesizer Requires Additional Lock Circuitry

A small number of DCM DFS locking failures have been observed during characterization.

A software workaround exists, as shown in [Figure 2](#). This circuit is automatically inserted by the ISE development software starting with version 9.1i. Using FPGA logic, the circuit monitors both the LOCKED output from the DCM\_SP function and the STATUS[2] bit, which indicates that the DFS output CLKFX has stopped. If LOCKED = 0 and STATUS[2] = 1, then the circuit asserts the DCM RESET input. If the FPGA application also resets the DCM, then OR the reset signal from the FPGA application with the monitored output signals.
