Thank you for your interest in the Xilinx Spartan™-3AN family XC3S700AN FPGA device engineering samples. Although Xilinx has made every effort to ensure the highest possible quality, these devices are subject to the limitations described in this errata notification. These errata do not apply to the XC3S700AN production FGAs.

These errata apply to the XC3S700AN engineering samples as shown in Table 1. See the top marking in Figure 1.

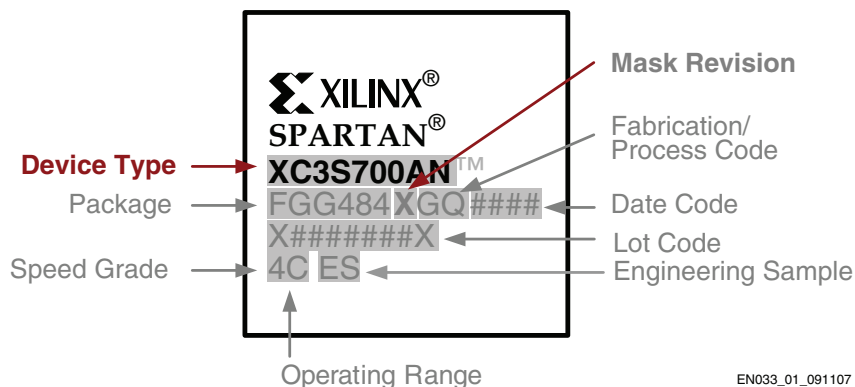
Figure 1: XC3S700AN FPGA Top Marking

XC3S700AN engineering samples are marked as shown in Figure 1. The other devices listed in Table 1 are marked similarly.
