# dsPIC33EPXXXGP50X, dsPIC33EPXXXMC20X/50X and PIC24EPXXXGP/MC20X

## dsPIC33EPXXXGP50X, dsPIC33EPXXXMC20X/50X and PIC24EPXXXGP/MC20X Family Silicon Errata and Data Sheet Clarification

The dsPIC33EPXXXGP50X, dsPIC33EPXXXMC20X/50X and PIC24EPXXXGP/MC20X family devices that you have received conform functionally to the current Device Data Sheet (DS70000657J), except for the anomalies described in this document.

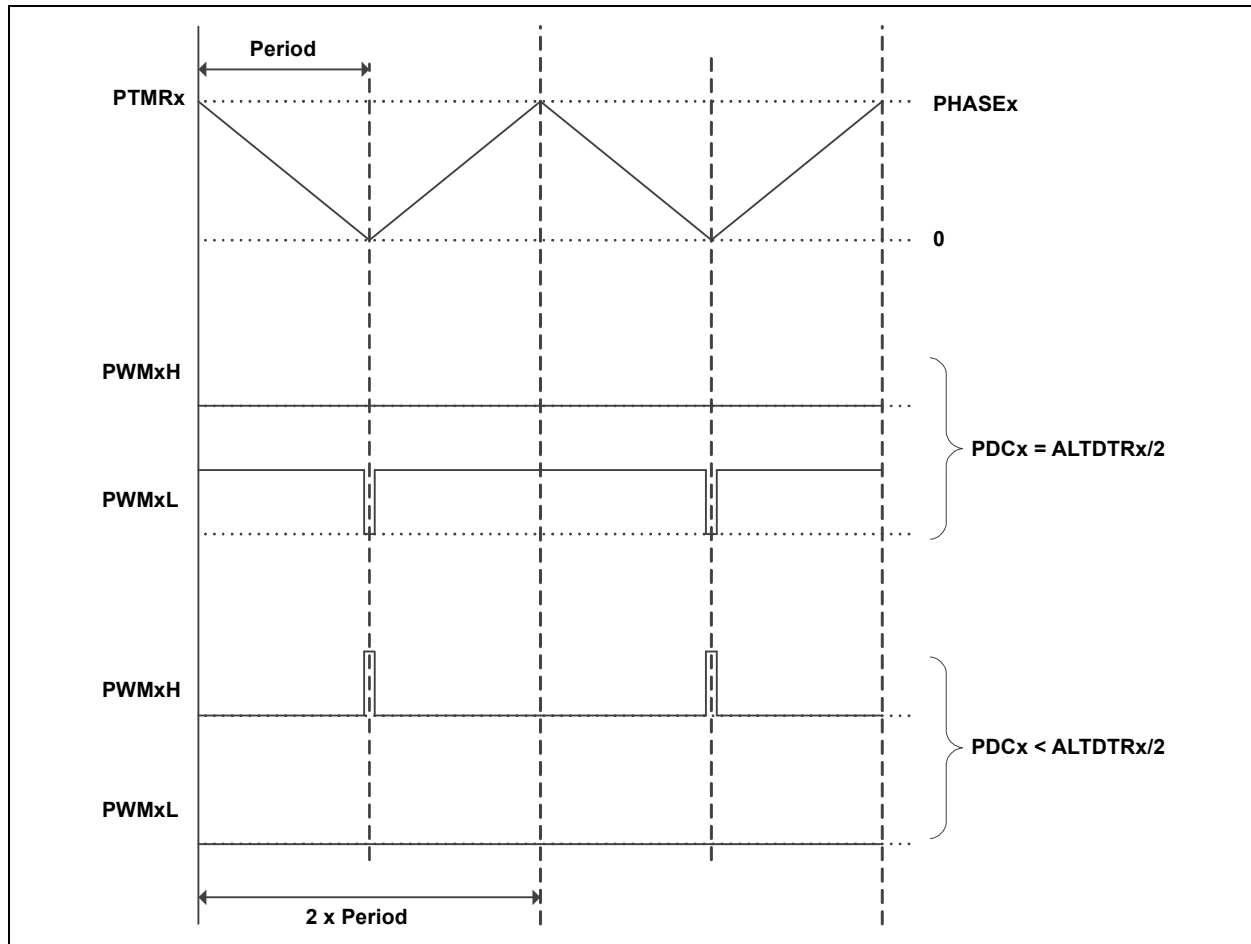
**FIGURE 4: PWM GENERATOR TIMING DIAGRAM**

In Center-Aligned Complementary mode with Independent Time Base, if the value in the PDCx register is less than one-half the value in the ALTDTRx register, the PWM generator will force the PWMxL to low, and on the PWMxH, generate pulses of width less than twice the dead time, as shown in Figure 4.

Include a software routine to ensure that the duty cycle value written to the PDCx register is always at least one-half of the value in ALTDTRx. [Example 3](#) shows one method, with PDCtemp representing the variable which has the value to be written to the PDCx register. Alternatively, for duty cycle values less than half the desired dead-time value, zero out the ALTDTRx register or dynamically reduce the value in the ALTDTRx register, such that ALTDTRx is always equal to 2 \* PDCx, as shown in [Example 4](#).

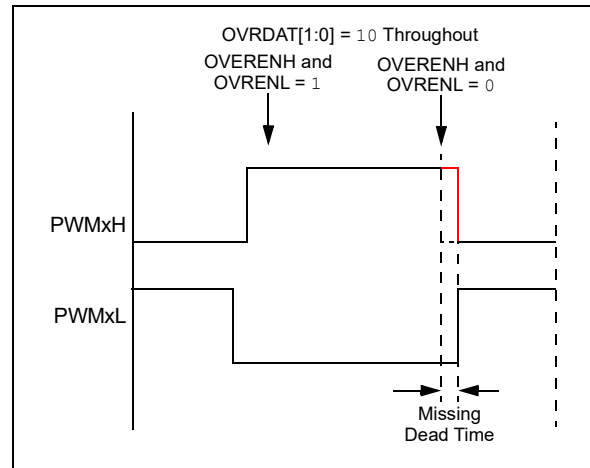
FIGURE 7:

This has been observed in both Center-Aligned and Edge-Aligned modes.

None.

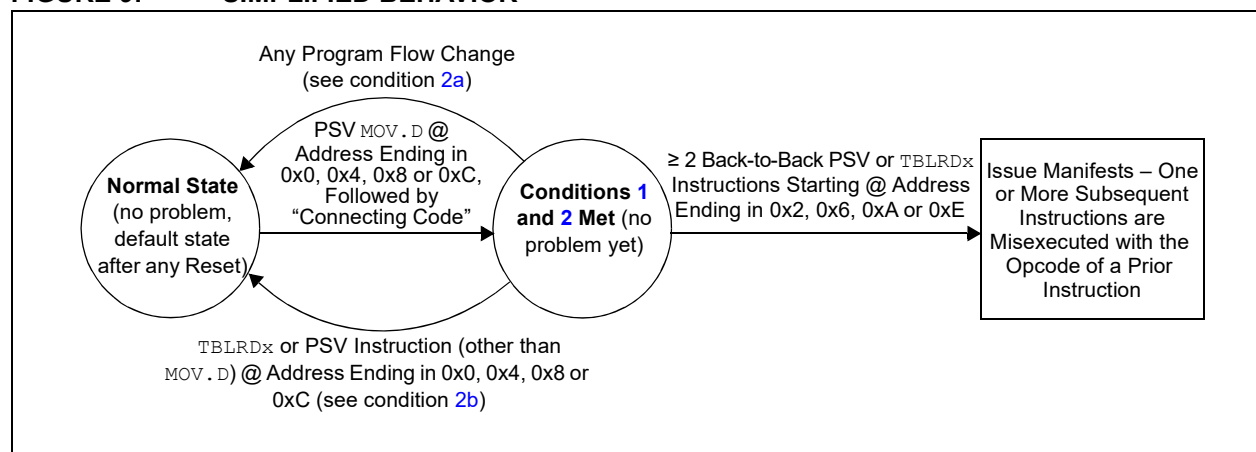
**FIGURE 9: SIMPLIFIED BEHAVIOR**

When two or more data Flash read instructions (via Program Space Visibility (PSV) read or table read) are executed back-to-back, one or more subsequent instructions can be misexecuted when all of the conditions in [Table 6](#) occur.

| 3. | ≥ 2 back-to-back PSV or <code>TBLRDx</code> instructions are executed (following the code of condition 2), where the first of the back-to-back instructions is located at an address ending in 0x2, 0x6, 0xA or 0xE. |

[Figure 9](#) provides an example of the effective behavior.

The issue can be avoided by ensuring any one or more of the requirements are not met. For example:

1. All instances of PSV `MOV.D` can be replaced with two PSV `MOV` instructions instead. Non-PSV `MOV.D` instructions acting on RAM/SFRs do not need to be modified; or
2. If not already present, a program flow change instruction (such as `BRA $+2`) can be inserted above back-to-back data Flash read sequences; or
3. Back-to-back data Flash read instruction sequences can be broken up by inserting a non-Flash read instruction (such as a `NOB`) in between the Flash read instructions; or
4. The alignment of the code can be shifted to avoid the required opcode location addresses.
