## dsPIC30F1010/202X Family Silicon Errata and Data Sheet Clarification

The dsPIC30F1010/202X family devices that you have received conform functionally to the current Device Data Sheet (DS70178C), except for the anomalies described in this document.

**Note:** This document summarizes all silicon errata issues from all revisions of silicon, previous as well as current. Only the issues indicated in the last column of [Table 2](#) apply to the current silicon revision (**A3**).

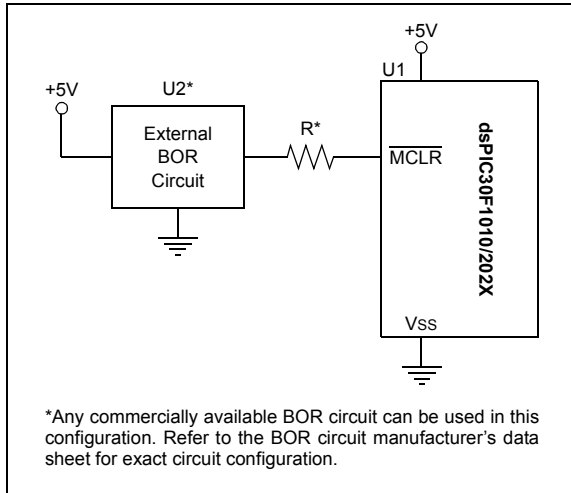
**FIGURE 1:**

It is recommended that an external Brown-out Reset (BOR) circuit be used to hold the device in Reset, during a brown-out event, to overcome this problem. The external BOR circuit will use the MCLR pin to hold the device in Reset. The following work around, in combination with the external BOR circuit, will ensure that the device is cleanly reset after a brown-out event occurs.

The dsPIC DSC SMPS device must be powered up with the PLL disabled, the Fail-Safe Clock Monitor (FSCM) enabled and clock switching enabled. The PLL should be enabled in software via a clock switch after the device is reset (refer to **Section 29. "Oscillator"** (DS70268) in the *"dsPIC30F Family Reference Manual"* for details on clock switching). This ensures that the MCLR pin is functional and that the device can be reset by an external BOR circuit (see [Figure 1](#)).
