## dsPIC30F4011/4012 Family Silicon Errata and Data Sheet Clarification

The dsPIC30F4011/4012 family devices that you have received conform functionally to the current Device Data Sheet (DS70135F), except for the anomalies described in this document.

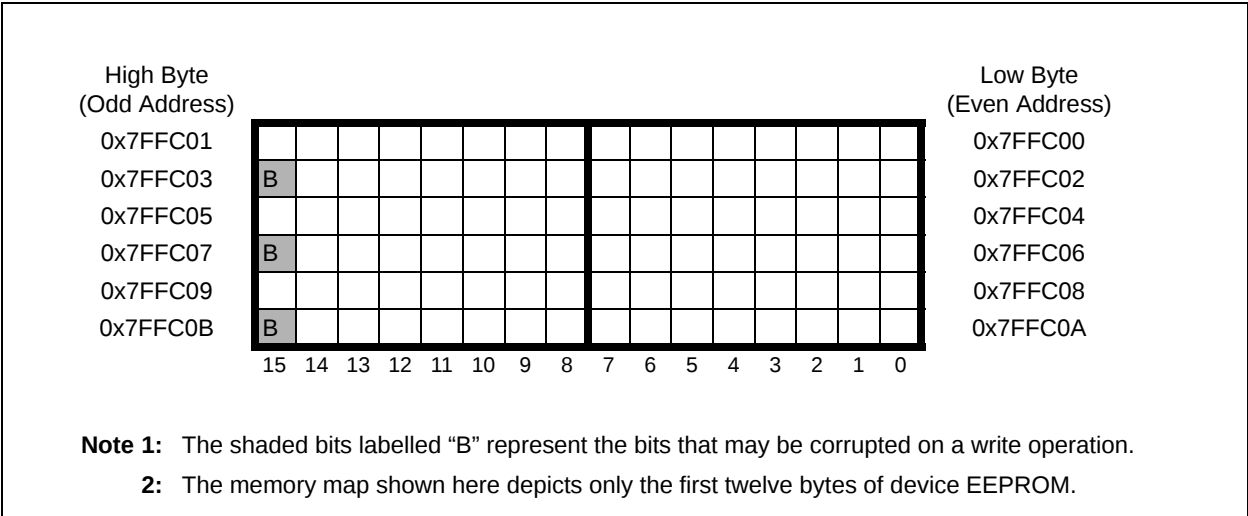
FIGURE 1: dsPIC30F4011/4012 DATA EEPROM

| Module | Feature | Item Number | Issue Summary | Affected Revisions <sup>(1)</sup> | | | |
|---|---|---|---|---|---|---|---|
| Data EEPROM | — | 26. | The Most Significant bit (MSb) of every fourth byte in Data EEPROM may be corrupted. | X | | | |
