**MICROCHIP****dsPIC30F6011/6012/6013/6014**

## dsPIC30F6011/6012/6013/6014 Family Silicon Errata and Data Sheet Clarification

The dsPIC30F6011/6012/6013/6014 family devices that you have received conform functionally to the current Device Data Sheet (DS70117F), except for the anomalies described in this document.

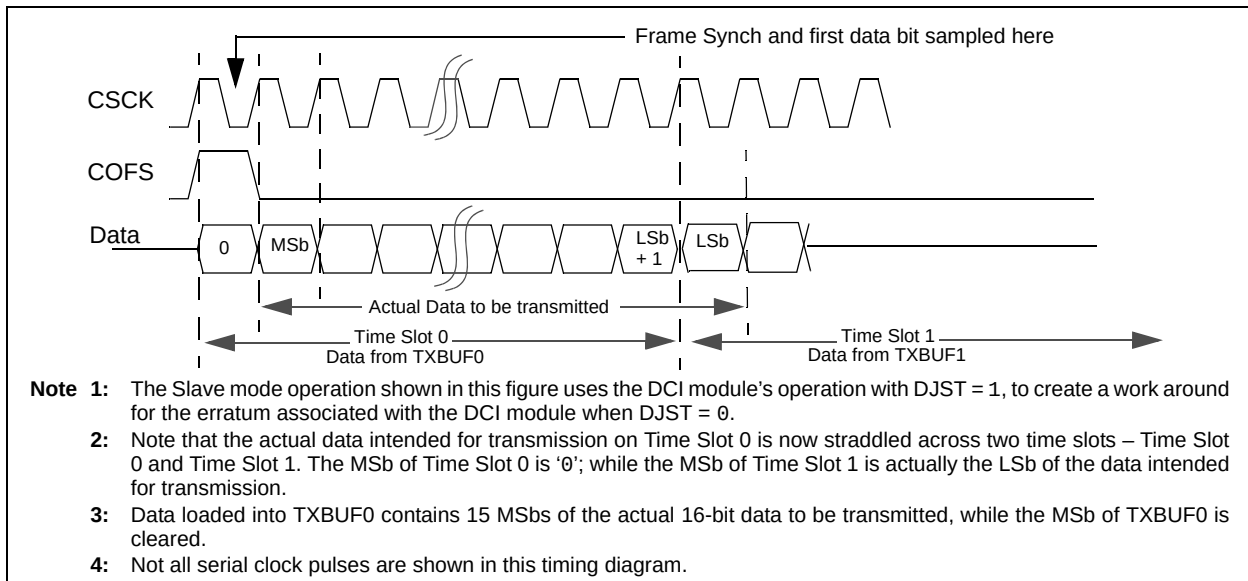
**FIGURE 1: DCI SLAVE WORK AROUND**

The Data Converter Interface (DCI) module does not function correctly in Slave mode when the following conditions are true:
