## dsPIC33CH512MP508 Family Silicon Errata and Data Sheet Clarification

The dsPIC33CH512MP508 family devices that you have received conform functionally to the current Device Data Sheet (DS70005371D), except for the anomalies described in this document.

The silicon issues discussed in the following pages are for silicon revisions with the Device and Revision IDs listed in [Table 1](#). The silicon issues are summarized in [Table 2](#).

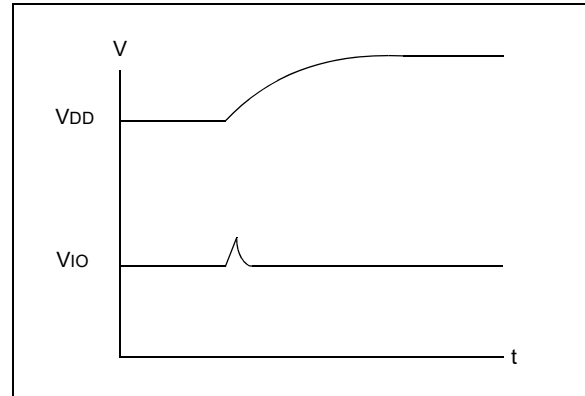
FIGURE 1-1: I/O RAMP

During a fast device power-up, when the  $V_{DD}$  ramp is less than 4 mS, the I/O pins may drive up to 100  $\mu$ A current for a duration of up to 10  $\mu$ S (Figure 1-1).

Example applications affected may include complementary power switches, where a transient current shoot-through might occur. High-voltage applications with complementary switches should power the high-voltage 200  $\mu$ Sec later than powering the dsPIC<sup>®</sup> device to avoid the current shoot-through. This behavior is specific to each device and not affected by aging.

1. Slow down the  $V_{DD}$  ramp time (greater than 4 mS for  $V_{DD}$  to ramp 0V to 3.3V).
2. Ensure the circuitry that is connected to the pins can endure this pulse.
