## dsPIC33EPXXGS50X Family Silicon Errata and Data Sheet Clarification

The dsPIC33EPXXGS50X family devices that you have received conform functionally to the current Device Data Sheet (DS70005127D), except for the anomalies described in this document.

The silicon issues discussed in the following pages are for silicon revisions with the Device and Revision IDs listed in [Table 1](#). The silicon issues are summarized in [Table 2](#).

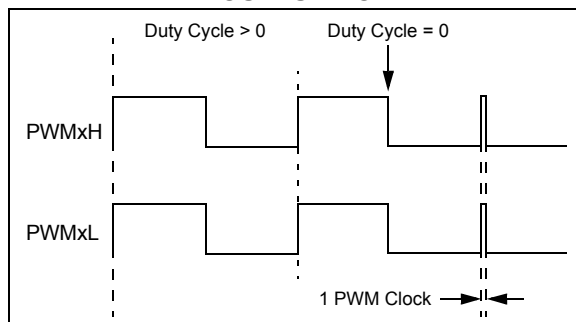
**FIGURE 1: EXAMPLE FOR REDUNDANT OUTPUT MODE**

In the Redundant Output mode (IOCONx[11:10] = 0b01) and Push-Pull Output mode (IOCONx[11:10] = 0b10), with the Immediate Update Enable bit disabled (PWMCONx[0] = 0), when the Duty Cycle register is updated from a non-zero value to zero, a glitch pulse of a width equal to one PWM clock will appear at the next PWM period boundary, as shown in Figure 1 (for the Redundant Output mode). The Duty Cycle register refers to the PDCx register if PWMCONx[8] = 0 or the MDC register if PWMCONx[8] = 1.

If the application requires a zero duty cycle output, there are two possible work around methods:

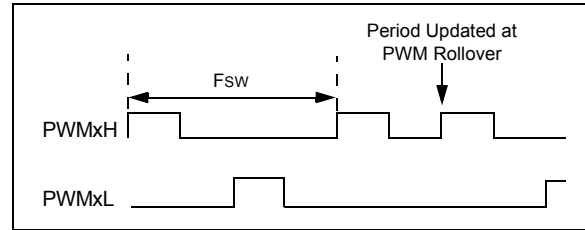
FIGURE 2:

When the PWM module is configured for Push-Pull mode (IOCONx[11:10] = 0b10) with the Enable Immediate Period Update bit enabled (PTCON[10] = 1), a write to the Period register that coincides with the period rollover event may cause the push-pull output logic to produce back-to-back pulses on the PWMx pins (Figure 2).

Ensure that the update to the PWM Period register occurs away from the PWM rollover event by setting the EIPU bit (PTCON[10] = 1). Use either the PWM Special Event Trigger (SEVTCMP) or the PWM Primary Trigger (TRIGx) to generate a PWM Interrupt Service Routine (ISR) near the start of the PWM cycle. This ISR will ensure that period writes do not occur near the PWM period rollover event.

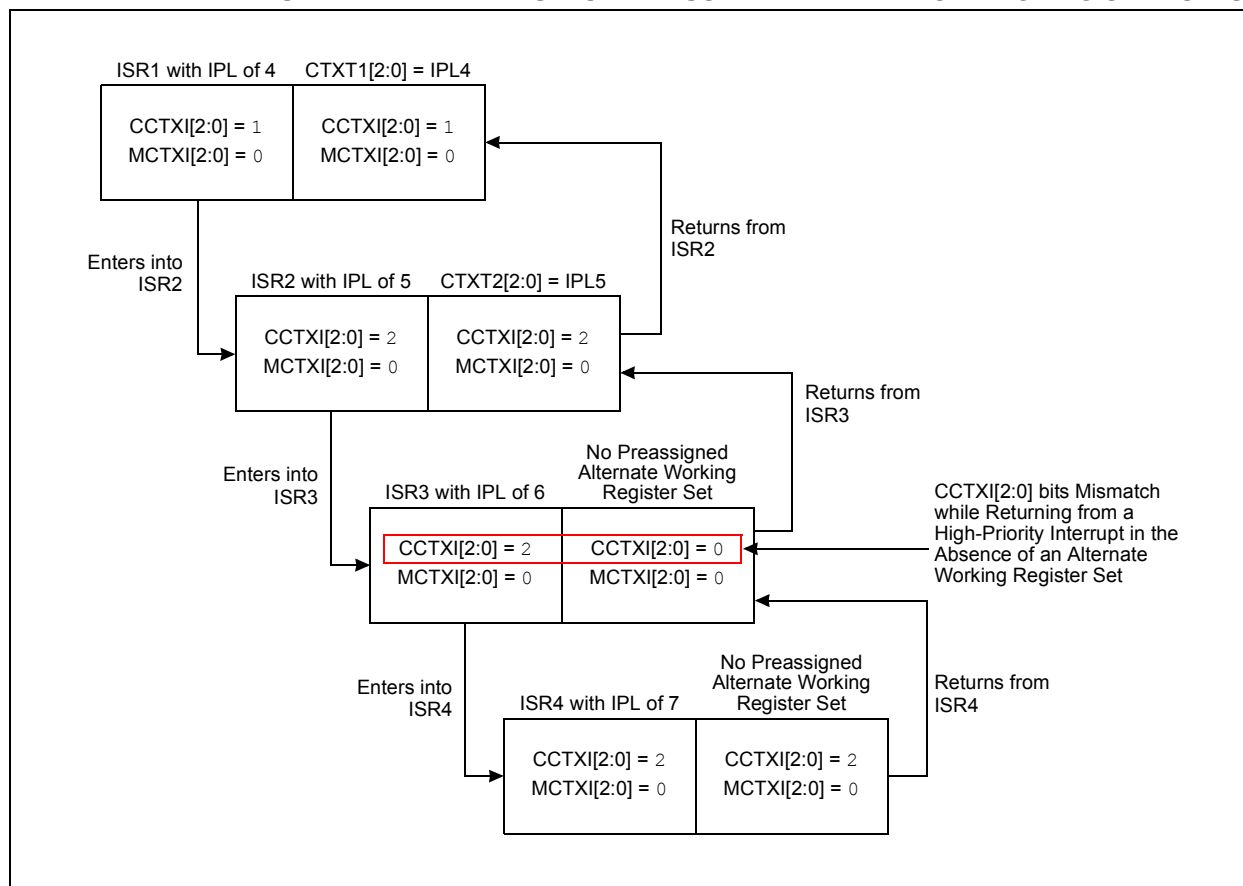
**FIGURE 3: MISMATCH OF WORKING REGISTER SET WHEN NESTING MORE THAN ONE INTERRUPT WITHIN INTERRUPTS THAT USE ALTERNATE WORKING REGISTER SETS**

Issue and work around are illustrated in [Figure 3](#) and [Figure 4](#), respectively. The figures show the status bits, `CCTXI[2:0]` and `MCTXI[2:0]`, after entering into an ISR from a lower priority ISR (left pane), and after returning to the same ISR from a higher priority ISR (right pane).

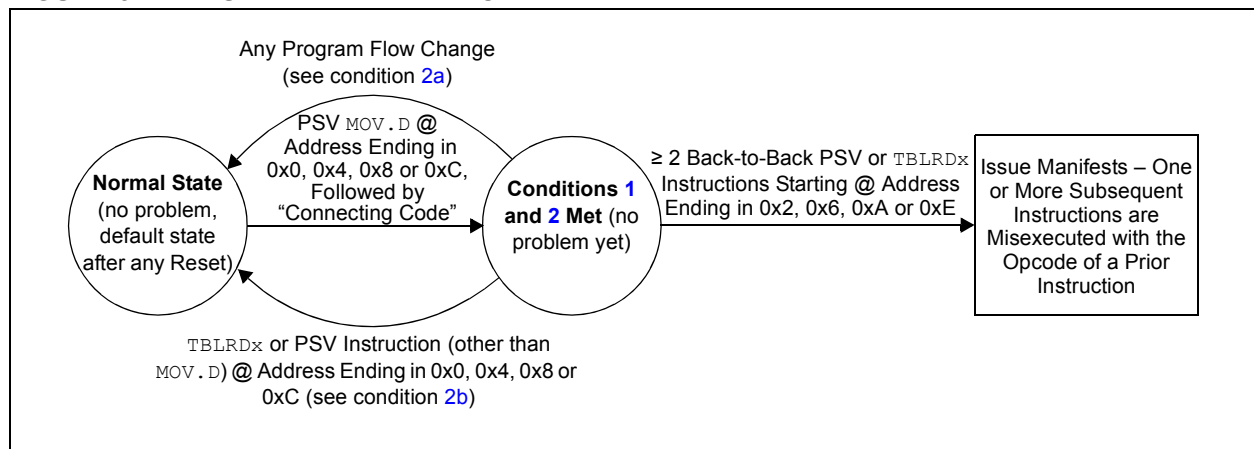
**FIGURE 5: SIMPLIFIED BEHAVIOR**

When two or more data Flash read instructions (via Program Space Visibility (PSV) read or table read) are executed back-to-back, one or more subsequent instructions can be misexecuted when all of the conditions in [Table 5](#) occur.

[Figure 5](#) provides an example of the effective behavior.

1. All instances of PSV `MOV.D` can be replaced with two PSV `MOV` instructions instead. Non-PSV `MOV.D` instructions acting on RAM/SFRs do not need to be modified; or
2. If not already present, a program flow change instruction (such as `BRA $+2`) can be inserted above back-to-back data Flash read sequences; or
3. Back-to-back data Flash read instruction sequences can be broken up by inserting a non-Flash read instruction (such as a `NOP`), in between the Flash read instructions; or
4. The alignment of the code can be shifted to avoid the required opcode location addresses.

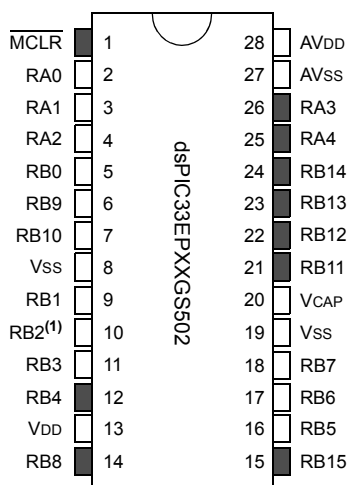
#### 28-Pin SOIC

A note has been added to the RB2 port pin, as shown below in **bold**. This note applies to RB2 on all available packages.

**Note 1:** At device power-up (POR), a pulse with an amplitude around 2V and a duration greater than 500  $\mu$ s, may be observed on this device pin independent of pull-down resistors. It is recommended not to use this pin as an output driver unless the circuit being driven can endure this active duration.
