## dsPIC33EPXXGS202 Family Silicon Errata and Data Sheet Clarification

The dsPIC33EPXXGS202 family devices that you have received conform functionally to the current Device Data Sheet (DS70005208E), except for the anomalies described in this document.

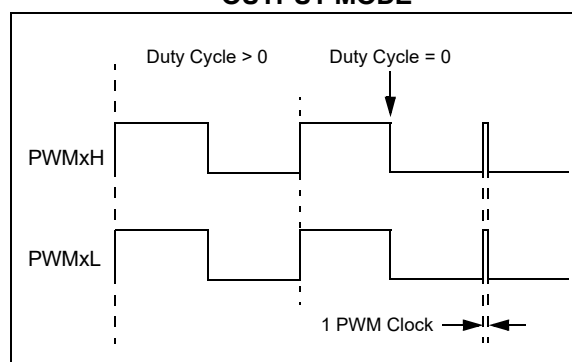
**FIGURE 1: EXAMPLE FOR REDUNDANT OUTPUT MODE**

In the Redundant Output mode (`IOCONx[11:10] = 0b01`) and Push-Pull Output mode (`IOCONx[11:10] = 0b10`), with the Immediate Update Enable bit disabled (`PWMCONx[0] = 0`), when the Duty Cycle register is updated from a non-zero value to zero, a glitch pulse of a width equal to one PWM clock will appear at the next PWM period boundary, as shown in Figure 1 (for the Redundant Output mode). The Duty Cycle register refers to the `PDCx` register if `PWMCONx[8] = 0` or the `MDC` register if `PWMCONx[8] = 1`.

If the application requires a zero duty cycle output, there are two possible work around methods:

1. Use the PWM override feature to override the PWM output to a low state instead of writing to the Duty Cycle register. In order to switch back to a non-zero duty cycle output, turn off the PWM override. The override-on and override-off events must be timed close to the PWM period boundary if the `IOCONx` register has been configured with `IOCONx[0] = 0` (i.e., output overrides through the `OVDDAT[1:0]` bits occur on the next CPU clock boundary).
2. Enable the Immediate Update Enable bit (`PWMCONx[0] = 1`) while configuring the PWMx module (i.e., before enabling the PWMx module, `PTCON[15] = 1`). With the Immediate Update enabled, writes to the Duty Cycle register can have an immediate effect on the PWM output. Therefore, the duty cycle write operations must be timed close to the PWM period boundary in order to avoid distortions in the PWM output.

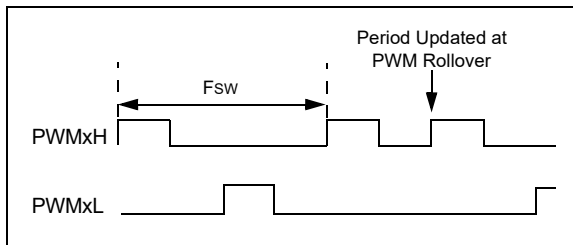
FIGURE 2:

When the PWM module is configured for Push-Pull mode (IOCONx[11:10] = 0b10) with the Enable Immediate Period Update bit enabled (PTCON[10] = 1), a write to the Period register that coincides with the period rollover event may cause the push-pull output logic to produce back-to-back pulses on the PWMx pins (Figure 2).

If the EIPU bit is set (PTCON[10] = 1), ensure that the update to the PWM Period register occurs away from the PWM rollover event. Use either the PWM Special Event Trigger (SEVTCMP) or the PWM Primary Trigger (TRIGx) to generate a PWM Interrupt Service Routine (ISR) near the start of the PWM cycle. The PWM Period register could be updated inside this ISR so that the period writes do not occur near the PWM period rollover event.

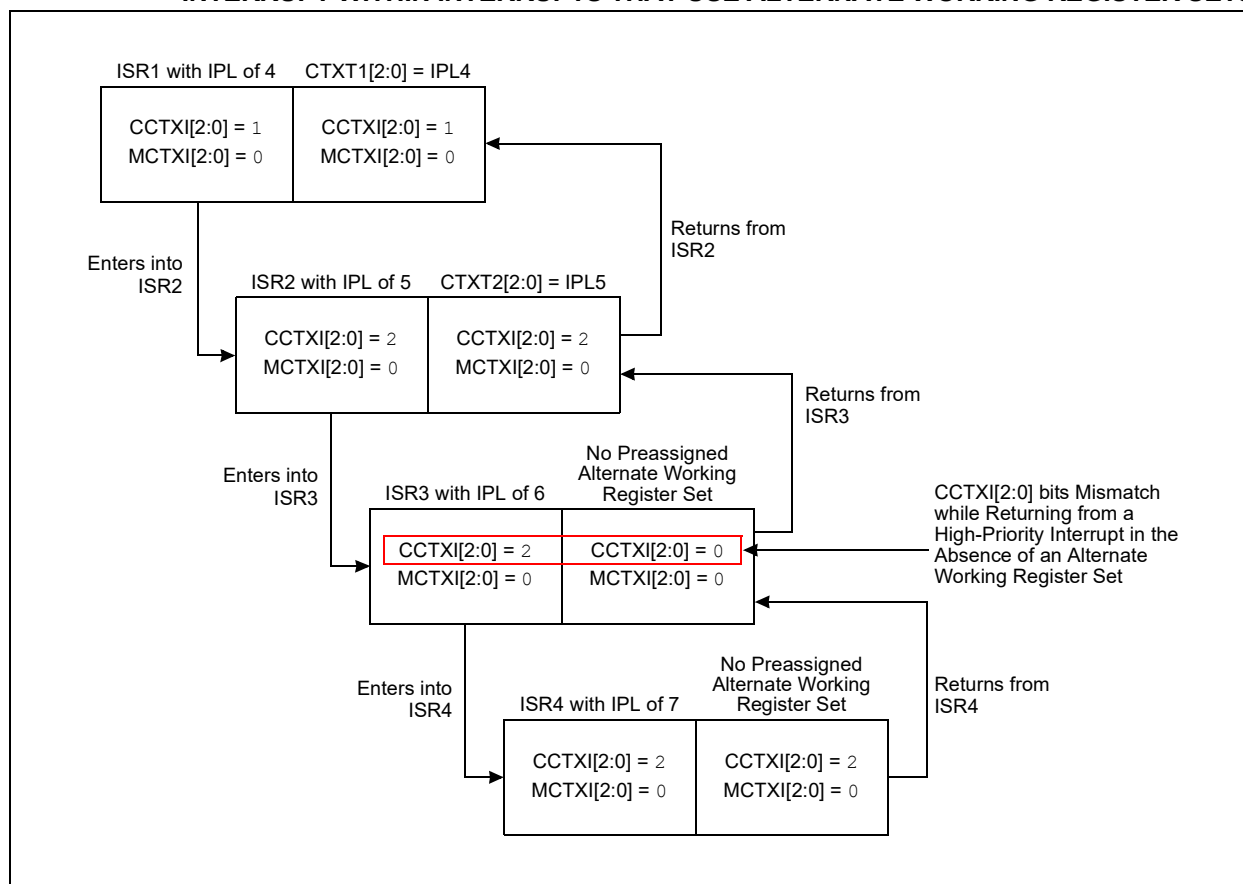
**FIGURE 3: MISMATCH OF WORKING REGISTER SET WHEN NESTING MORE THAN ONE INTERRUPT WITHIN INTERRUPTS THAT USE ALTERNATE WORKING REGISTER SETS**

Issue and work around are illustrated in [Figure 3](#) and [Figure 4](#), respectively. The figures show the status bits, `CCTXI[2:0]` and `MCTXI[2:0]`, after entering into an ISR from a lower priority ISR (left pane), and after returning to the same ISR from a higher priority ISR (right pane).

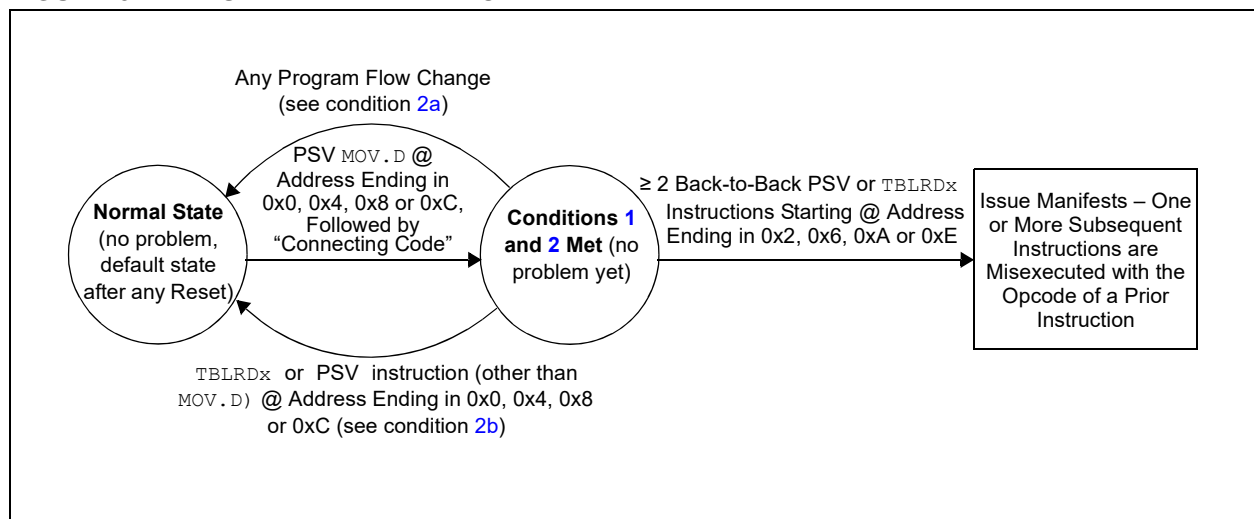
**FIGURE 5: SIMPLIFIED BEHAVIOR**

When two or more data Flash read instructions (via Program Space Visibility (PSV) read or table read) are executed back-to-back, one or more subsequent instructions can be misexecuted when all of the conditions in [Table 4](#) occur.

[Figure 5](#) provides an example of the effective behavior.

1. All instances of PSV MOV.D can be replaced with two PSV MOV instructions instead. Non-PSV MOV.D instructions acting on RAM/SFRs do not need to be modified; or
2. If not already present, a program flow change instruction (such as BRA \$+2) can be inserted above back-to-back data Flash read sequences; or
3. Back-to-back data Flash read instruction sequences can be broken up by inserting a non-Flash read instruction (such as a NOP), in between the Flash read instructions; or
4. The alignment of the code can be shifted to avoid the required opcode location addresses.

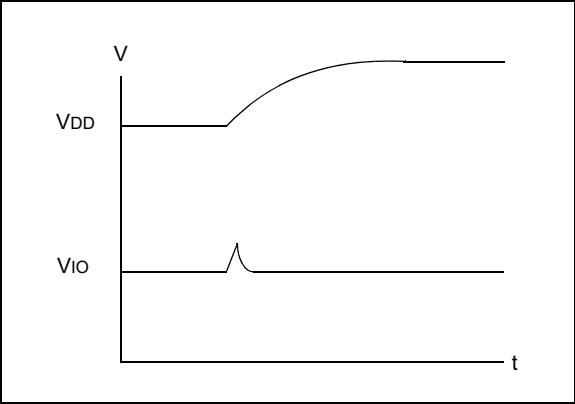
FIGURE 6: I/O RAMP

During device power-up, the I/O pins may drive up to 100  $\mu$ A current for a duration of up to 300  $\mu$ S. (Figure 6).

Ensure the circuitry that is connected to the pins can endure this pulse.
