# dsPIC33EPXXX(GP/MC/MU)806/810/814 and PIC24EPXXX(GP/GU)810/814

## dsPIC33EPXXX(GP/MC/MU)806/810/814 and PIC24EPXXX(GP/GU)810/814 Family Silicon Errata and Data Sheet Clarification

The dsPIC33EPXXX(GP/MC/MU)806/810/814 and PIC24EPXXX(GP/GU)810/814 family devices that you have received conform functionally to the current Device Data Sheet (DS70616G), except for the anomalies described in this document.

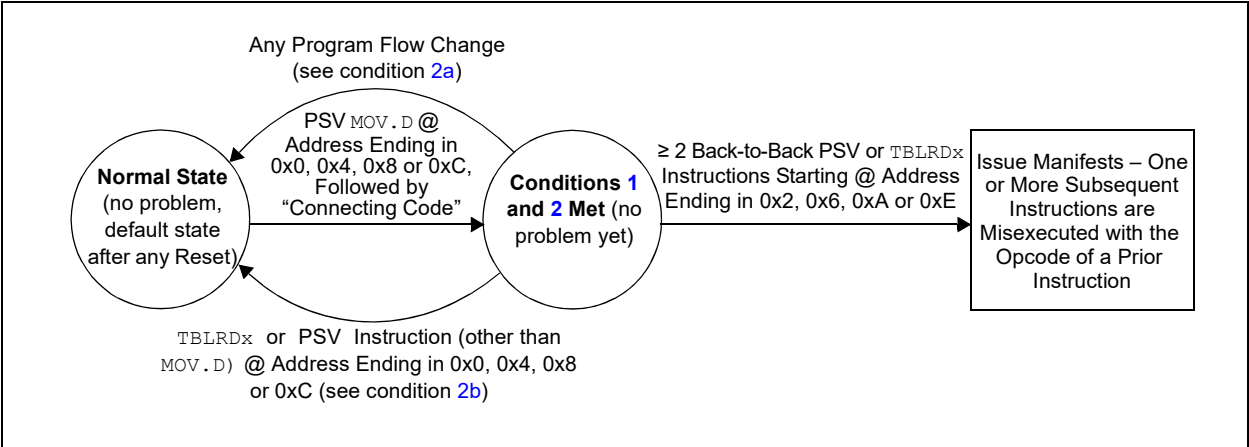
FIGURE 1: SIMPLIFIED BEHAVIOR

When two or more data Flash read instructions (via Program Space Visibility (PSV) read or table read) are executed back-to-back, one or more subsequent instructions can be misexecuted when all of the conditions in Table 3 occur.

| 3. | ≥ 2 back-to-back PSV or <code>TBLRDx</code> instructions are executed (following the code of condition 2), where the first of the back-to-back instructions is located at an address ending in 0x2, 0x6, 0xA or 0xE. |

Figure 1 provides an example of the effective behavior.

The issue can be avoided by ensuring any one or more of the requirements are not met. For example:

1. All instances of PSV `MOV.D` can be replaced with two PSV `MOV` instructions instead. Non-PSV `MOV.D` instructions acting on RAM/SFRs do not need to be modified; or
2. If not already present, a program flow change instruction (such as `BRA $+2`) can be inserted above back-to-back data Flash read sequences; or
3. Back-to-back data Flash read instruction sequences can be broken up by inserting a non-Flash read instruction (such as a `NOB`) in between the Flash read instructions; or
4. The alignment of the code can be shifted to avoid the required opcode location addresses.
