## dsPIC33EPXXXGM3XX/6XX/7XX Family Silicon Errata and Data Sheet Clarification

The dsPIC33EPXXXGM3XX/6XX/7XX family devices that you have received conform functionally to the current Device Data Sheet (DS70000689D), except for the anomalies described in this document.

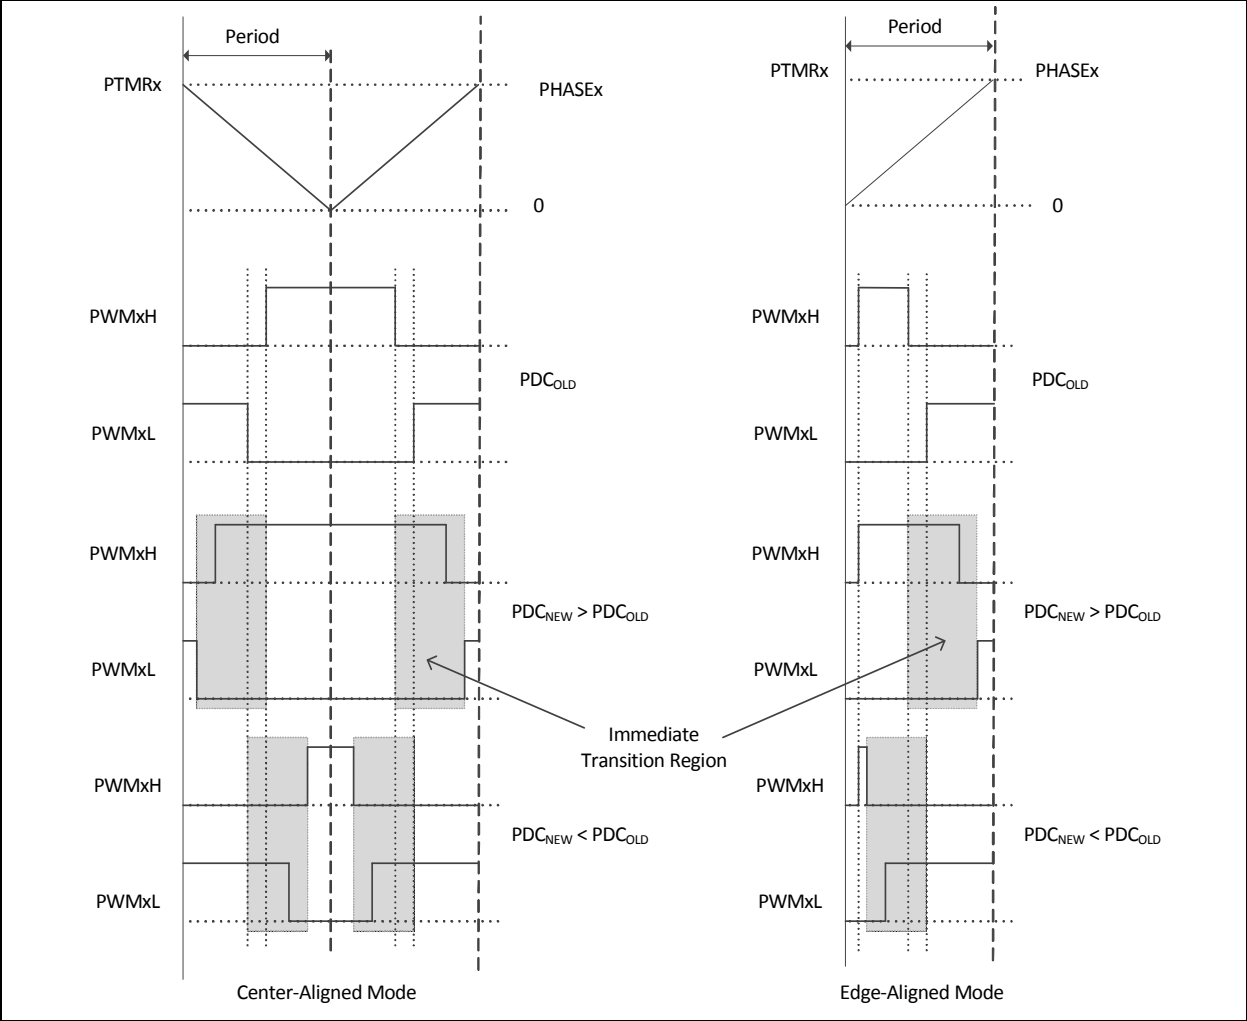
FIGURE 1: TIMING DIAGRAMS FOR CENTER-ALIGNED AND EDGE-ALIGNED MODES

The PWM generator may not assert dead time on the edges of transitions. This has been observed when all of the following conditions are present:

In [Figure 1](#), if the duty cycle write occurred in the shaded box, then PWMxH and PWMxL will make an immediate transition without dead time.

None.

In most applications, the duty cycle update timing can be controlled using the TRIGx trigger, or Special Event Trigger, such that the above mentioned conditions are avoided altogether.

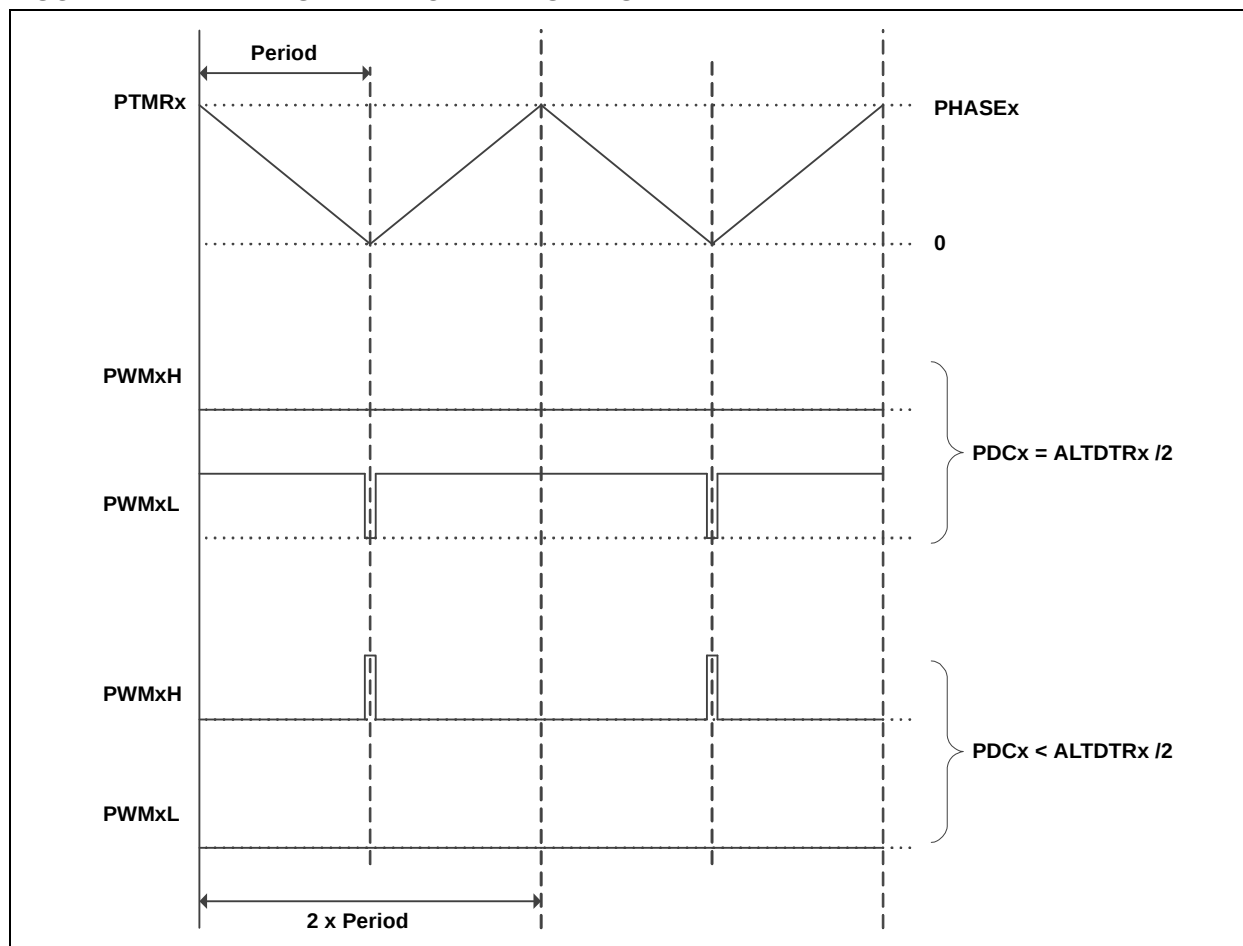
**FIGURE 2: PWM GENERATOR TIMING DIAGRAM**

In Center-Aligned Complementary mode with Independent Time Base, if the value in the PDCx register is less than one-half the value in the ALTDTRx register, the PWM generator will force the PWMxL to low, and on the PWMxH, generates pulses of a width less than twice the dead time, as shown in Figure 2.

Include a software routine to ensure that the duty cycle value written to the PDCx register is at least one-half of the value in ALTDTRx. Example 1 shows one method, with PDCtemp representing the variable which has the value to be written to the PDCx register. Alternatively, for duty cycle values less than half the desired dead-time value, zero out the ALTDTRx register or dynamically reduce the value in the ALTDTRx register, such that ALTDTRx is always equal to  $2 \times PDCx$ , as shown in Example 2.

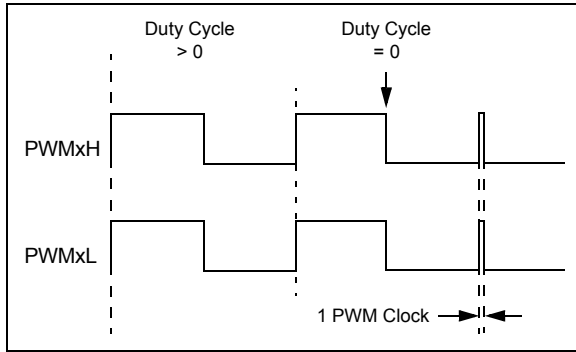
**FIGURE 3:**

In certain output modes, the PWMx module produces a pulse glitch of one PWM clock in width (Figure 3). This has been observed only when all of the following are true:

The pulse glitch has been observed to occur at the beginning of the following PWM boundary period.

If the application requires a duty cycle of zero, two possible work arounds are available.

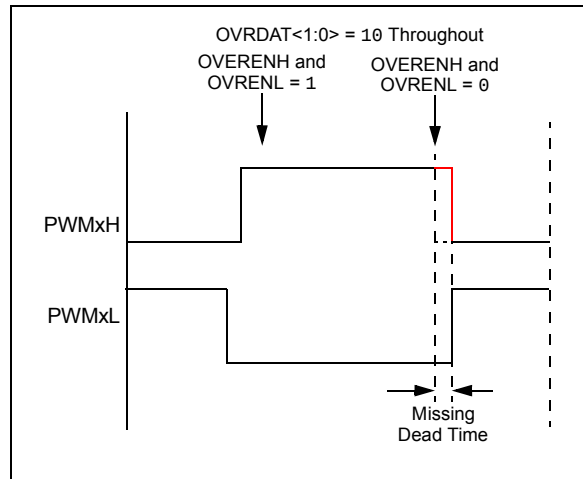
**FIGURE 4:**

This has been observed in both Center-Aligned and Edge-Aligned modes.

None.

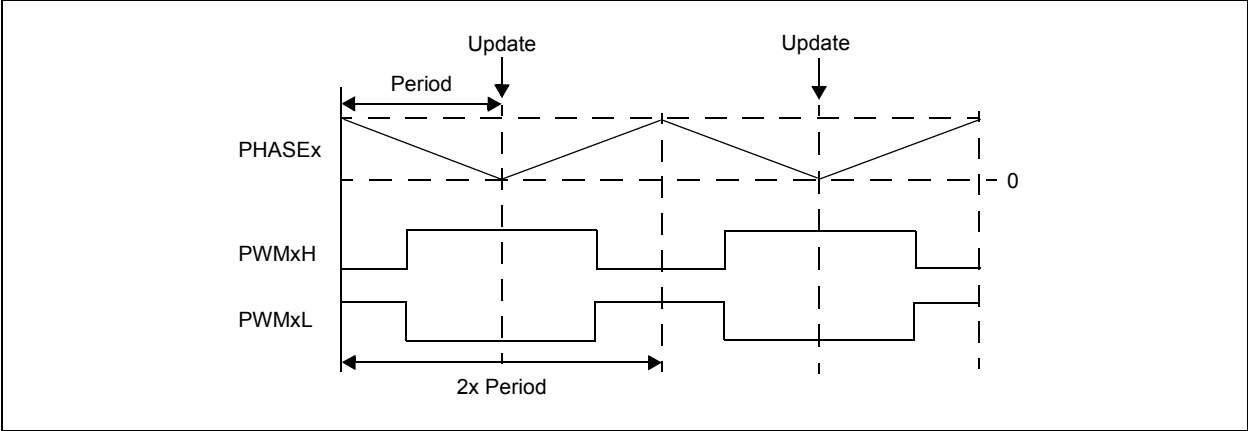
FIGURE 5:

In Center-Aligned Complementary mode with Independent Time Base, updates to the PHASEx register take effect in the middle of a Center-Aligned PWM cycle, as shown in Figure 5. This occurs only when the Immediate Update feature is disabled (IUE = 0). If Immediate Update is enabled (IUE = 1), the PHASEx register updates will take effect immediately.

None.

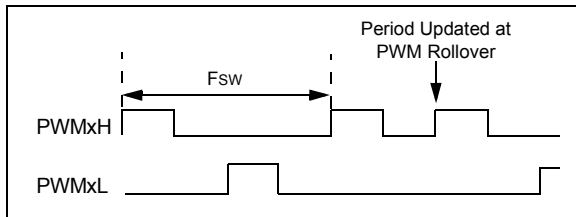
**FIGURE 6:**

When the PWM module is configured for Push-Pull mode (IOCONx<11:10> = 10) with the Enable Immediate Period Update bit enabled (PTCON<10> = 1), a write to the Period register that coincides with the period rollover event may cause the push-pull output logic to produce back-to-back pulses on the PWMx pins (Figure 6).

Ensure that the update to the PWM Period register occurs away from the PWM rollover event by setting the EIPU bit (PTCON<10> = 1). Use either the PWM Special Event Trigger (SEVTCMP) or the PWM Primary Trigger (TRIGx) to generate a PWM Interrupt Service Routine (ISR) near the start of the PWM cycle. This ISR will ensure that period writes do not occur near the PWM period rollover event.

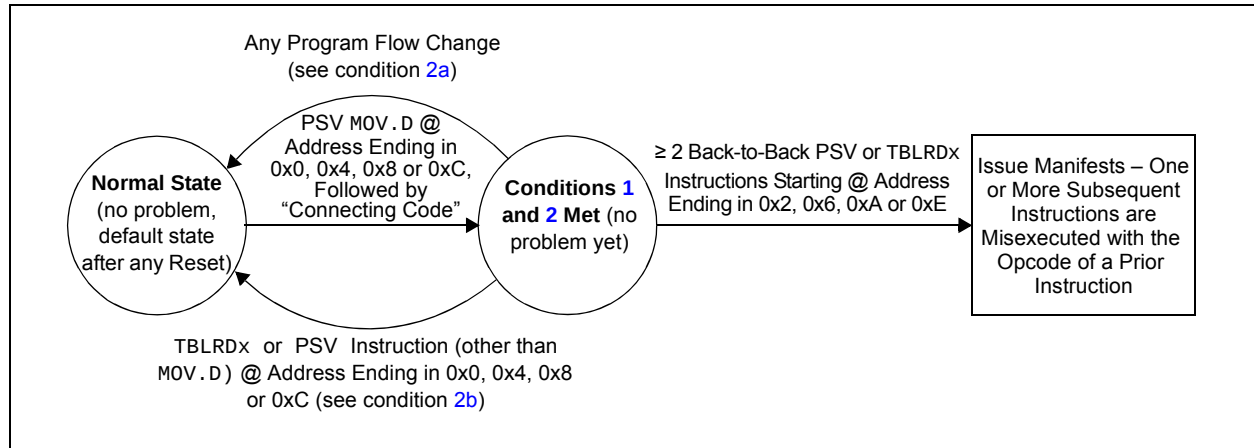
**FIGURE 7: SIMPLIFIED BEHAVIOR**

When two or more data Flash read instructions (via Program Space Visibility (PSV) read or table read) are executed back-to-back, one or more subsequent instructions can be misexecuted when all of the conditions in [Table 6](#) occur.

[Figure 7](#) provides an example of the effective behavior.

1. All instances of PSV MOV.D can be replaced with two PSV MOV instructions instead. Non-PSV MOV.D instructions acting on RAM/SFRs do not need to be modified; or
2. If not already present, a program flow change instruction (such as BRA \$+2) can be inserted above back-to-back data Flash read sequences; or
3. Back-to-back data Flash read instruction sequences can be broken up by inserting a non-Flash read instruction (such as a NOP), in between the Flash read instructions; or
4. The alignment of the code can be shifted to avoid the required opcode location addresses.
