## dsPIC33EPXXXGS70X/80X Family Silicon Errata and Data Sheet Clarification

The dsPIC33EPXXXGS70X/80X family devices that you have received conform functionally to the current Device Data Sheet (DS70005258C), except for the anomalies described in this document.

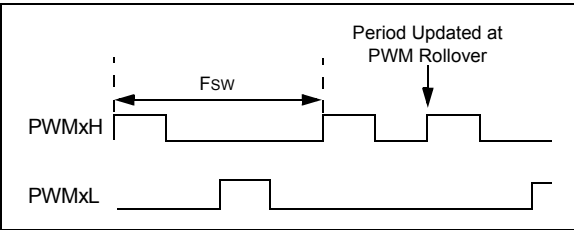
FIGURE 1:

When the PWM module is configured for Push-Pull mode (IOCONx[11:10] = 0b10) with the Enable Immediate Period Update bit enabled (PTCON [10] = 1), a write to the Period register that coincides with the period rollover event may cause the push-pull output logic to produce back-to-back pulses on the PWMx pins (see Figure 1).

Ensure that the update to the PWM Period register occurs away from the PWM rollover event by setting the EIPU bit (PTCON[10] = 1). Use either the PWM Special Event Trigger (SEVTCMP) or the PWM Primary Trigger (TRIGx) to generate a PWM Interrupt Service Routine (ISR) near the start of the PWM cycle. This ISR will ensure that period writes do not occur near the PWM period rollover event.

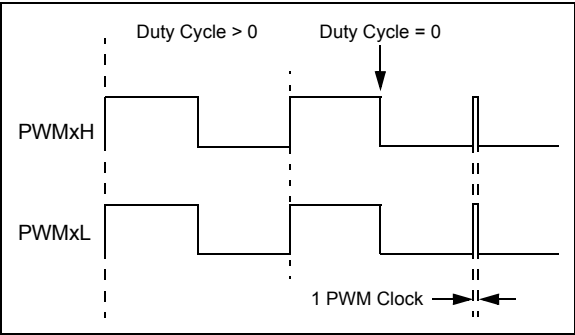
FIGURE 2: EXAMPLE FOR REDUNDANT OUTPUT MODE

In the Redundant Output mode (IOCONx[11:10] = 0b01) and Push-Pull Output mode (IOCONx[11:10] = 0b10), with the Immediate Update Enable bit disabled (PWMCONx[0] = 0), when the Duty Cycle register is updated from a non-zero value to zero, a glitch pulse of a width equal to 1 PWM clock will appear at the next PWM period boundary, as shown in Figure 2 (for the Redundant Output mode). The Duty Cycle register refers to the PDCx register if PWMCONx[8] = 0 or the MDC register if PWMCONx[8] = 1.

If the application requires a zero duty cycle output, there are two possible work around methods:

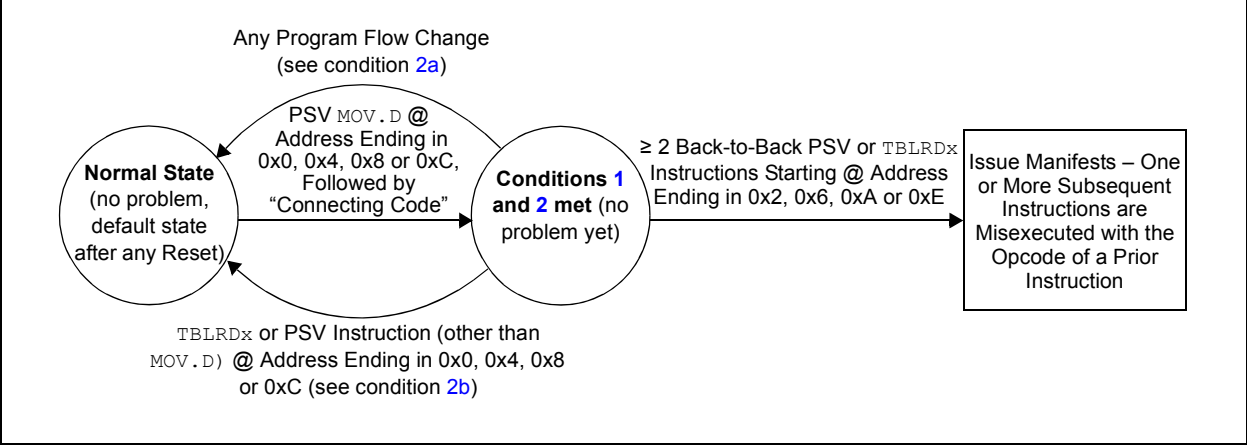
FIGURE 3: SIMPLIFIED BEHAVIOR

When two or more data Flash read instructions (via Program Space Visibility (PSV) read or Table Read) are executed back-to-back, one or more subsequent instructions can be misexecuted when all of the conditions in Table 4 occur.

Figure 3 provides an example of the effective behavior.

The issue can be avoided by ensuring any one or more of the requirements are not met. For example:

1. All instances of PSV `MOV.D` can be replaced with two PSV `MOV` instructions instead. Non-PSV `MOV.D` instructions acting on RAM/SFRs do not need to be modified; or
2. If not already present, a program flow change instruction (such as `BRA $+2`) can be inserted above back-to-back data Flash read sequences; or
3. Back-to-back data Flash read instruction sequences can be broken up by inserting a non-Flash read instruction (such as a `NOP`), in between the Flash read instructions; or
4. The alignment of the code can be shifted to avoid the required opcode location addresses.
