**dsPIC33EVXXXGM00X/10X FAMILY**

## **dsPIC33EVXXXGM00X/10X Family Silicon Errata and Data Sheet Clarification**

The dsPIC33EVXXXGM00X/10X family devices that you have received conform functionally to the current Device Data Sheet (DS70005144H), except for the anomalies described in this document.

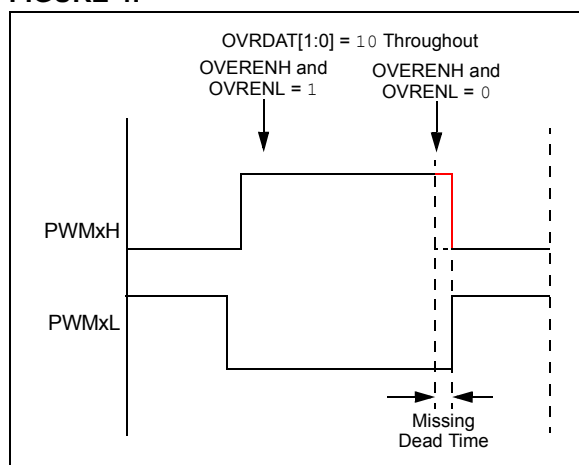
FIGURE 4:

- Output override synchronization is configured to occur on the CPU clock boundary (IOCONx[0] = 0);
- Both PWMxH and PWMxL overrides are enabled prior to the event (OVRENH and OVRENL are both '1'), and
- Both overrides are disabled (OVRENH and OVRENL are both '0') at the instant the dead time should be asserted (Figure 4). This has been observed in both Center-Aligned and Edge-Aligned modes.

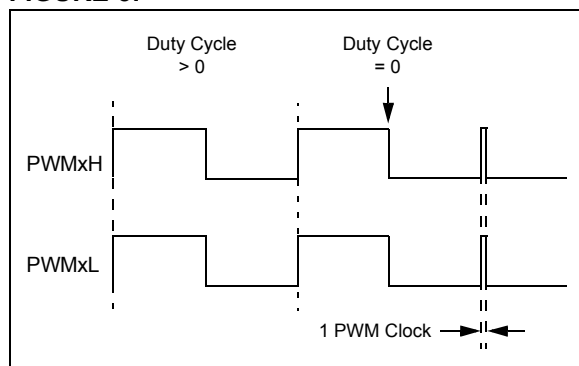
**FIGURE 5:**

In the Redundant Output mode (IOCONx[11:10] = 10) and Push-Pull Output mode (IOCONx[11:10] = 01) with Immediate Update disabled (PWMCONx[0] = 0), when the Duty Cycle register is updated from a non-zero value to zero, a glitch pulse of a width equal to one PWM clock will appear at the next PWM period boundary, as shown in Figure 5, for the Redundant Output mode. Here, the Duty Cycle register refers to the PDCx register if PWMCONx[8] = 0 or the MDC register if PWMCONx[8] = 1.

If the application requires a zero duty cycle output, there are two possible work around methods:

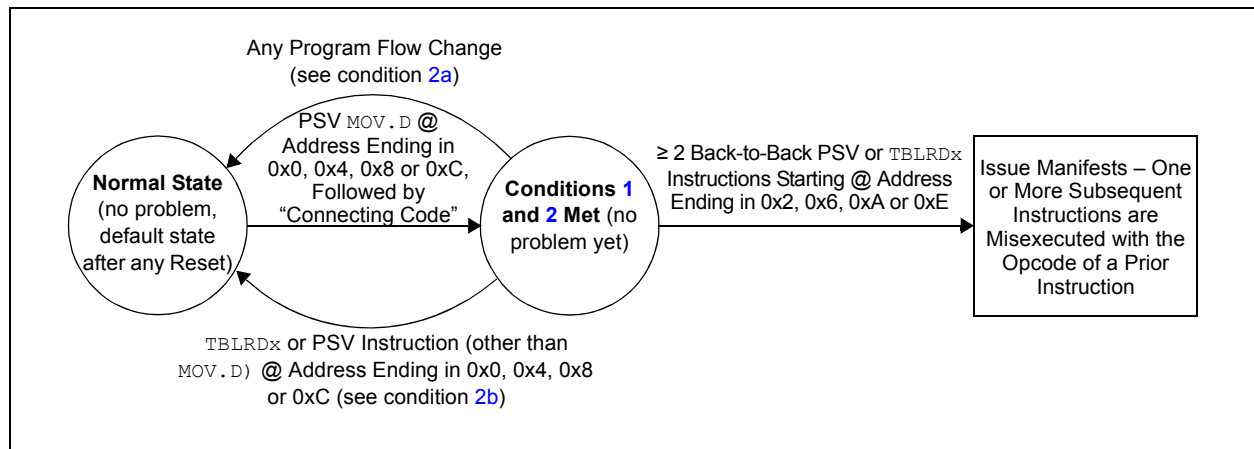
**FIGURE 7: SIMPLIFIED BEHAVIOR**

When two or more data Flash read instructions (via Program Space Visibility (PSV) read or table read) are executed back-to-back, one or more subsequent instructions can be misexecuted when all of the conditions in [Table 6](#) occur.

| 3. | ≥ 2 back-to-back PSV or <code>TBLRDx</code> instructions are executed (following the code of condition 2), where the first of the back-to-back instructions is located at an address ending in 0x2, 0x6, 0xA or 0xE. |

1. All instances of PSV `MOV.D` can be replaced with two PSV `MOV` instructions instead. Non-PSV `MOV.D` instructions acting on RAM/SFRs do not need to be modified; or
2. If not already present, a program flow change instruction (such as `BRA $+2`) can be inserted above back-to-back data Flash read sequences; or
3. Back-to-back data Flash read instruction sequences can be broken up by inserting a non-Flash read instruction (such as a `NOP`), in between the Flash read instructions; or
4. The alignment of the code can be shifted to avoid the required opcode location addresses.
