# dsPIC33FJ32GS406/606/608/610 and dsPIC33FJ64GS406/606/608/610

## dsPIC33FJ32GS406/606/608/610 and dsPIC33FJ64GS406/606/608/610 Family Silicon Errata and Data Sheet Clarification

The dsPIC33FJ32GS406/606/608/610 and dsPIC33FJ64GS406/606/608/610 family devices that you have received conform functionally to the current Device Data Sheet (DS70000591F), except for the anomalies described in this document.

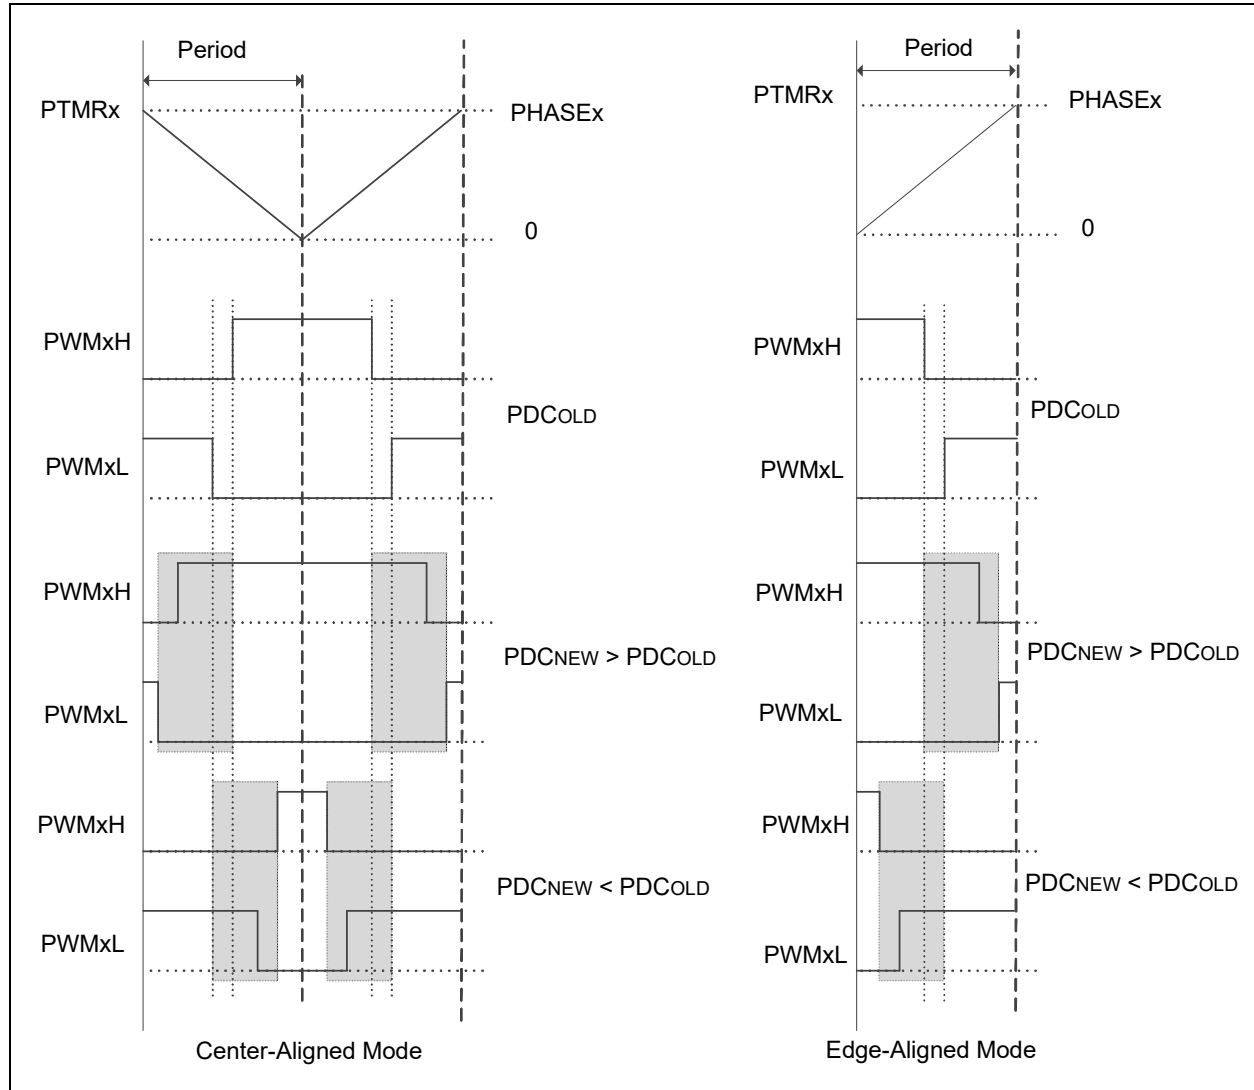
FIGURE 1: TIMING DIAGRAMS FOR CENTER-ALIGNED AND EDGE-ALIGNED MODES

The PWMx generator may not assert dead time on the edges of transitions. This has been observed when all of the following conditions are present:

In [Figure 1](#) (following page), if the duty cycle write occurred in the shaded box, then PWMxH and PWMxL will make an immediate transition without dead time.

None. However, in most applications the duty cycle update timing can be controlled using the TRIGx trigger or Special Event Trigger, such that the above mentioned conditions are avoided altogether.

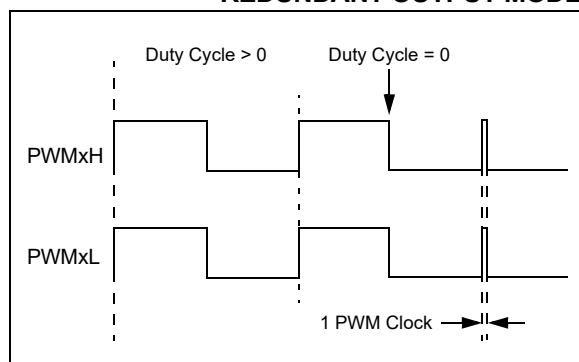
**FIGURE 2: ISSUE EXAMPLE FOR REDUNDANT OUTPUT MODE**

In Redundant Output mode ( $\text{IOCONx}[11:10] = 01$ ) and Push-Pull Output mode ( $\text{IOCONx}[11:10] = 10$ ), with the Immediate Update Enable bit disabled ( $\text{PWMCONx}[0] = 0$ ), when the Duty Cycle register is updated from a non-zero value to zero, a glitch pulse of a width equal to one PWM clock will appear at the next PWM period boundary, as shown in Figure 2 (for the Redundant Output mode). The Duty Cycle register refers to the  $\text{PDCx}$  register if  $\text{PWMCONx}[8] = 0$  or the  $\text{MDC}$  register if  $\text{PWMCONx}[8] = 1$ .

If the application requires a zero duty cycle output, there are two possible work around methods:

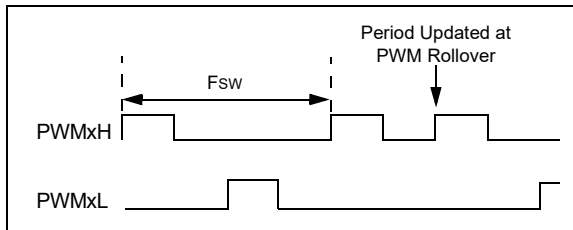
**FIGURE 3:**

When the PWM module is configured for Push-Pull mode ( $\text{IOCONx}[11:10] = 10$ ) with the Enable Immediate Period Update bit enabled ( $\text{PTCON}[10] = 1$ ), a write to the Period register that coincides with the period rollover event may cause the push-pull output logic to produce back-to-back pulses on the PWMx pins (Figure 3).

Ensure that the update to the PWM Period register occurs away from the PWM rollover event by setting the EIPU bit ( $\text{PTCON}[10] = 1$ ). Use either the PWM Special Event Trigger (SEVTCMP) or the PWM Primary Trigger (TRIGx) to generate a PWM Interrupt Service Routine (ISR) near the start of the PWM cycle. This ISR will ensure that period writes do not occur near the PWM period rollover event.

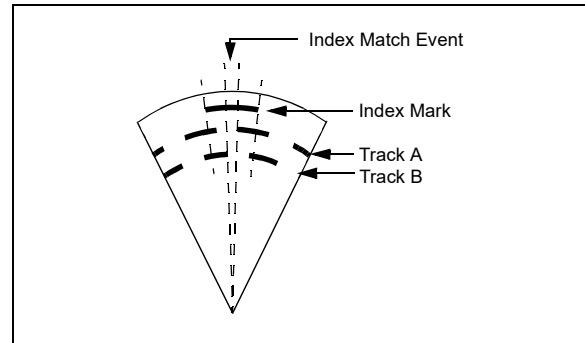
**FIGURE 4: ENCODER IN THE SECTOR AROUND THE INDEX MARK**

This issue is most likely to be seen in specific motor applications using a rotation encoder with an ungated index pulse, operating at near zero speed and/or in the presence of mechanical vibration. In these applications, the encoder may change direction and incrementally rock back and forth. If this happens with the encoder positioned in the vicinity of its index mark, the module will detect the first index match event as the encoder rotates into the index match event area, but not subsequent events if it drifts into and out of that position but stays within the index mark area (Figure 4). If the encoder count increments or decrements in only one direction, the index match will only occur once.

As a result of this, the value of POSxCNT may leave its expected range of 0 to maximum count (defined as the number of encoder pulses per revolution, minus 1), resulting in erroneous reporting of the rotor's position.

None.

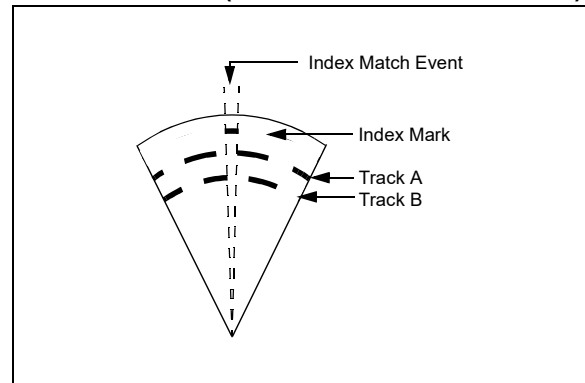
**FIGURE 5: ENCODER IN THE SECTOR AROUND THE INDEX MARK (ONE COUNT WIDTH INDEX)**

This issue is not seen when the encoder uses an index mark that is one encoder count in width (Figure 5).
