# dsPIC33FJ06GS001/101A/102A/202A and dsPIC33FJ09GS302

## dsPIC33FJ06GS001/101A/102A/202A and dsPIC33FJ09GS302 Family Silicon Errata and Data Sheet Clarification

The dsPIC33FJ06GS001/101A/102A/202A and dsPIC33FJ09GS302 family devices that you have received conform functionally to the current Device Data Sheet (DS75018C), except for the anomalies described in this document.

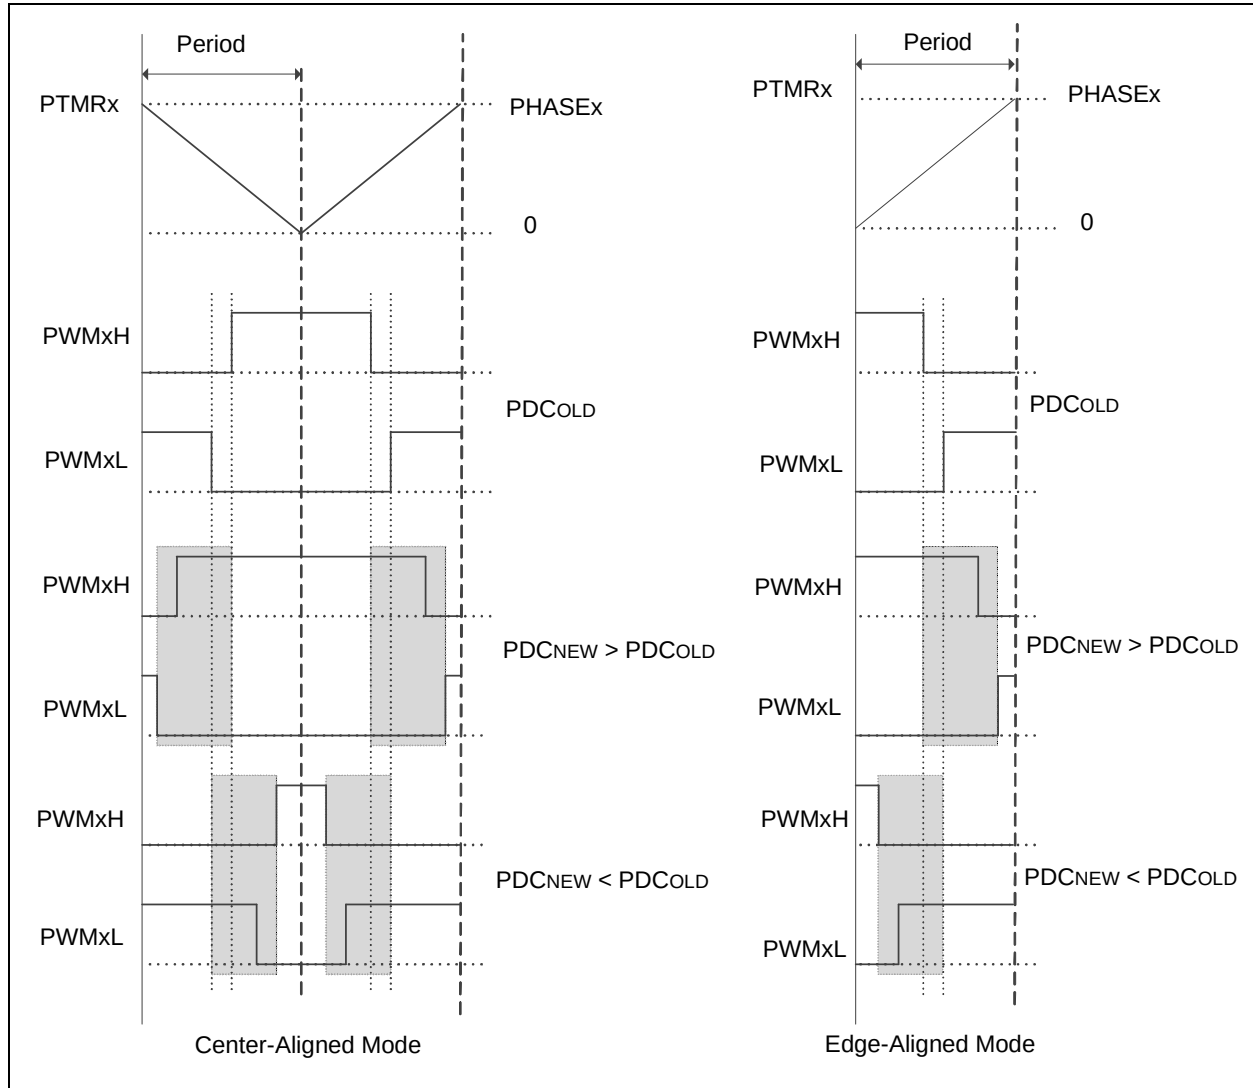
FIGURE 1: TIMING DIAGRAMS FOR CENTER-ALIGNED AND EDGE-ALIGNED MODES

The PWMx generator may not assert dead time on the edges of transitions. This has been observed when all of the following conditions are present:

- The PWMx generator is configured to operate in Complementary mode with the independent time base or master time base;
- Immediate update is enabled; and
- The value in the PDCx register is updated in such a manner that the PWMxH and PWMxL outputs make an immediate transition.

The current duty cycle, PDCOLD, newly calculated duty cycle, PDCNEW, and the point at which the write to the Duty Cycle register occurs within the PWMx time base, will determine if the PWMxH and PWMxL outputs make an immediate transition. PWMxH and PWMxL outputs make an immediate transition if the Duty Cycle register is written with a new value, PDCNEW, at a point of time when the PWMx time base is counting a value that is in between PDCNEW and PDCOLD. Additionally, writing to the Duty Cycle register close to the instant of time where dead time is being applied may result in reduced dead time, effective on the PWMxH and PWMxL transition edges.

In [Figure 1](#) (following page), if the duty cycle write occurred in the shaded box, then PWMxH and PWMxL will make an immediate transition without dead time.

None. However, in most applications the duty cycle update timing can be controlled using the TRIGx trigger or Special Event Trigger such that the above mentioned conditions are avoided altogether.

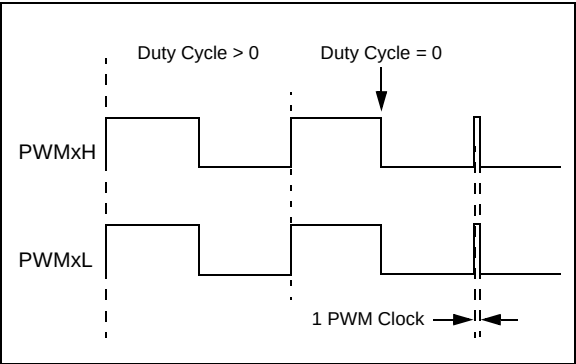
FIGURE 2: ISSUE EXAMPLE FOR REDUNDANT OUTPUT MODE

In Redundant Output mode (IOCONx<11:10> = 01) and Push-Pull Output mode (IOCONx<11:10> = 10) with the Immediate Update Enable bit (PWMCONx<0> = 0) disabled, when the Duty Cycle register is updated from a non-zero value to zero, a glitch pulse of a width equal to 1 PWM clock will appear at the next PWM period boundary, as shown in Figure 2 (for the Redundant Output mode). The Duty Cycle register refers to the PDCx register if PWMCONx<8> = 0 or the MDC register if PWMCONx<8> = 1.

If the application requires a zero duty cycle output, there are two possible work around methods:

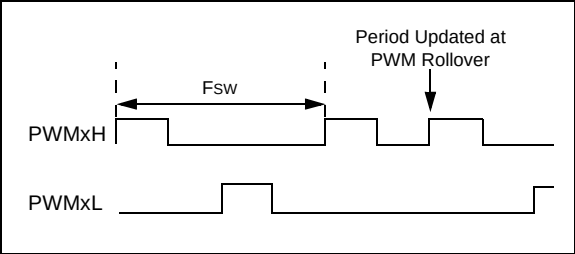
FIGURE 3: ISSUE EXAMPLE IN PUSH-PULL MODE

When the PWM module is configured for Push-Pull mode (IOCONx<11:10> = 10) with the Enable Immediate Period Updates bit enabled (PTCON<10> = 1), a write to the Period register that coincides with the period rollover event may cause the push-pull output logic to produce back-to-back pulses on the PWMx output pins (Figure 3).

Use either the PWMx Special Event Compare (SEVTCMP) or PWMx Primary Trigger Compare Value (TRIGx) to generate a PWM Interrupt Service Routine (ISR) near the start of the PWM cycle. This ISR will ensure that period writes do not occur near the PWM period rollover event.

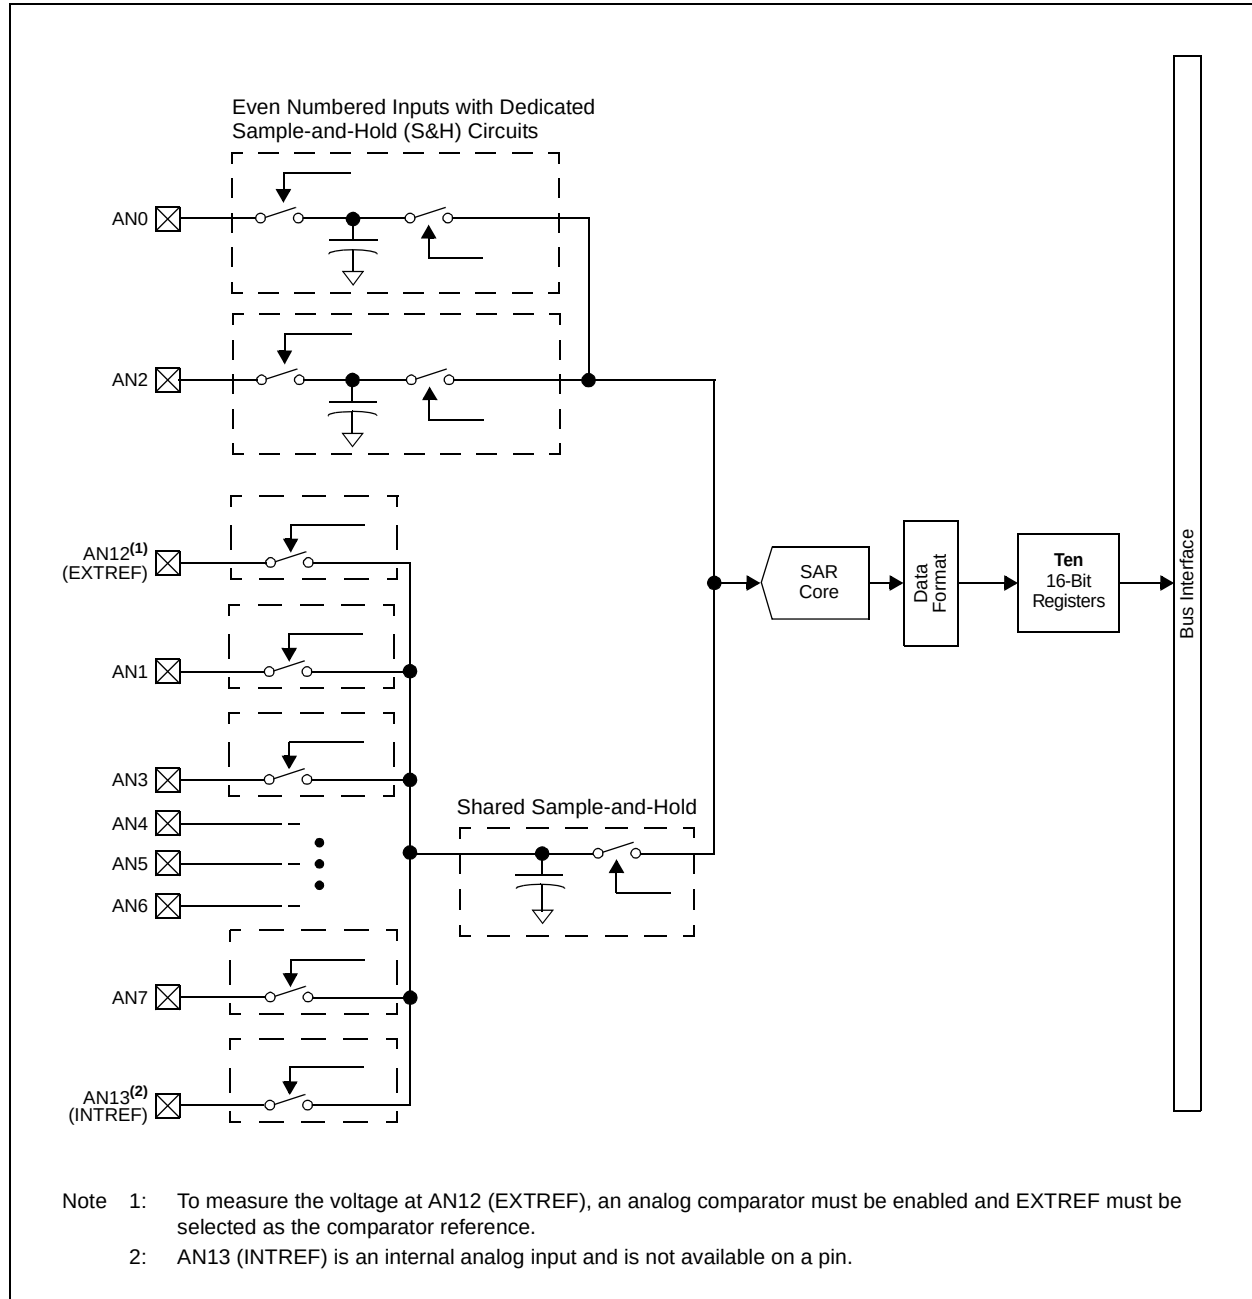
**FIGURE 19-5: ADC BLOCK DIAGRAM FOR THE dsPIC33FJ09GS302 DEVICE**

In [Figure 19-5](#), the number of output registers has been changed from eight to ten. The changes are shown in bold below:
