# dsPIC33FJ06GS101/X02 and dsPIC33FJ16GSX02/X04

## dsPIC33FJ06GS101/X02 and dsPIC33FJ16GSX02/X04 Family Silicon Errata and Data Sheet Clarification

The dsPIC33FJ06GS101/X02 and dsPIC33FJ16GSX02/X04 family devices that you have received conform functionally to the current Device Data Sheet (DS70000318G), except for the anomalies described in this document.

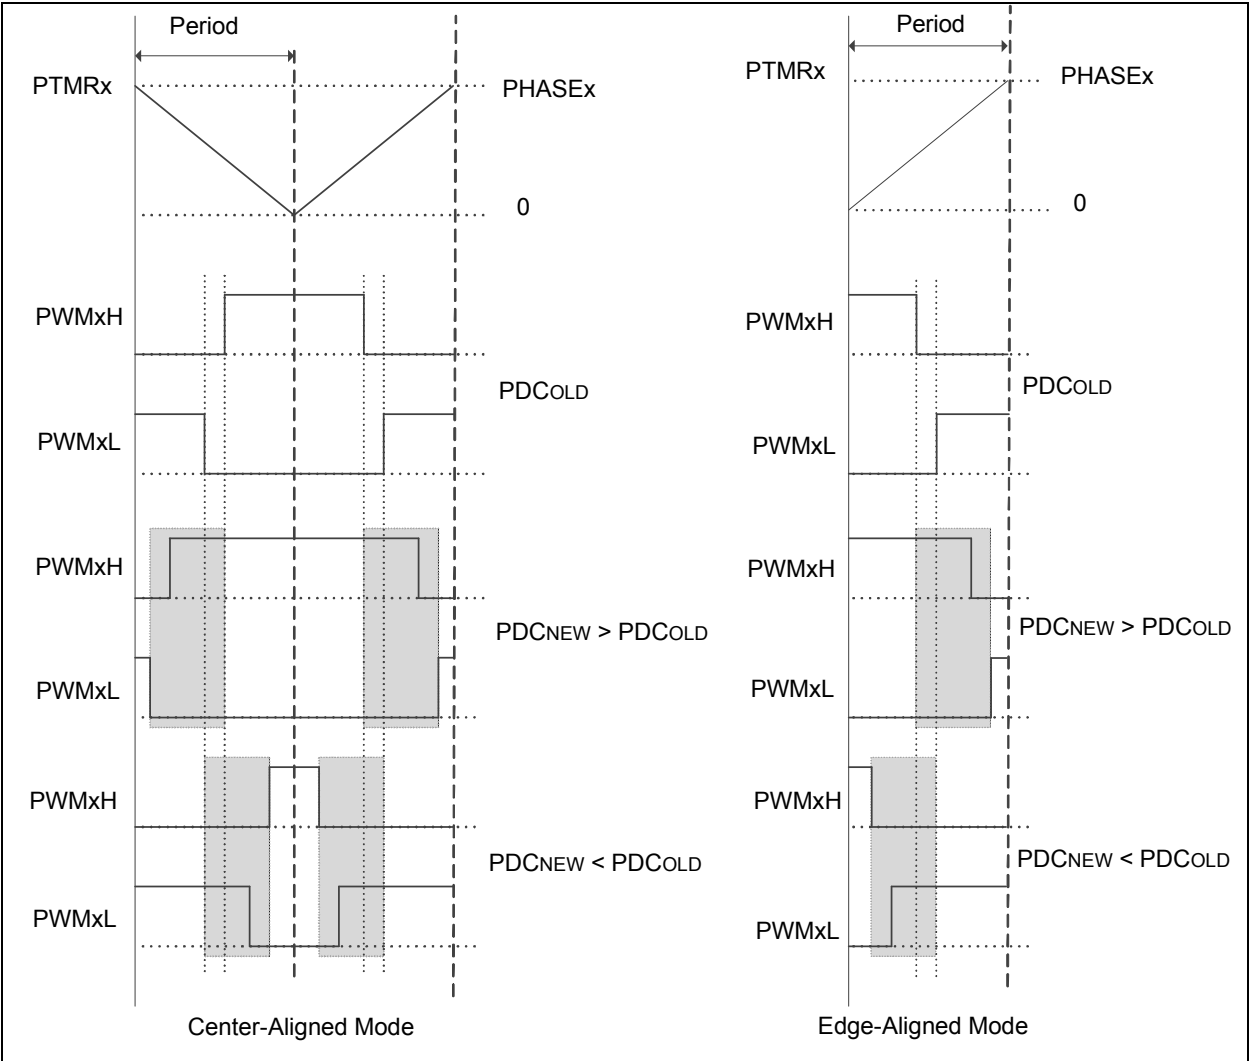
**FIGURE 1: TIMING DIAGRAMS FOR CENTER-ALIGNED AND EDGE-ALIGNED MODES**

The PWMx generator may not assert dead time on the edges of transitions. This has been observed when all of the following conditions are present:

None. However, in most applications, the duty cycle update timing can be controlled using the TRIGx trigger or Special Event Trigger, such that the above mentioned conditions are avoided altogether.

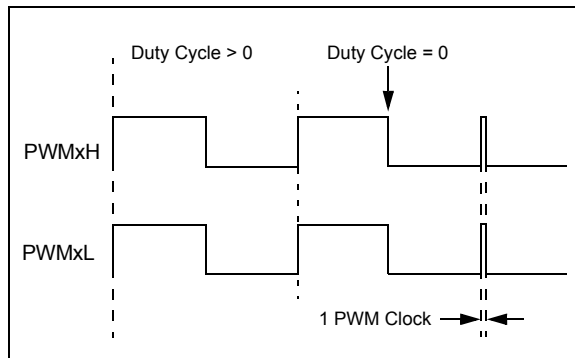
**FIGURE 2: ISSUE EXAMPLE FOR REDUNDANT OUTPUT MODE**

In Redundant Output mode (IOCONx[11:10] = 01) and Push-Pull Output mode (IOCONx[11:10] = 10), with the Immediate Update disabled (PWMCONx[0] = 0), when the Duty Cycle register is updated from a non-zero value to zero, a glitch pulse of a width equal to 1 PWM clock will appear at the next PWM period boundary, as shown in Figure 2 (for the Redundant Output mode). The Duty Cycle register refers to the PDCx register if PWMCONx[8] = 0 or the MDC register if PWMCONx[8] = 1.

If the application requires a zero duty cycle output, there are two possible work around methods:

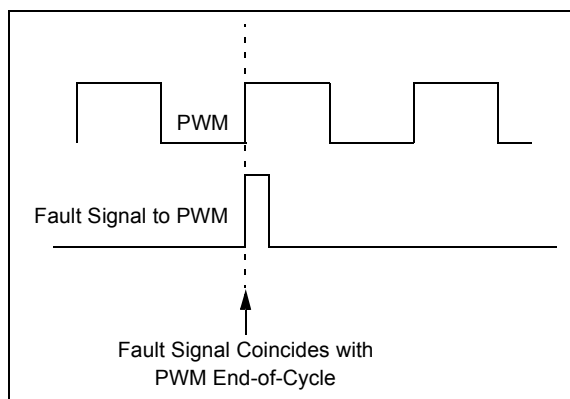
When the PWM module is operated in Complementary, Redundant, Push-Pull or True Independent Output modes and the PWM Fault/Current-Limit Fault are configured to provide a Fault event to the PWM, under certain conditions where the Fault event active edge happens to coincide with the PWM End-of-Cycle (EOC) event, the PWM fails to recognize the Fault event.

Configure the PWM module to include Leading-Edge Blanking bits, LEB[6:0] (LEBCONx [9:3]), with a count always greater than eight, with the appropriate PWMxH/PWMxL Leading-Edge Blanking triggers.
