# Silicon Errata for the MSC8101 Processor, Mask 0K40A

This document presents the errata for the 0K40A mask of the Freescale MSC8101 device. The errata are classified and numbered, and each erratum is provided with a description and workarounds. **Table 1** lists the mask numbers and the corresponding versions of the MSC8101 device.

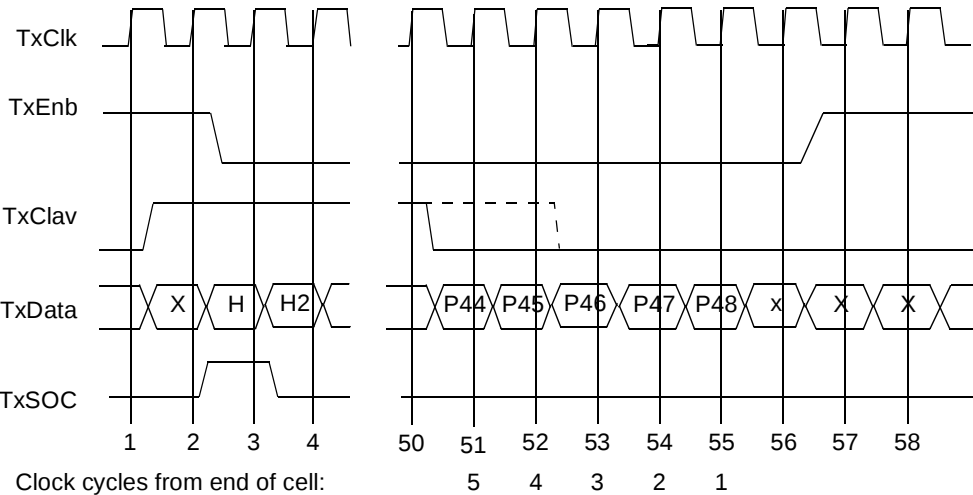
| Errata Number | Errata Description | Applies to Mask |
|---|---|---|
| CPM101 | <p align="center"><b>FCC RxClav Timing Violation (Slave)</b></p> <p><b>Date Added:</b> 1/15/2004<br/> <b>Date Revised:</b> 11/05/2004</p> <p><b>Description:</b> FCC ATM Receive UTOPIA slave mode. When the RxFIFO is full, RxClav is negated 2 cycles before the end of the cell transfer, instead of 4. A master that polls RxClav or pauses 3 or 4 cycles before the end of the cell transfer may sample a false RxClav, and an overrun condition may occur. The dashed line in the timing diagram below depicts the actual RxClav negation (two cycles before the end of the cell transfer instead of four cycles). The signals in the timing diagram are with respect to the master, so the Tx interface is shown.</p> <p><b>Workaround:</b></p> <ol style="list-style-type: none"> <li>1. The master should not poll RxClav or pause a cell transfer 4 cycles before the end of a cell transfer. The master should poll 2 cycles before the end of the current cell or later. This can be achieved by introducing cell-to-cell polling (and transfer) delay, which is equal or larger than one cell transfer time. If this can be achieved, the impact on performance is minimal.</li> <li>2. Configuring ATM only on FCC1 and setting FPSMR[TPRI] ensures the highest priority to FCC1 Rx. In addition, for CPM usage lower than 80 percent (as reported by the CPM performance tool based on UTOPIA maximal bus rate), the CPM performance is enough to guarantee that the RxFIFO does not fill up.</li> </ol> <p align="center">Clock cycles from end of cell:                      5    4    3    2    1</p> | 0K40A |
