## XC2200 Derivatives

16/32-Bit Single-Chip Microcontroller  
with 32-Bit Performance

Errata Sheet

V1.11 2014-10

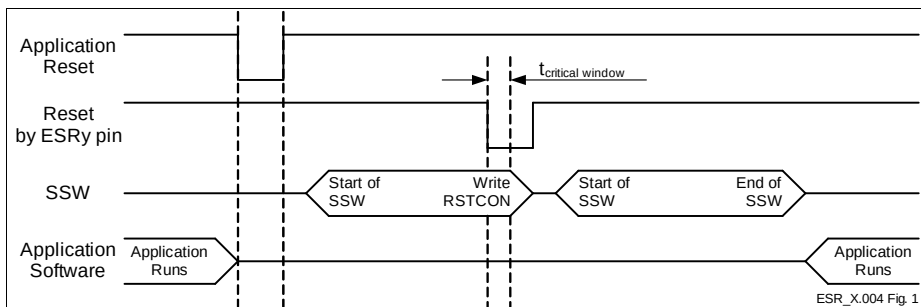
**Figure 1 Critical application reset sequence**

SCU\_RSTCONx registers are reset only by Power-On, but they may be wrongly affected after a second application reset requested by an ESRy pin. This may lead to the SCU\_RSTCONx register values being set to zero, which could unexpectedly disable reset sources within the user application. The conditions which lead to this behavior are:

1. First, an application reset by SW (software), CPU (Central Processing Unit), MP (Memory), WDT (Watchdog Timer) or ESRy (External Service Request y) occurs.
2. Following this, an application reset on an ESRy pin occurs.
3. If the above mentioned ESRy reset occurs during a critical time window of the SSW (startup software), then it's possible that the application will operate with the wrong SCU\_RSTCONx register value. The critical time window occurs when the SSW is writing the SCU\_RSTCONx registers, and at the same time, the ESRy reset request is processed by the reset circuitry. The width of this critical window  $f_{critical\ window}$  is less than 13 cycles.

### Workaround

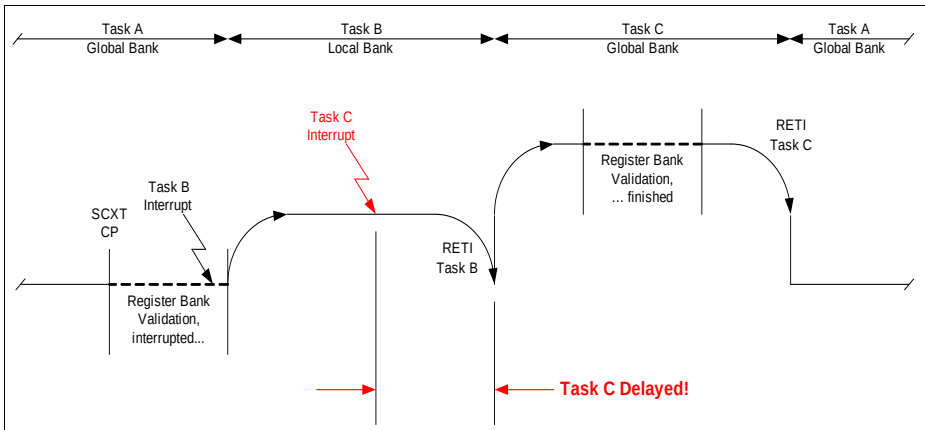
**Figure 2 Example for Case 2: Interrupt Service for Task C delayed**

- The Context Pointer CP is written to (e.g. by POP, MOV, SCXT ... instructions) within a routine (Task A) that uses a **global** register bank (bit field PSW.BANK = 00<sub>B</sub>), i.e. the context for this routine will be modified,
- This context switch procedure (19 cycles) is interrupted by an interrupt request (Task B) which is programmed (with GPRSELx = 1X<sub>B</sub>) to automatically use one of the **local** banks via the bank selection registers BNKSEL0...3 (i.e. the interrupting routine has a priority level  $\geq 12$ ),
- Before the corresponding interrupt service routine is finished, another interrupt request (Task C) occurs which is programmed (with GPRSELx = 00<sub>B</sub>) to automatically use the **global** bank via the bank selection registers BNKSEL0...3 (i.e. the interrupting routine has a priority level  $\geq 13$ ).

In this case service of this interrupt request (for Task C) is delayed until bit field PSW.BANK becomes 00<sub>B</sub> after executing the RETI instruction at the end of the routine (Task B) using the local bank.

### **Workaround for Case 1**

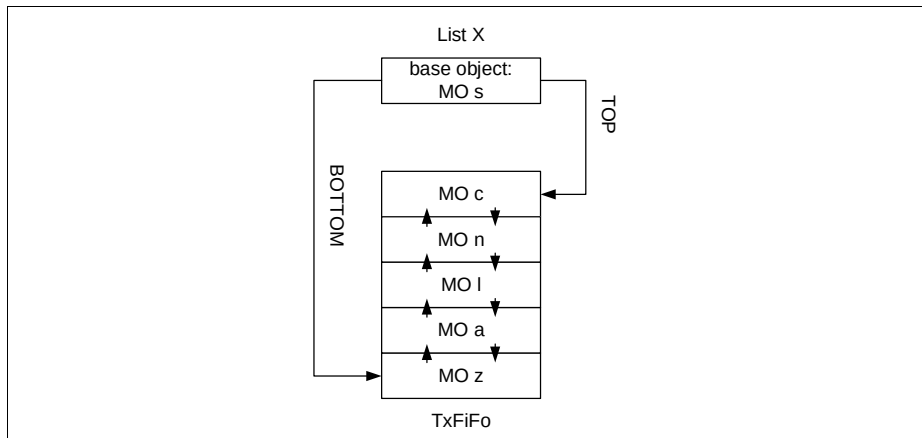
Figure 3 FIFO structure

After the successful transmission of a Tx FIFO element, a Tx overflow interrupt is generated if the FIFO base object fulfils these conditions:

If Tx FIFO overflow interrupt needed, take the FIFO base object out of the circular list of the Tx message objects. That is to say, just use the FIFO base object for FIFO control, but not to store a Tx message.

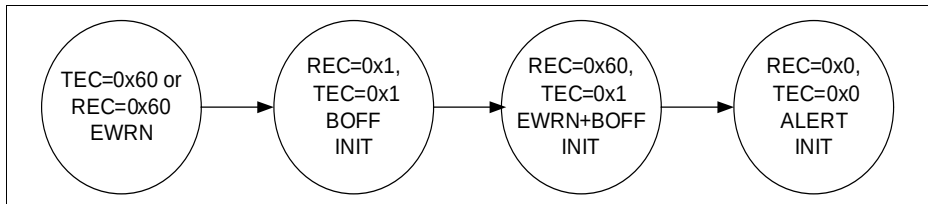
**Figure 5 Alert Interrupt Behavior in case of Bus-Off**

The MultiCAN module shows the following behavior in case of a bus-off status:

When the threshold for error warning (EWRN) is reached (default value of Error Warning Level EWRN = 0x60), then the EWRN interrupt is issued. The bus-off (BOFF) status is reached if TEC > 255 according to CAN specification, changing the MultiCAN module with REC and TEC to the same value 0x1, setting the INIT bit to 1<sub>B</sub>, and issuing the BOFF interrupt. The bus-off recovery phase starts automatically. Every time an idle time is seen, REC is incremented. If REC = 0x60, a combined status EWRN+BOFF is reached. The corresponding interrupt can also be seen as a pre-warning interrupt, that the bus-off recovery phase will be finished soon. When the bus-off recovery phase has finished (128 times idle time have been seen on the bus), EWRN and BOFF are cleared, the ALERT interrupt bit is set and the INIT bit is still set.

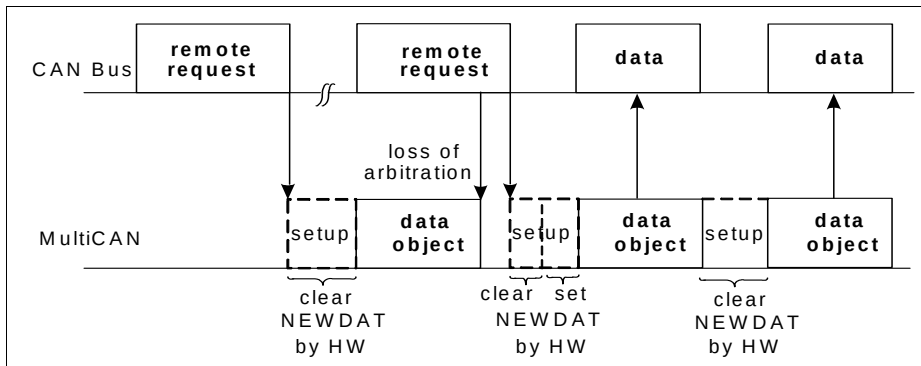
Figure 6 Loss of Arbitration

When the appropriate message object (data frame) triggered by the first remote frame wins the arbitration, it will be sent out and NEWDAT is not reset. This leads to an additional data frame, that will be sent by this message object (clearing NEWDAT).

There will, however, not be more data frames than there are corresponding remote requests.
