Errata Document for CY7C1312V18 & CY7C1314V18

This document describes errata for the CY7C1312V18 and CY7C1314V18. Details include errata trigger conditions, available workarounds, and silicon revision applicability. This document should be used as a supplement to the existing datasheet.

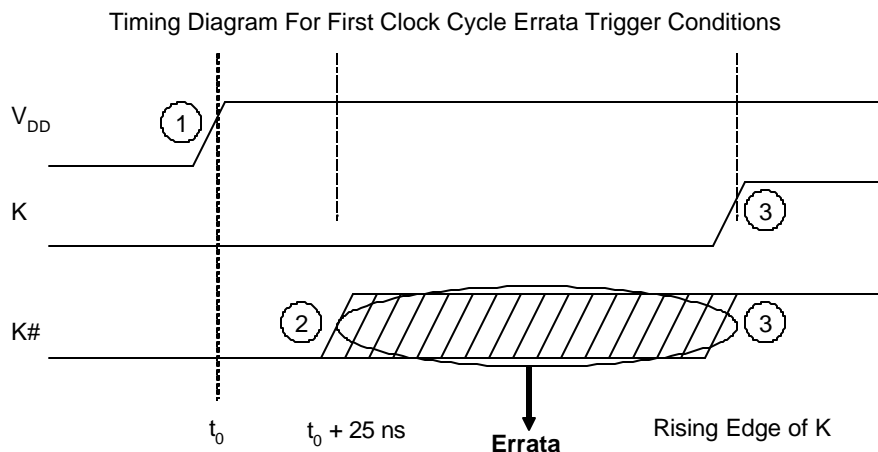
This errata will only occur during the first clock cycle seen by the device. It will not occur after the second rising edges of the K and K# clocks. Therefore, if the device sees any clock cycles during power up, this errata will not occur.

- (1) V_{DD} reaches 1.7 V at t_0 ,
- (2) K# rises from low to high after $t_0 + 25$ ns,
- (3) K# rises from low to high before the first rising edge of K.

A timing diagram for these trigger conditions is shown below:

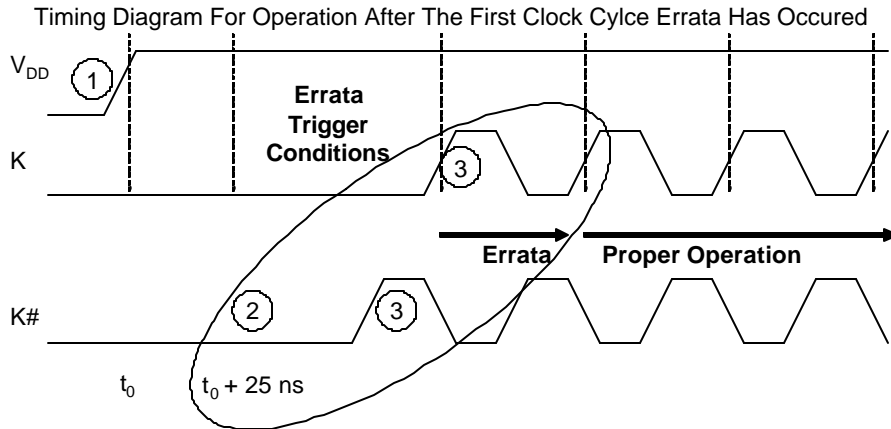
In the first clock cycle seen by the device, it is possible for data to be written into the memory array incorrectly. Specifically, the first word may be written to the second burst address and the second word may be written to the first burst address. This can only occur in the first clock cycle seen by the device and will not occur in subsequent clock cycles.

This errata only impacts the data integrity of data written during the first clock cycle seen by the device. All subsequent writes will be written correctly.

A timing diagram describing device operation after the first clock cycle errata is triggered is shown below.
