## Active Errata List

## CAN Microcontrollers

**T89C51CC01**  
**T89C51CC01UA**  
**T89C51CC01CA**

## Errata Sheet

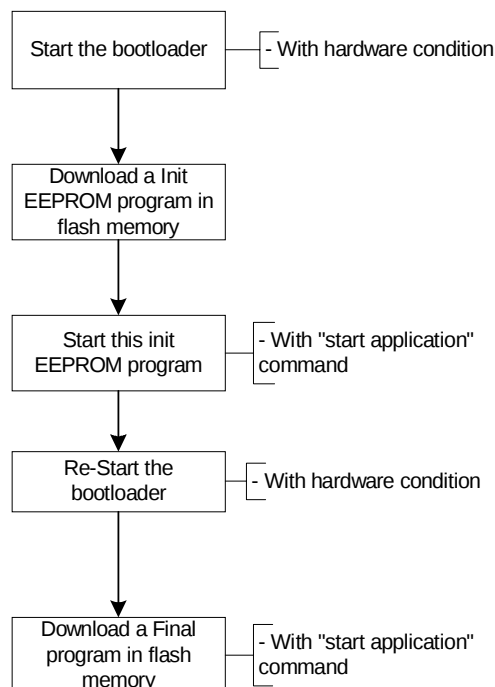
## 16. EEPROM – Lock-up during ISP write

Program lock-up can be experienced when using Atmel FLIP software or a custom In system Programming tools to write in the internal EEPROM. This problem occurs with clock frequency > 12MHz in X2 mode or 24MHz in X1 mode. Neither the code Flash nor the EEPROM are corrupted by the lock-up. Although the EEPROM cannot be written by the bootloader.

This problem is bootloader related and doesn't affect the capability for the user to read and write into the EEPROM. This problem is technology dependant. The likelihood of experiencing the problem is low at Clock frequency > 24 MHz in X1 mode and non-existent below. A reset can be applied to recover from the lock-up.

### Workaround

The following process can be done to work around the problem.

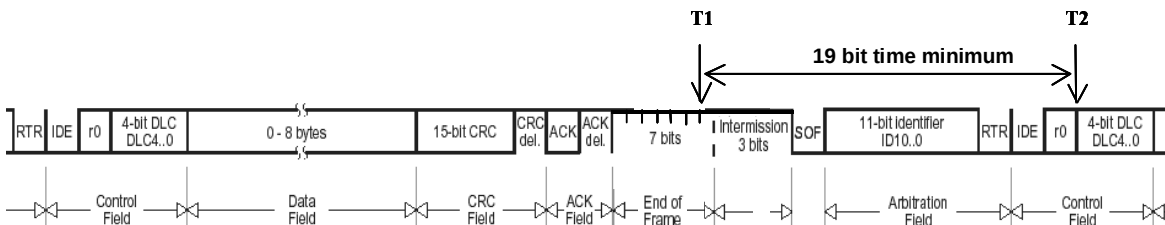
### CAN2.0A

## 17. Transmission after a 3 bit Intermessage

If a Transmit Message Object (MOB) is enabled while the CAN bus is busy with an on going message, the transmitter will wait for the 3-bit Intermission before starting its transmission. This is in full agreement with the CAN recommendation.

If the transmitter lost arbitration against another node, two conditions can occur :

1. At least one Receive MOB of the chip are programmed to accept the incoming message. In this case, the transmitter will wait for the next 3-bit Intermission to retry its transmission.
2. No Receive MOB of the chip are programmed to accept the incoming message. In this case the transmitter will wait for a 4-bit Intermission to retry its transmission. In this case, any other CAN nodes ready to transmit after a 3-bit Intermission will start transmit before the chip transmitter, even if their messages have lower priority IDs.

## Workaround

Always have a Receive MOB enabled ready to accept any incoming messages. Thanks to the implementation of the CAN interface, a Receive MOB must be enable at latest, before the 1<sup>st</sup> bit of the DLC field. The Receive MOB status register is written (RXOK if message OK) immediately after the 6th bit of the End of Frame field. This will leave in CAN2.0A mode a minimum 19-bit time delay to respond to the end of message interrupt (RXOK) and re-enable the Receive MOB before the start of the DLC field of the next incoming message. This minimum delay will be 39-bit time in CAN2.0B. See CAN2.0A CAN2.0B frame timings below.
