## Active T89C51AC2, AT89C51AC2 Errata List

## A/T89C51AC2 Errata History

AT89C51AC2  
T89C51AC2

Errata Sheet

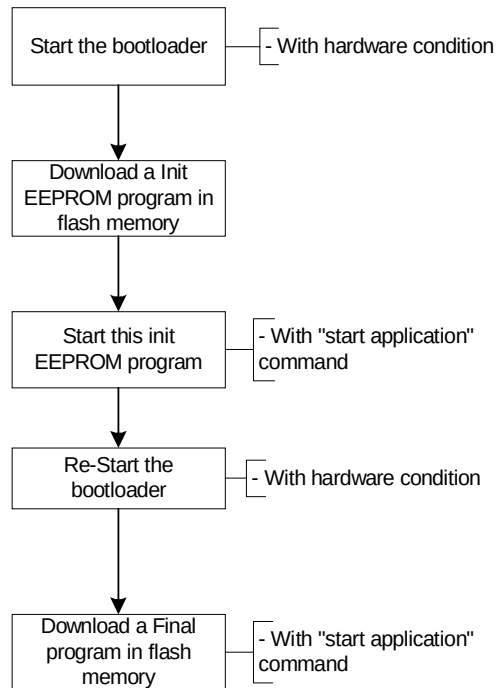
#### **13. EEPROM – Lock-up during ISP write.**

Program lock-up can be experienced when using Atmel FLIP software or a custom In system Programming tools to write in the internal EEPROM. This problem occurs with clock frequency > 12MHz in X2 mode or 24MHz in X1 mode. Neither the code Flash nor the EEPROM are corrupted by the lock-up. Although the EEPROM cannot be written by the bootloader.

This problem is bootloader related and doesn't affect the capability for the user to read and write into the EEPROM. This problem is technology dependant. The likelihood of experiencing the problem is low at Clock frequency > 24 MHz in X1 mode and null below. A reset can be applied to recover from the lock-up.

##### **Workaround**

The following process can be done to work around the problem.

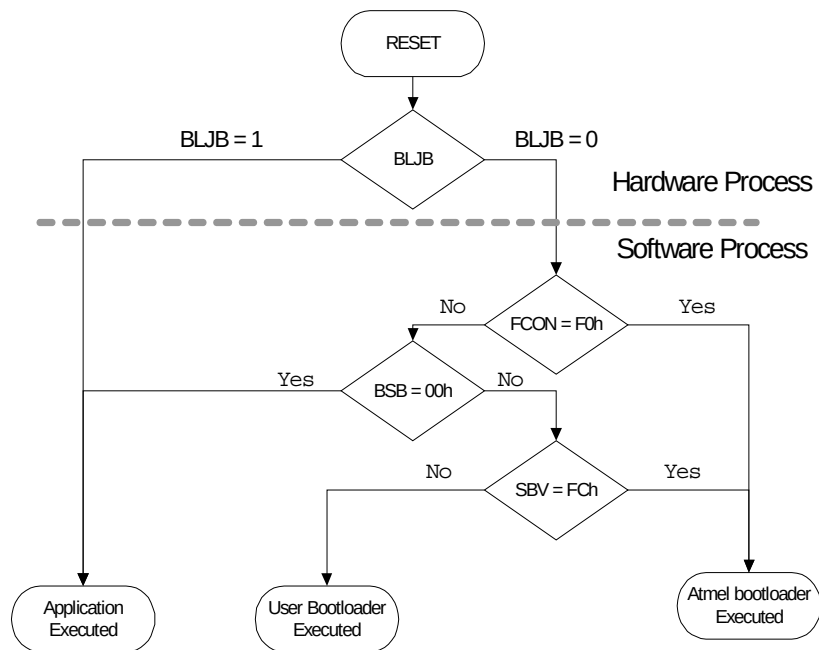
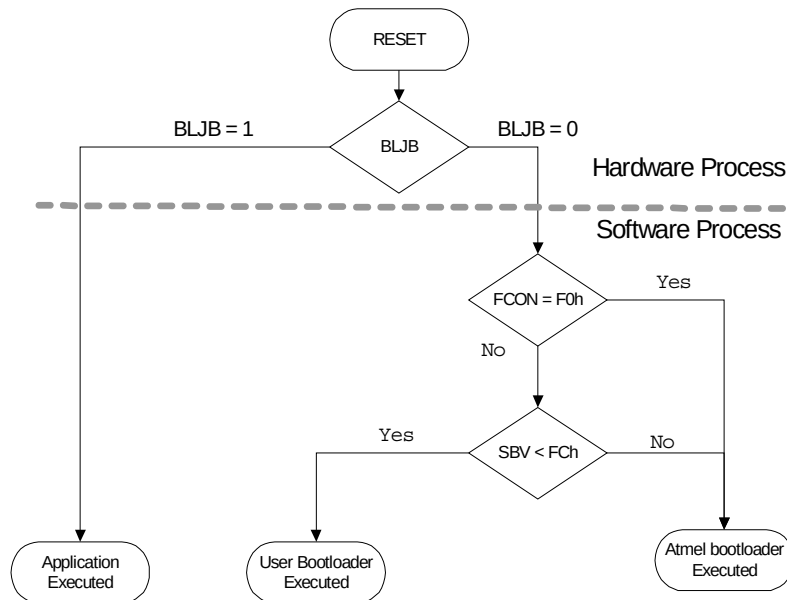
## 4. Boot Process Compatibility

There are some differences between Boot process of bootloader 1.2 and newer versions.

## Workaround

Use the fuse bit BLJB to start the application on both versions.
