## XC2300 Derivatives

16/32-Bit Single-Chip Microcontroller  
with 32-Bit Performance

Errata Sheet

V1.9 2014-10

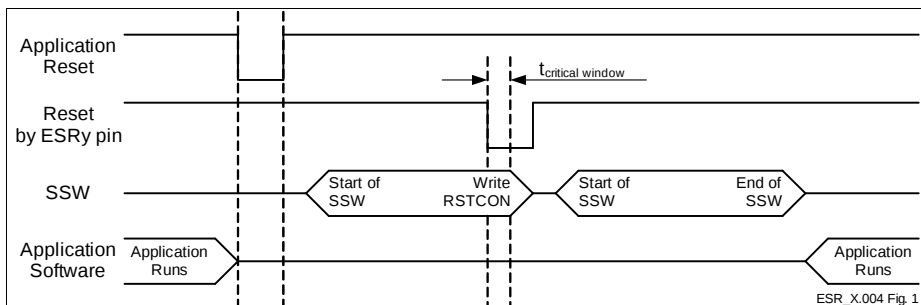
**Figure 1 Critical application reset sequence**

SCU\_RSTCONx registers are reset only by Power-On, but they may be wrongly affected after a second application reset requested by an ESRy pin. This may lead to the SCU\_RSTCONx register values being set to zero, which could unexpectedly disable reset sources within the user application. The conditions which lead to this behavior are:

1. First, an application reset by SW (software), CPU (Central Processing Unit), MP (Memory), WDT (Watchdog Timer) or ESRy (External Service Request y) occurs.
2. Following this, an application reset on an ESRy pin occurs.
3. If the above mentioned ESRy reset occurs during a critical time window of the SSW (startup software), then it's possible that the application will operate with the wrong SCU\_RSTCONx register value. The critical time window occurs when the SSW is writing the SCU\_RSTCONx registers, and at the same time, the ESRy reset request is processed by the reset circuitry. The width of this critical window  $f_{critical\ window}$  is less than 13 cycles.

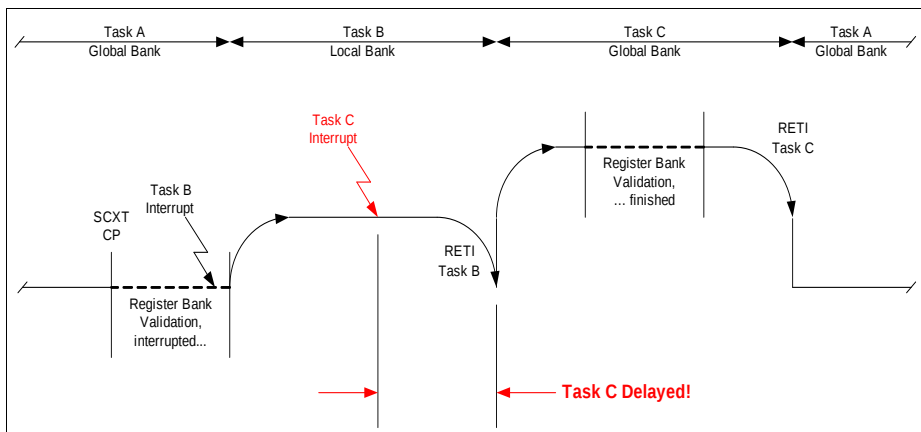
**Figure 2 Example for Case 2: Interrupt Service for Task C delayed**

- The Context Pointer CP is written to (e.g. by POP, MOV, SCXT ... instructions) within a routine (Task A) that uses a **global** register bank (bit field PSW.BANK = 00<sub>B</sub>), i.e. the context for this routine will be modified,
- This context switch procedure (19 cycles) is interrupted by an interrupt request (Task B) which is programmed (with GPRSELx = 1X<sub>B</sub>) to automatically use one of the **local** banks via the bank selection registers BNKSEL0...3 (i.e. the interrupting routine has a priority level  $\geq 12$ ),
- Before the corresponding interrupt service routine is finished, another interrupt request (Task C) occurs which is programmed (with GPRSELx = 00<sub>B</sub>) to automatically use the **global** bank via the bank selection registers BNKSEL0...3 (i.e. the interrupting routine has a priority level  $\geq 13$ ).

In this case service of this interrupt request (for Task C) is delayed until bit field PSW.BANK becomes 00<sub>B</sub> after executing the RETI instruction at the end of the routine (Task B) using the local bank.

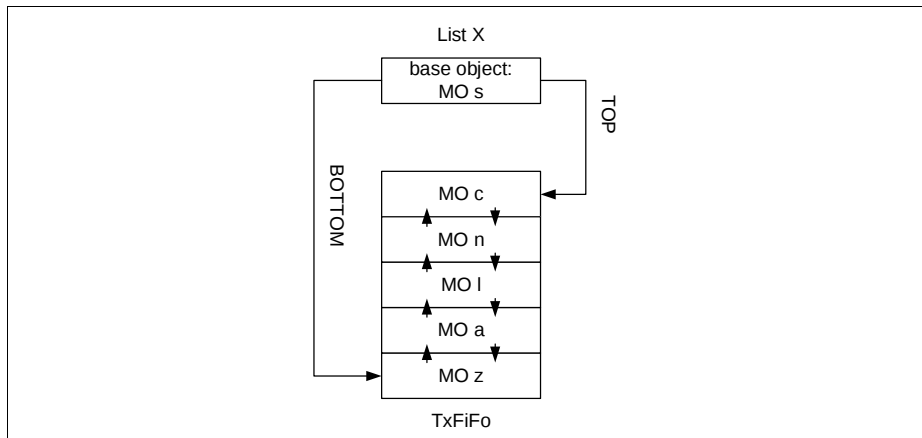
Figure 3 FIFO structure

After the successful transmission of a Tx FIFO element, a Tx overflow interrupt is generated if the FIFO base object fulfils these conditions:

If Tx FIFO overflow interrupt needed, take the FIFO base object out of the circular list of the Tx message objects. That is to say, just use the FIFO base object for FIFO control, but not to store a Tx message.

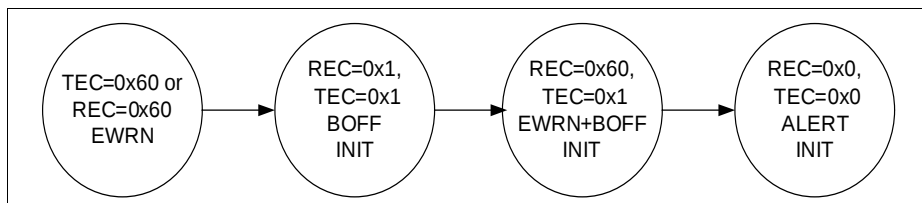
**Figure 5 Alert Interrupt Behavior in case of Bus-Off**

When the threshold for error warning (EWRN) is reached (default value of Error Warning Level EWRN = 0x60), then the EWRN interrupt is issued. The bus-off (BOFF) status is reached if TEC > 255 according to CAN specification, changing the MultiCAN module with REC and TEC to the same value 0x1, setting the INIT bit to 1<sub>B</sub>, and issuing the BOFF interrupt. The bus-off recovery phase starts automatically. Every time an idle time is seen, REC is incremented. If REC = 0x60, a combined status EWRN+BOFF is reached. The corresponding interrupt can also be seen as a pre-warning interrupt, that the bus-off recovery phase will be finished soon. When the bus-off recovery phase has finished (128 times idle time have been seen on the bus), EWRN and BOFF are cleared, the ALERT interrupt bit is set and the INIT bit is still set.

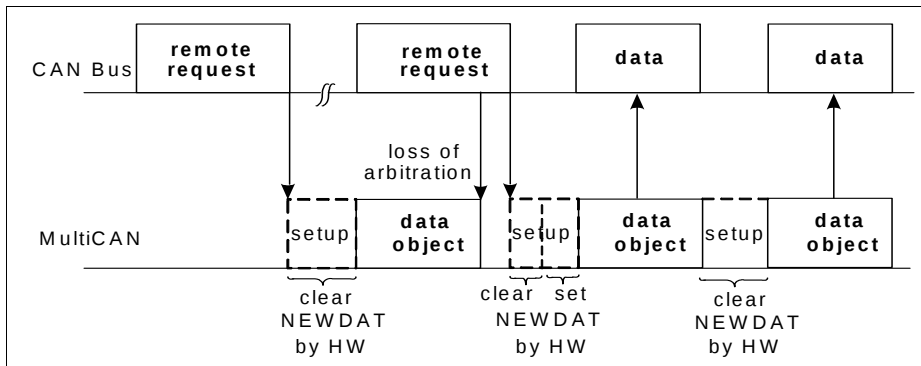
Figure 6 Loss of Arbitration

When the appropriate message object (data frame) triggered by the first remote frame wins the arbitration, it will be sent out and NEWDAT is not reset. This leads to an additional data frame, that will be sent by this message object (clearing NEWDAT).

There will, however, not be more data frames than there are corresponding remote requests.
