STM32WB50CG device errata

This document applies to STM32WB50CG devices and the device variants as stated in this page.

It gives a summary and a description of the device errata, with respect to the device datasheet and reference manual RM0471.

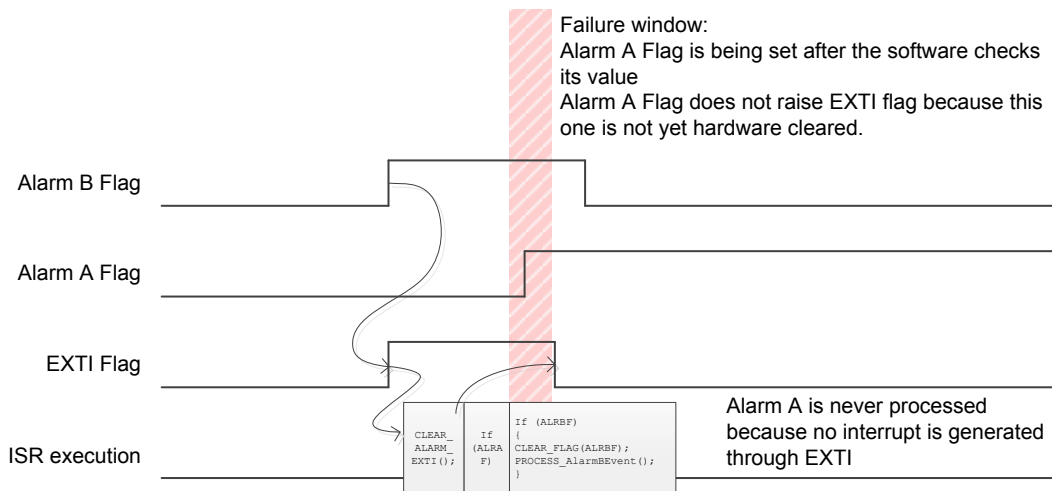
Figure 1. Masked RTC interrupt

The following code example and figure illustrate the failure mechanism: The Alarm A event is lost (fails to generate interrupt) as it occurs in the failure window, that is, after checking the Alarm A event flag but before the effective clear of the EXTI interrupt flag by hardware. The effective clear of the EXTI interrupt flag is delayed with respect to the software instruction to clear it.

Workaround

In the interrupt service routine, apply three consecutive event flag checks - source one, source two, and source one again, as in the following code example:
