**TMS320C6713, TMS320C6713B**  
**Digital Signal Processors**  
**Silicon Errata**

**C6713 Silicon Revision 1.1**

**C6713B Silicon Revision 2.0**

*SPRZ191J*  
December 2002  
Revised August 2005

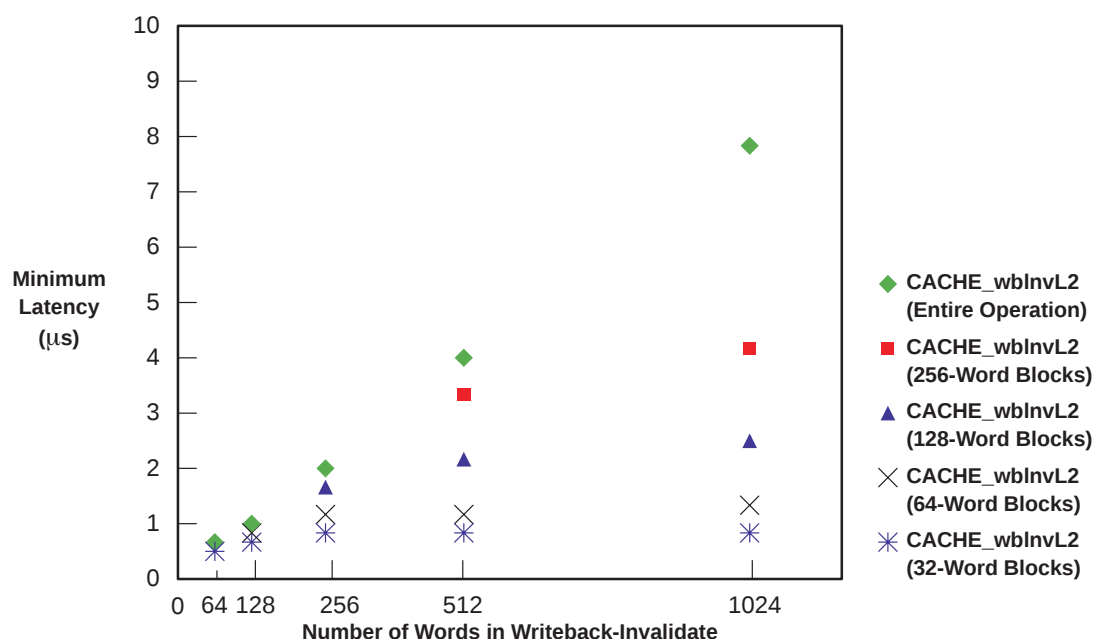
**Figure 2. Minimum Required Latency Between McBSP Events for a Successful Transfer with Concurrent L2 Writeback-Invalidates at 200-MHz CPU and 50-MHz EMIF, Using Entire Operations and Block Breakdown**

For example, if the CPU is running at 200 MHz with a 50-MHz EMIF and you have a McBSP hard real-time deadline of 5  $\mu$ s, Figure 2 shows that a 1024-word L2 writeback-invalidate may cause data loss since back-to-back McBSP events can only be serviced at  $\sim 8 \mu$ s. By breaking down the L2 writeback-invalidate into 256-word blocks, you can then meet the 5- $\mu$ s McBSP deadline. In other words, when performing a 1024-word L2 writeback-invalidate operation with the CPU and EMIF conditions cited above, the McBSP events can be serviced in  $\sim 8 \mu$ s for the entire operation (one whole block), in  $\sim 4 \mu$ s when breaking it into 256-word blocks, in  $\sim 2.5 \mu$ s when breaking it into 128-word blocks, etc.

To avoid cache operations blocking other time-sensitive EDMA accesses, observe the following guidelines:

1. Avoid placing real-time data in EMIF address range. Instead, real-time data should be placed in the L2 address range.
2. If data must be placed in the EMIF address range:
  - Avoid global cache operations in favor of block-based cache operations.
  - Block-based cache operations should be submitted in small blocks, such that the total amount of time that the EMIF is blocked is less than the amount of time between serial samples.

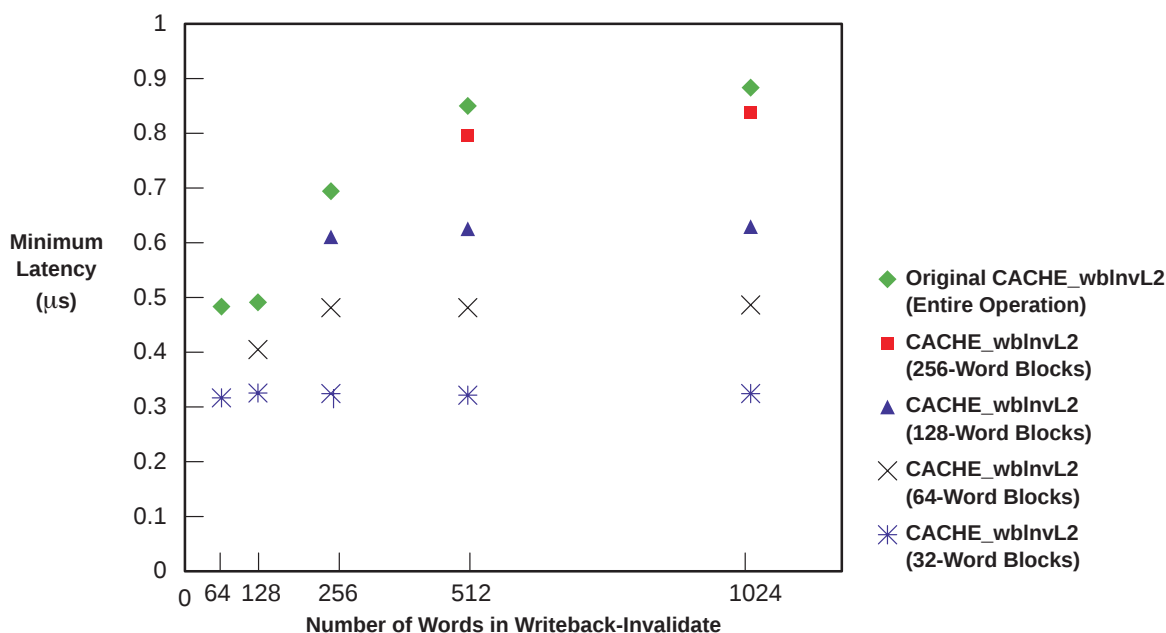
**Figure 3. Minimum Required Latency Between McBSP Events for a Successful Transfer With Concurrent Writeback-Invalidates at 225-MHz CPU and 100-MHz EMIF, Using Entire Operations and Block Breakdown**

When the CPU is set to 225 MHz and the EMIF is set to 100 MHz, breaking down the cache operations will still improve the block-out problem. Figure 3 shows the improvement in the McBSP's performance with this frequency ratio.

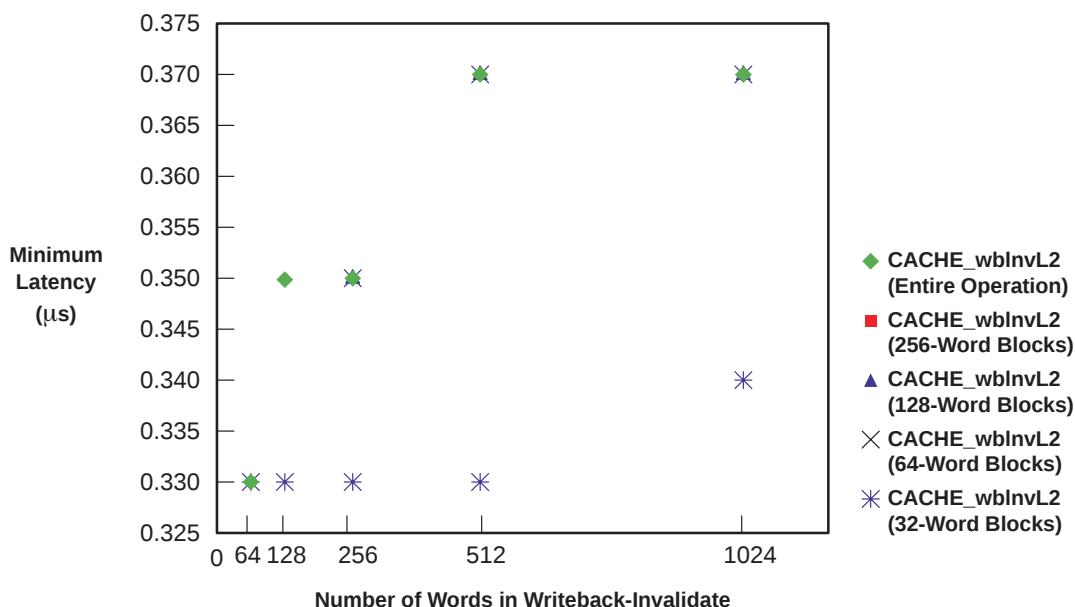
**Figure 4. Minimum Required Latency Between McBSP Events for a Successful Transfer With Concurrent Writeback-Invalidates at 150-MHz CPU and 100-MHz EMIF, Using Entire Operations and Block Breakdown**

When the CPU is set to 150 MHz and the EMIF is set to 100 MHz, there is virtually no benefit from breaking down the coherency cache operations. Figure 4 shows the McBSP's performance with this frequency ratio.

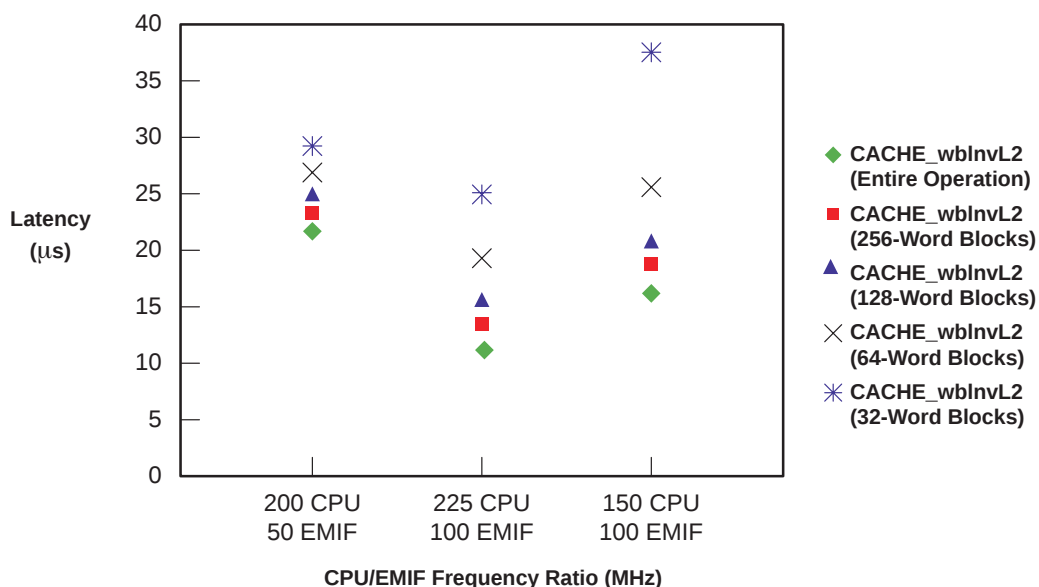
**Figure 5. 1024-Word L2 Writeback-Invalidate Performance at Various Frequency Ratios With Old and New CACHE\_wbInvL2()**

Breaking down the cache operations into smaller blocks takes longer to complete than performing the entire cache function as one large block. Figure 5 shows how much extra overhead is incurred by breaking down an L2 writeback-invalidate operation to transfer 1024 words with different sized blocks and at various frequency ratios. Notice that for the 200-MHz CPU and the 50-MHz EMIF frequency ratio, where the new functions are most critical for peripherals such as the McBSP, the least overhead is incurred.

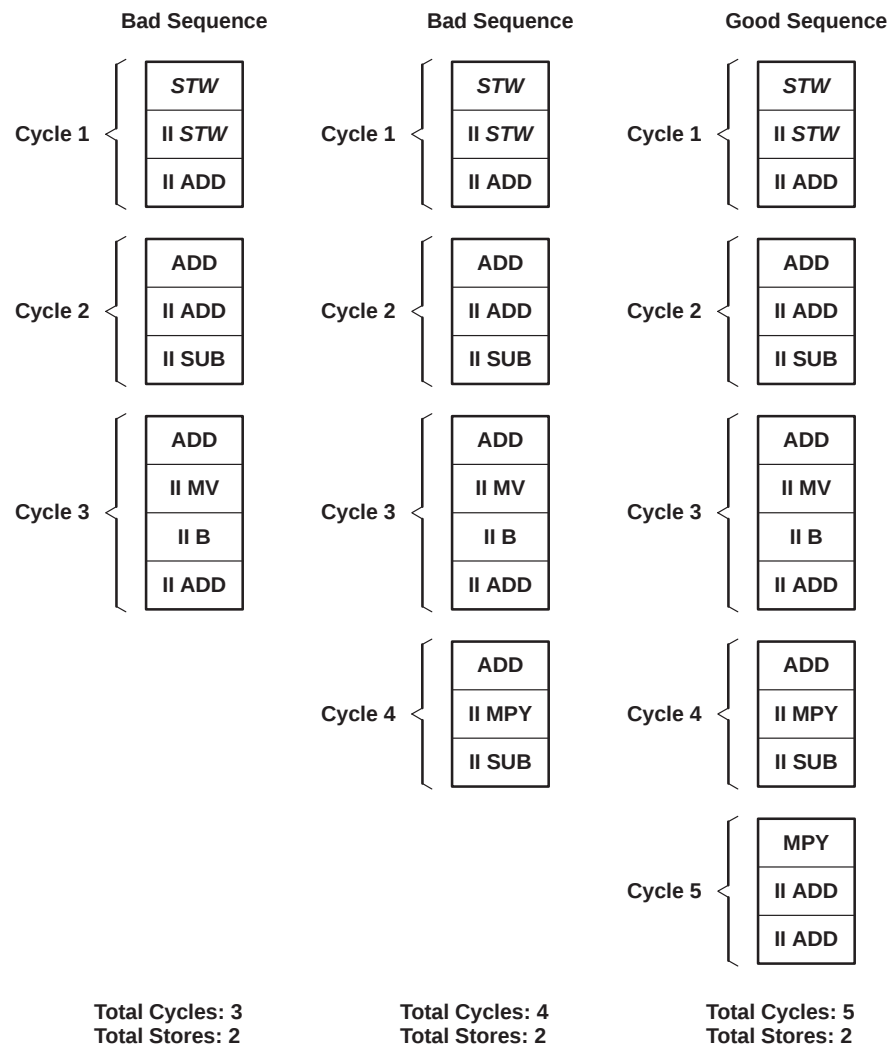
Figure 7. Pseudo Code Example With Parallel Stores (Criteria 2)

Figure 7 outlines this scenario. Note that the STW instruction represents a store of any word size (32-, 16-, or 8-bit).

In most looped code, more than one instruction would likely be executed on each cycle, i.e., instructions would be executed in parallel. In this case, as long as a store is one of the instructions being executed in parallel on a particular cycle, that cycle counts as a cycle on which a store occurs. Instructions with parallel bars (||) at the beginning of the line of assembly execute in parallel with instructions on the preceding line.

- A. Reduce the duration of the loop by breaking into smaller loops. If a particular problem loop has a length of 4 cycles (determined by looking at the software pipeline kernel in the assembly file), and the loop runs 200 times, then the total loop duration is ~800 cycles. If the deadline is 586 cycles, then loop could cause a problem (assuming the loop meets all the other criteria). The workaround is to break the loop into four smaller loops of 50 iterations each. Then any one loop will only run for 200 cycles allowing the EDMA transfer to complete between the smaller loops.

- B. Try to break criteria 2. The quickest way to do this is to turn off optimization for the file containing the problem loop (this is done in the File Specific Options for the file). Instead of using the compiler switch -o3, use the compiler switch -o1 for the particular problem file. This will cause the problem loop to not be software pipelined and less likely to meet criteria 2. The downside to this fix is that all the loops in the particular file will be un-optimized, not just the problem loop.

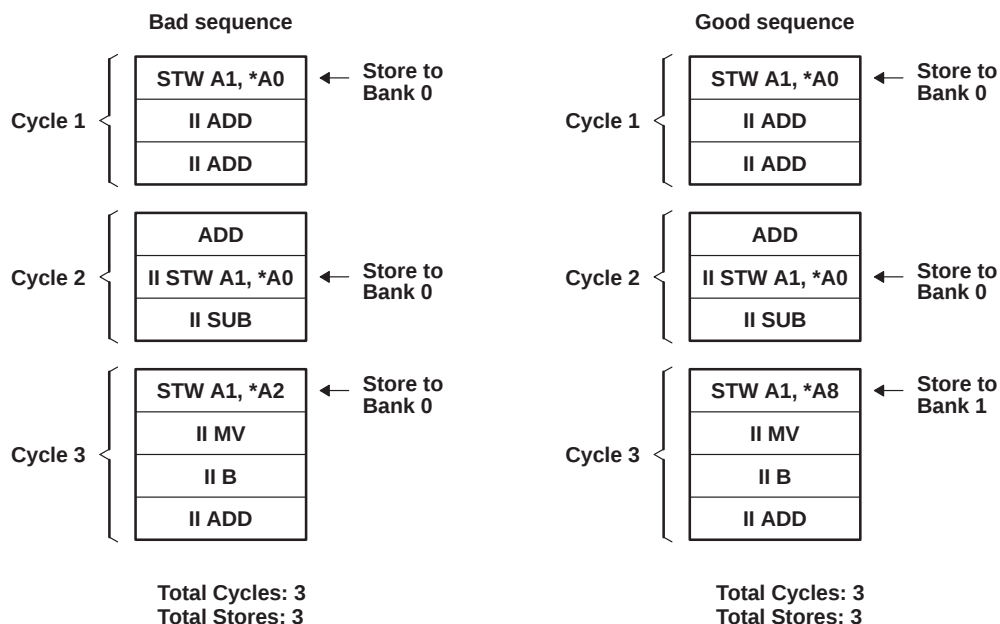
**Figure 8. Pseudo Code Example Stores to Specified Banks (Criteria 3)**

3. All stores in the loop must be to the same bank of L2. If there are any stores to another bank, this will free the first bank long enough for the EDMA access to get in (see Figure 8).

In the case of two stores occurring on the same cycle, in parallel, the same rules apply. If both stores are to the same bank (and there are no other stores in the sequence to a different bank), then a problem may occur. If each of the parallel stores is to a different bank, then the problem cannot occur.

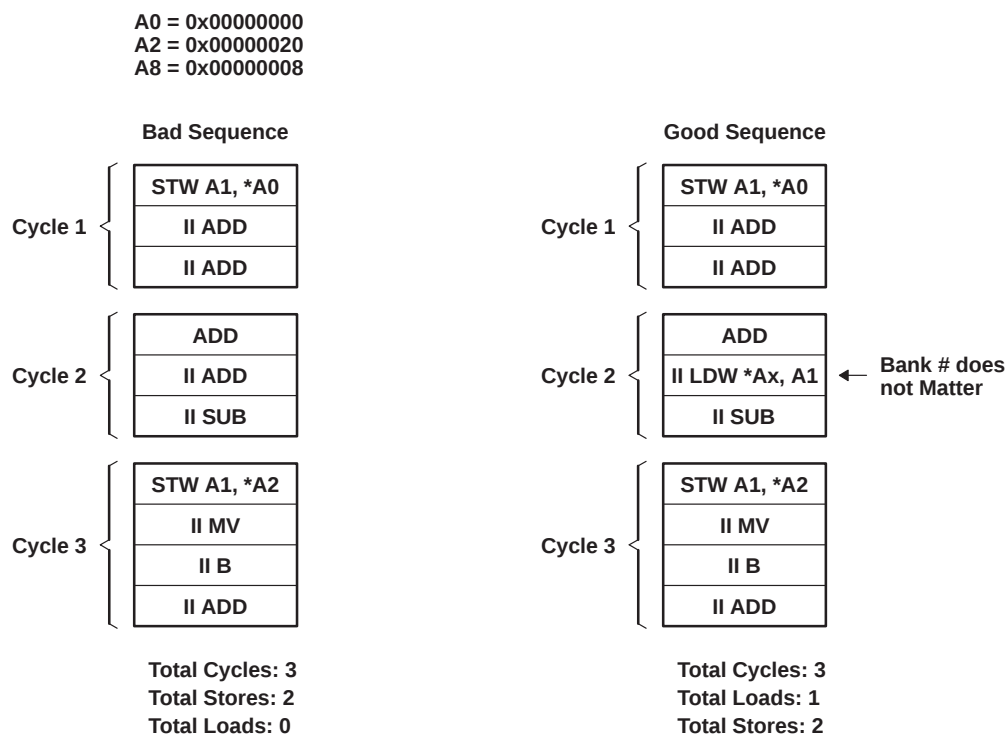
**Figure 9. Pseudo Code Example Stores and Loads (Criteria 4)****Workaround:**

A load from L2 provides enough of a gap to allow the EDMA to access L2. The good sequence would not cause a problem even if the load were executed in parallel with one of the stores, as long as the load occurred somewhere in the sequence. Notice that although the good sequence satisfies criteria 2 and 3, it would not cause a problem.
