# USB251xB/xBi

## USB251xB/xBi Family Silicon Errata

The USB251xB/xBi family devices that you have received conform functionally to the current Device Data Sheet (DS00001692A), except for the anomalies described in this document.

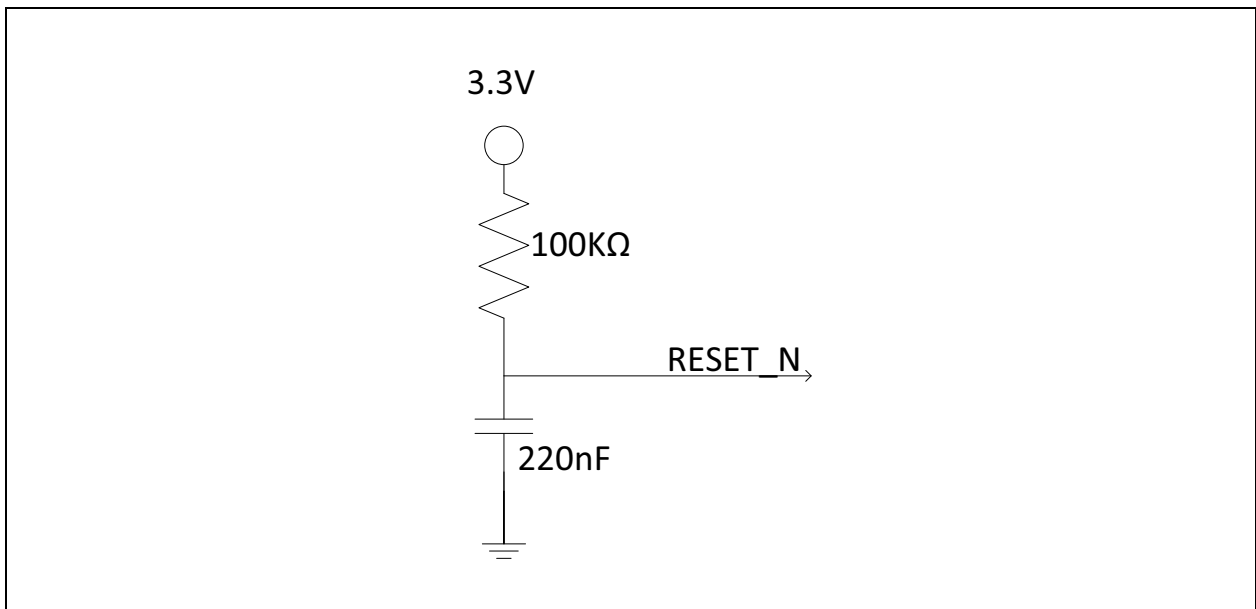
**FIGURE 1: RC CIRCUIT DIAGRAM**

When the Hub is powering up, the DP pin is asserted before other internal logic has started. When the internal logic does start, it can cause a low pulse on the SMBus and DP pins.

The USB protocol can handle a glitch on DP, so no user impact on the USB lines. The SMBus glitch can impact the state machine of the SMBus Controller.

Keep the RESET\_N pin low during POR to remove this glitch. Control RESET\_N through a digital controller or an RC circuit by connecting a 100K $\Omega$  pull-up resistor to 3.3V and a 220nF capacitor to ground. See RC circuit diagram below.
