## MSP430F5438A Device Erratasheet

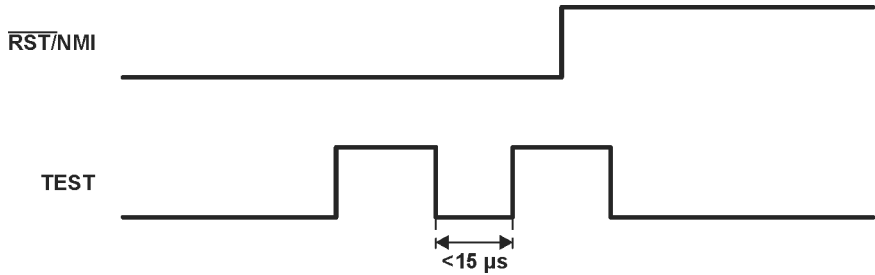
| <b>Function</b> | BSL entry sequence is subject to specific timing requirements |
| <b>Description</b> | <p>The BSL entry sequence requires that the low phase of the TEST/SBWTCK pin does not exceed 15us. This timing requirement is faster than most PC serial ports can provide, as shown in the following picture. If this requirement is not met, the entry sequence fails and the SYSBSLIND is not set.</p> |

| <b>Workaround</b> | An external hardware solution is recommended to provide the appropriate BSL entry sequence. See <a href="http://processors.wiki.ti.com/index.php/BSL_(MSP430)">http://processors.wiki.ti.com/index.php/BSL_(MSP430)</a> for recommendations on available BSL hardware. |
