# **TMS320C6746 Fixed- and Floating-Point DSP Silicon Revisions 2.3, 2.1, 2.0, 1.1 and 1.0**

## **Silicon Errata**

Literature Number: SPRZ304H  
June 2009–Revised March 2014

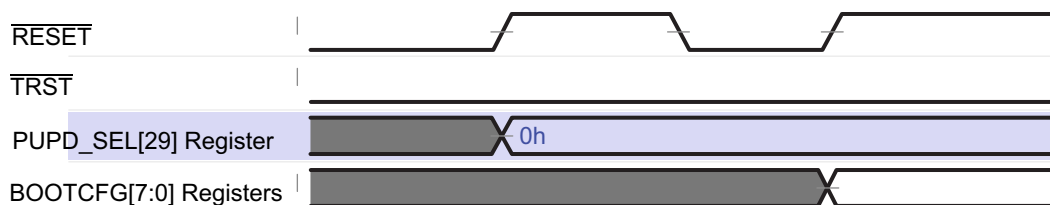
**Figure 10. Initialization of PUPD\_SEL[29] and BOOTCFG[7:0] Registers with Weak or No External Pull Resistors on BOOT[7:0] Pins**

Internal pullups being enabled on the BOOT[7:0] pins may result in boot failures. If weak external pulldown resistors are used on the PCB to select the boot mode, they may not be able to overpower the internal pullups. This can result in the wrong boot mode being latched in the BOOTCFG[7:0] register when coming out of Reset.

Once the device is out of Reset, the PUPD\_SEL[29] register is initialized, and the internal pulldown resistors for the BOOT[7:0] pins are all enabled. Issuing a second Power-On Reset ( $\overline{POR}$ ) results in the intended boot mode being latched, since the pins are internally pulled down as expected.

Figure 10 shows the behavior of the PUPD\_SEL[29] register before and after reset. Assuming weak or no external pull resistors are on the BOOT[7:0] pins, the BOOTCFG register will latch the unknown values after the device initially comes out of Reset. Note that, TRST **must** always be low in order to issue a POR and latch the boot pin values -- the boot pins are not latched after a Warm Reset.

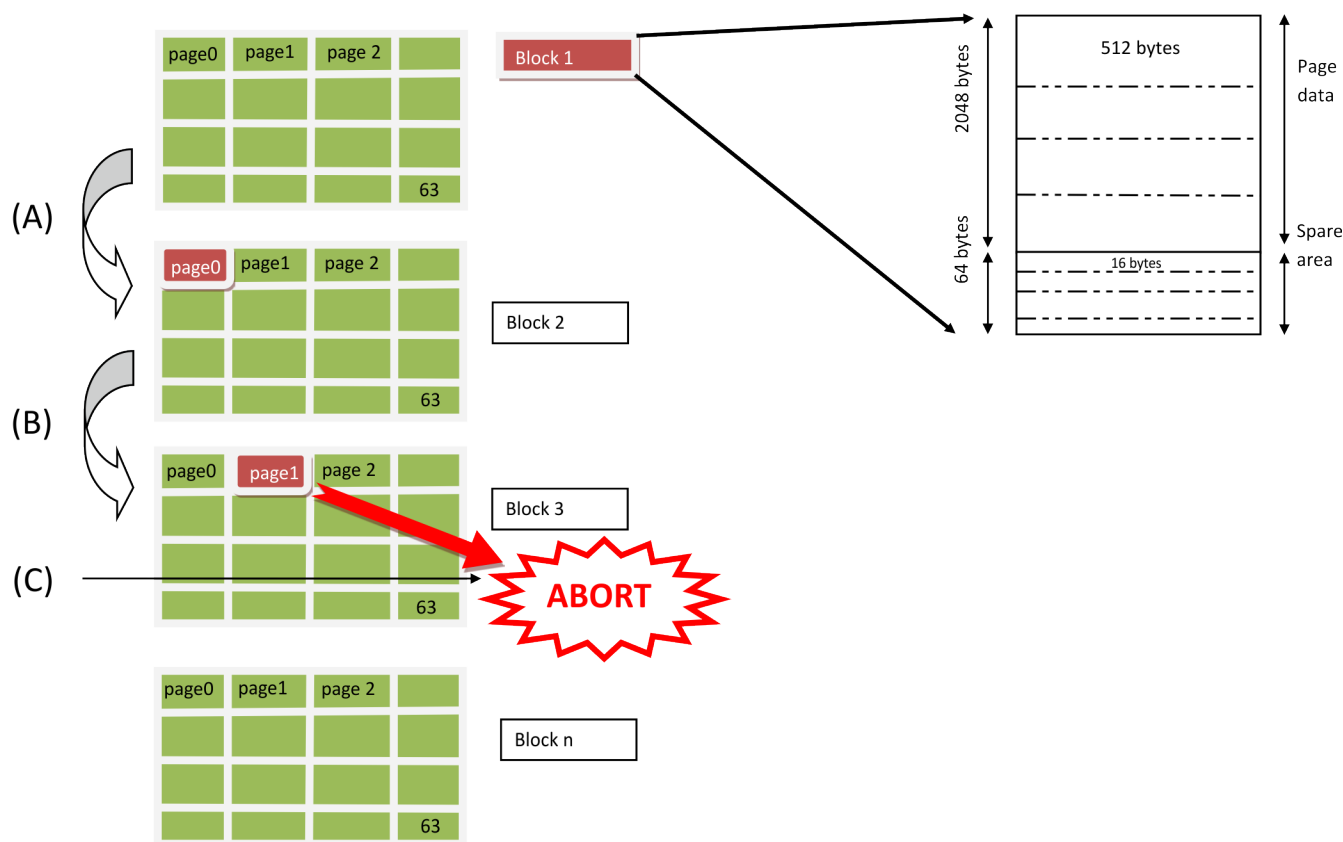
**Figure 11. D800K008 ROM Behavior Before Application of Software Patch<sup>(1)</sup>**

However, over the life span of the NAND flash, ECC data stored in the spare area can develop errors due to bit flips. When the calculated syndrome indicates an error in the ECC data, the ECC Correct and Read functions of the RBL abort the read process even though, it is possible to correct up to 4 bit errors combined in user and ECC data. Consequently the device fails to boot.

If page0 of the good block has an ECC data error or an uncorrectable error (more than 4 bit errors combined), the RBL skips to the next block (shown as (B) in [Figure 11](#)). This bad block check mechanism enables the device to check up to the first 32 blocks in the NAND flash for booting (the boot process will fail if all 32 blocks have uncorrectable or ECC data errors in page0). Note that the RBL does not abort on detecting an error in ECC data on page0.

Once the RBL finds a good block with a good page0, it continues to read subsequent pages in that block. If an uncorrectable or ECC error is detected in subsequent pages, the RBL will abort with a boot error (shown as (C) in [Figure 11](#)). The workaround, described below, enables the boot process to continue for both types of errors (ECC data and uncorrectable errors).

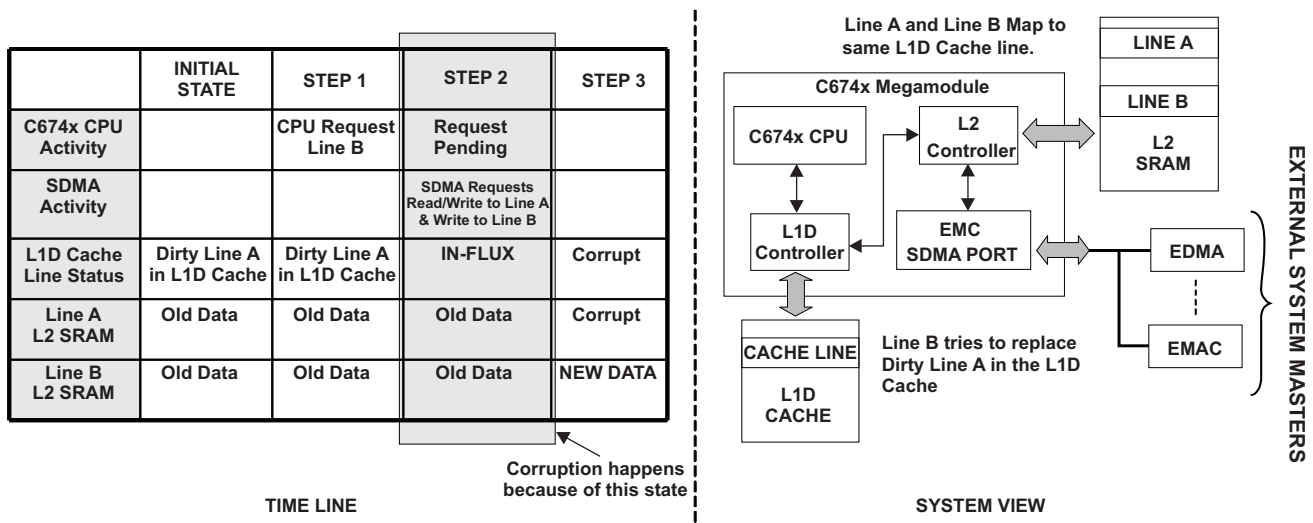
Figure 13. Example of L1D Cache and L2 RAM Corruption

An L1D cache-line corruption event occurs when all of the following conditions are met:

1. L1D cache evicts a dirty line (Line A) while allocating a new line (Line B) in the same set/way (cache Lines A and B consist of 64-bytes each). In order for this to happen, the following will have taken place:
  - (a) Line A was previously read by CPU because L1D is a read-allocate cache,
  - (b) Line A is dirty because its value was modified by CPU, and
  - (c) Line B is read by CPU
2. Both Line A and Line B are associated with L2 RAM, and
3. While the original L1D victim write-back from condition (1) is in progress, the SDMA performs both:
  - (a) a read or write operation to Line A in L2 RAM and
  - (b) a write operation to Line B in L2 RAM.

If all of the above conditions are met, the L2 RAM data associated with the Line A victim writeback will become corrupt. Additionally, the Line B data originating from the SDMA write will also become corrupt in L1D cache. [Figure 13](#) shows an example scenario of L1D cache and L2 RAM corruption.

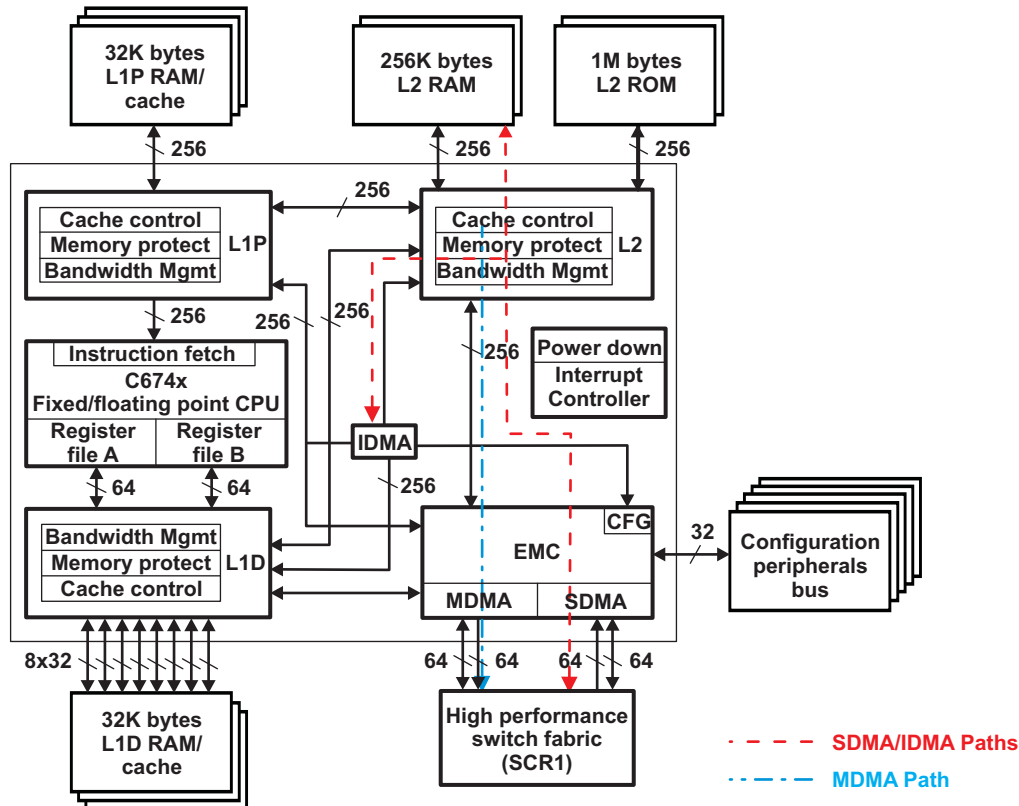
**Figure 14. C674x Megamodule**

Ideally, the MDMA (dashed-dotted line in [Figure 14](#)) and SDMA/IDMA paths (dashed lines in [Figure 14](#)) operate independently with minimal interference. Normally MDMA accesses may stall for extended periods of time due to expected system level delays (for example, bandwidth limitations). However, when using L2 as RAM, SDMA and IDMA accesses to L2/L1 may experience unexpected stalling in addition to the normal stalls seen by the MDMA interface. For latency-sensitive traffic, the SDMA stall can result in missing real-time deadlines. In a more severe case, the SDMA stall can produce a deadlock condition in the device. An IDMA stall cannot produce a deadlock condition.

**Note:** SDMA/IDMA accesses to L1P/D will not experience an unexpected stall if there are no SDMA/IDMA accesses to L2. Unexpected SDMA/IDMA stalls to L1 happen only when they are pipelined behind L2 accesses. Additionally, the deadlock scenario will be avoided if there are no SDMA accesses to L2.

The duration of the SDMA/IDMA stalls depend on the quantity/characteristics of the L1/L2 cache and the MDMA traffic in the system. Therefore, it is difficult to predict if stalling will occur and for how long.

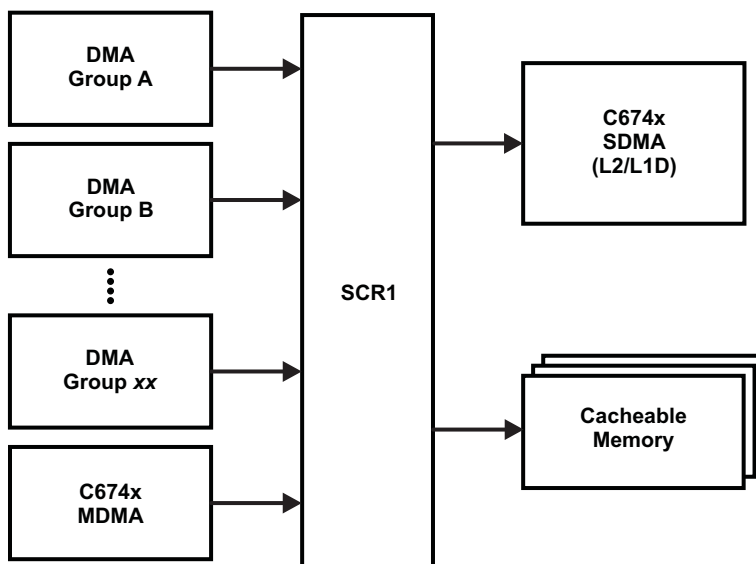
**Figure 15. SCR1 System Interconnect**

Step 2: The DSP's SDMA asserts itself as not ready and is unable to accept the write data from Step 1, and a cache line writeback is initiated from DSP memory to the same cacheable memory from Step 1. The cache line writeback command also passes through SCR1.

With the above scenario, it is possible for SCR1 to order the write commands from Step 1 in front of the write commands from Step 2. Due to the MDMA/SDMA blocking behavior, the SDMA commands from Step 2 will be waiting for the MDMA traffic from Step 1 to finish, resulting in a deadlock situation at SCR1. [Figure 15](#) is provided for illustrative purposes and is incomplete because of simplification.
