**TMS320DM6437/35/33/31**  
**Digital Media Processor (DMP)**  
**Silicon Revisions 1.3, 1.2, 1.1, and 1.0**

# **Silicon Errata**

Literature Number: SPRZ250E  
January 2007–Revised August 2011

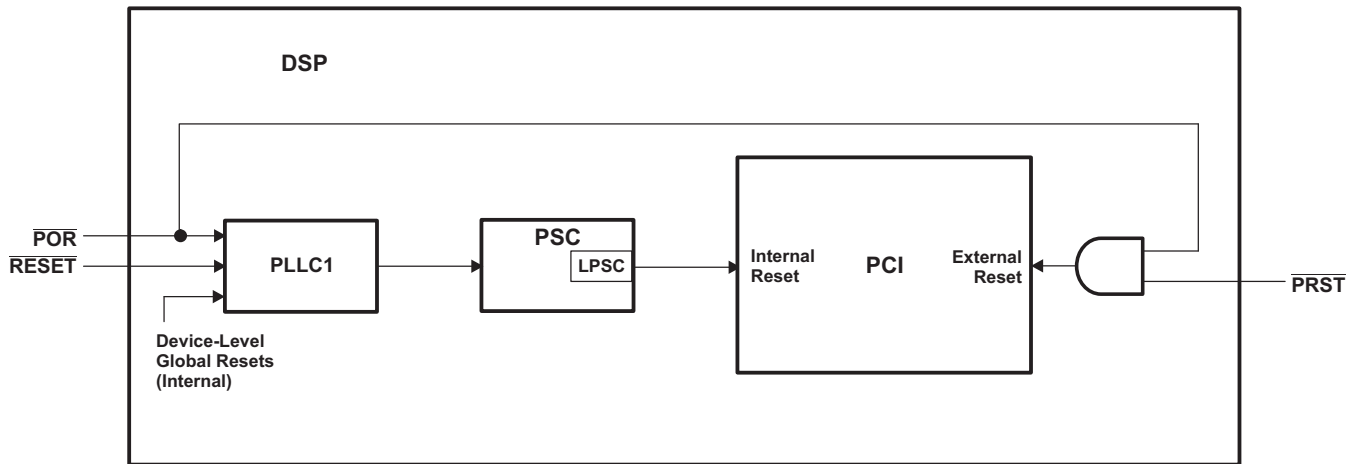
Figure 3. Internal and External Reset Inputs of the PCI Module

On all DM6437 and DM6433 silicon revisions, the PCI module has both an internal and external reset source (see Figure 3). The external reset is asserted through *either* the PCI Reset pin ( $\overline{\text{PRST}}$ ) or the Power-On Reset pin ( $\overline{\text{POR}}$ ). The internal reset is controlled by the Local Power and Sleep Controller (LPSC) of the PCI module. The PSC asserts the internal reset of the PCI module after a device-level global reset or when the DSP code programs the PSC to do so. A device-level global reset is generated through the Power-On-Reset pin ( $\overline{\text{POR}}$ ) or the Warm Reset pin ( $\overline{\text{RESET}}$ ); however, there are other methods to generate a device-level global reset. For these other methods, see Table 4.

Systems should be designed such that a device-level global reset *always* generates the PCI Reset ( $\overline{\text{PRST}}$ ) and vice-versa. The PCI module can lock-up or go into a bad state if its internal and external resets are asserted independently—meaning one is asserted and the other is not.

Figure 4 and Figure 5 show example circuits which ensure both the device-level global reset and the PCI Reset ( $\overline{\text{PRST}}$ ) are asserted together.

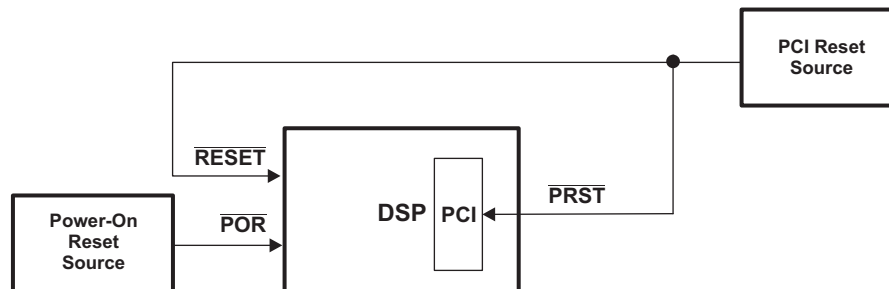
Figure 4. PCI Reset ( $\overline{\text{PRST}}$ ) and Warm Reset ( $\overline{\text{RESET}}$ ) Tied Together from Single External Source

In [Figure 4](#) and [Figure 5](#) a device-level global reset resets the DSP and the PCI module only; other devices on the PCI bus *will not* be reset. To avoid interrupting any ongoing PCI transactions to/from the DSP, the DSP PCI should be "disconnected" from the PCI system.

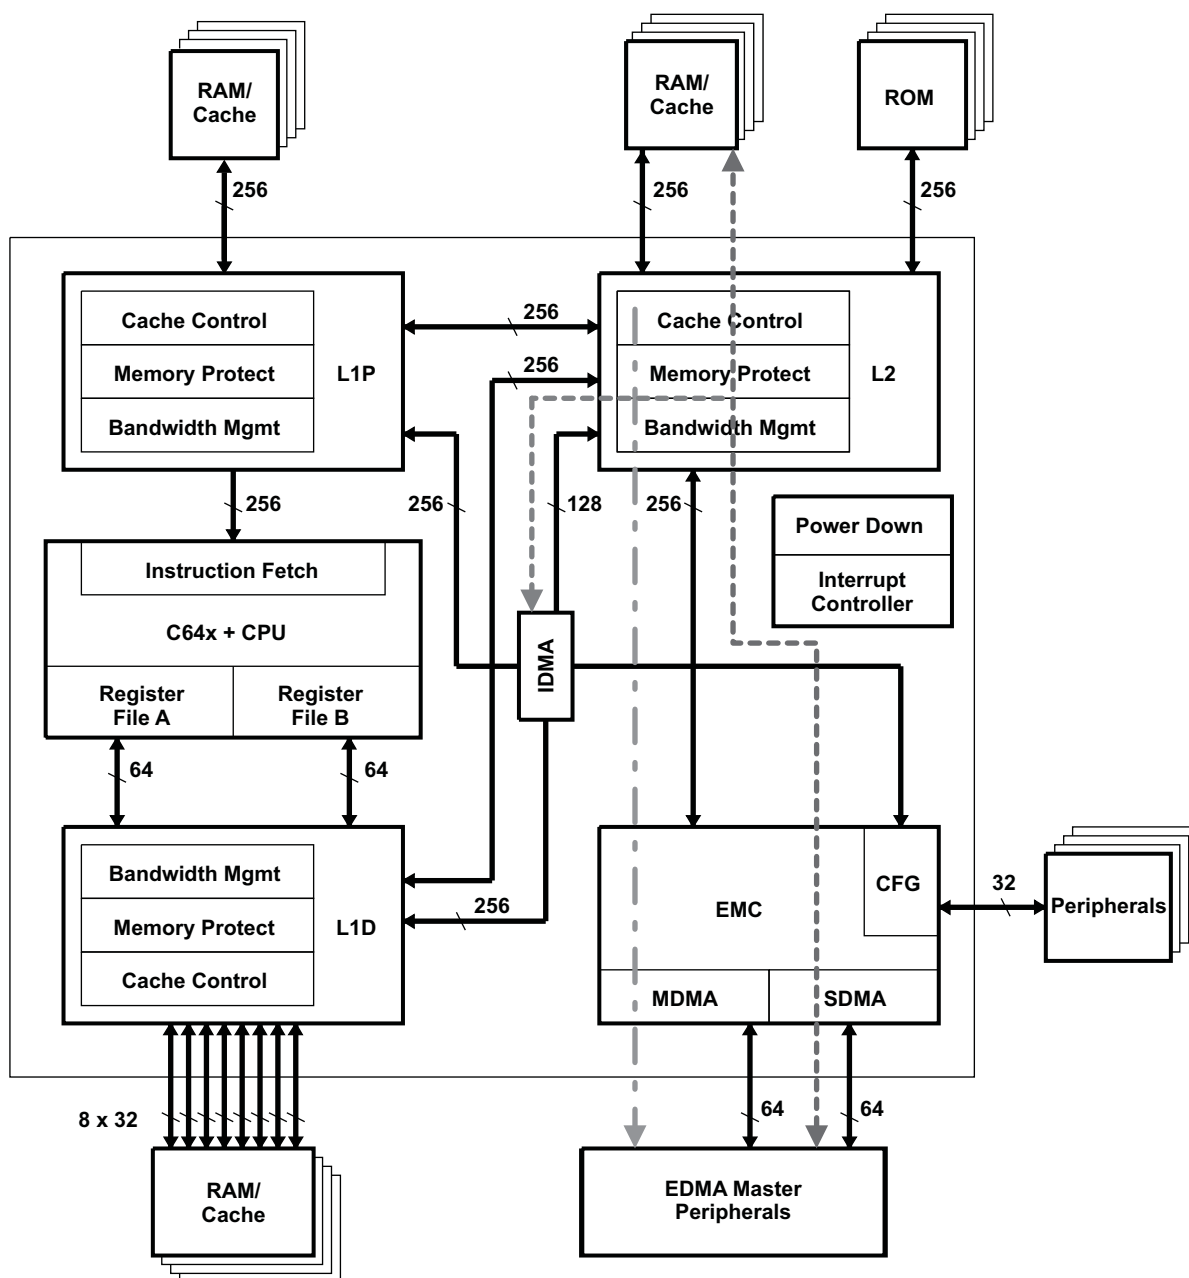
Figure 6. IDMA, SDMA, MDMA Paths

| <b>Details</b> | <p><b>Note:</b> This advisory is not applicable if DSP L2 memory is configured as 100% cache <b>or</b> L2 RAM is <i>not</i> accessed by IDMA or SDMA during run-time.</p> <p>The C64x+ Megamodule has a Master Direct Memory Access (MDMA) bus interface and a Slave Direct Memory Access (SDMA) bus interface. The MDMA interface provides DSP access to resources outside the C64x+ Megamodule (i.e., DDR2, EMIFA, VLYNQ remote memory). The MDMA interface is typically used for CPU/cache accesses to memory beyond the Level 2 (L2) memory level. These accesses include cache line allocates, write-backs, and non-cacheable loads and stores to/from system memories. The SDMA interface allows other master peripherals, including EDMA transfer controllers, VPSS (OSD/CCDC), UHPI, PCI, EMAC, and VLYNQ, to access Level 1 Data (L1D), Level 1 Program (L1P), and L2 RAM DSP memories. The DSP Internal DMA (IDMA) is a C64x+ Megamodule DMA engine used to move data between internal DSP memories (L1,L2) and/or the DSP peripheral configuration bus. The IDMA engine shares resources with the SDMA interface.</p> <p>The C64x+ Megamodule has an L1D cache and L2 cache both implementing write-back data caches— it holds updated values for external memory as long as possible. It writes these updated values, called "victims", to external memory when it needs to make room for new data <i>or</i> when requested to do so by the application. The L1D sends its victims to L2. The caching architecture has pipelining, meaning multiple requests could be pending between L1, L2, and MDMA. For more details on the C64x+ Megamodule and its MDMA and SDMA ports, see the <i>TMS320C64x+ Megamodule Reference Guide</i> (literature number <a href="#">SPRU871</a>).</p> <p>Ideally, the MDMA (dashed-dotted line in <a href="#">Figure 6</a>) and SDMA/IDMA paths (dashed lines in <a href="#">Figure 6</a>) operate independently with minimal interference. Normally MDMA accesses may stall for extended periods of time due to expected system level delays (e.g., bandwidth limitations, DDR2 memory refreshes). However, when using L2 as RAM, SDMA and IDMA accesses to L2/L1 may experience unexpected stalling in addition to the normal stalls seen by the MDMA interface. For latency-sensitive traffic, the SDMA stall can result in missing real-time deadlines. In a more severe case, the SDMA stall can produce a deadlock condition in the device. An IDMA stall cannot produce a deadlock condition.</p> <p><b>Note:</b> SDMA/IDMA accesses to L1P/D <b>will not</b> experience an unexpected stall if there are no SDMA/IDMA accesses to L2. Unexpected SDMA/IDMA stalls to L1 happen <i>only</i> when they are pipelined behind L2 accesses. Additionally, the deadlock scenario will be avoided if there are no SDMA accesses to L2.</p> <p><a href="#">Figure 6</a> is provided for illustrative purposes and is incomplete for simplification. The IDMA/SDMA (dashed-lines) path could also go to L1D/L1P memories, and IDMA can go to DSP CFG peripherals. MDMA transactions can originate also from L1P or L1D through the L2 controller or directly from DSP.</p> |

- (b) L1D read request missing L2 (going external) while another L1D request is pending. The SDMA/IDMA may be stalled until the external memory access is complete.

Entirely eliminate IDMA/SDMA stalling and potential for a deadlock condition using one or both of the following methods:
