TMS570LS31x/21x Microcontroller

Silicon Revision C

Silicon Errata

Literature Number: SPNZ195G
February 2013–Revised May 2016

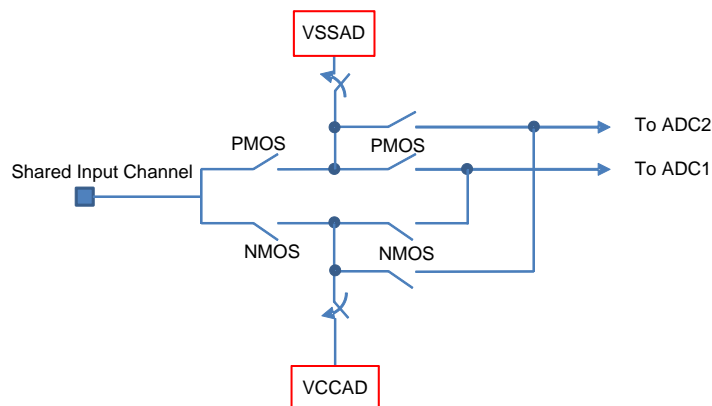
Figure 2. Shared Input Channel in "Open" State

Issue This microcontroller (MCU) has two Analog-to-Digital Converters (ADCs). Some of the input channels are unique to ADC1 while some are shared between ADC1 and ADC2. [Figure 2](#) shows a block diagram of an input channel shared between ADC1 and ADC2.

The PMOS and NMOS switches are open indicating that this shared input channel is not currently being sampled either by ADC1 or by ADC2. Also, there are switches to VCCAD and VSSAD that are closed. If any current is injected into this analog input, any leakage through the open PMOS switch will be shunted to VSSAD. These switches to VSSAD and VCCAD are opened as soon as this shared input channel is being sampled by either ADC1 or ADC2.

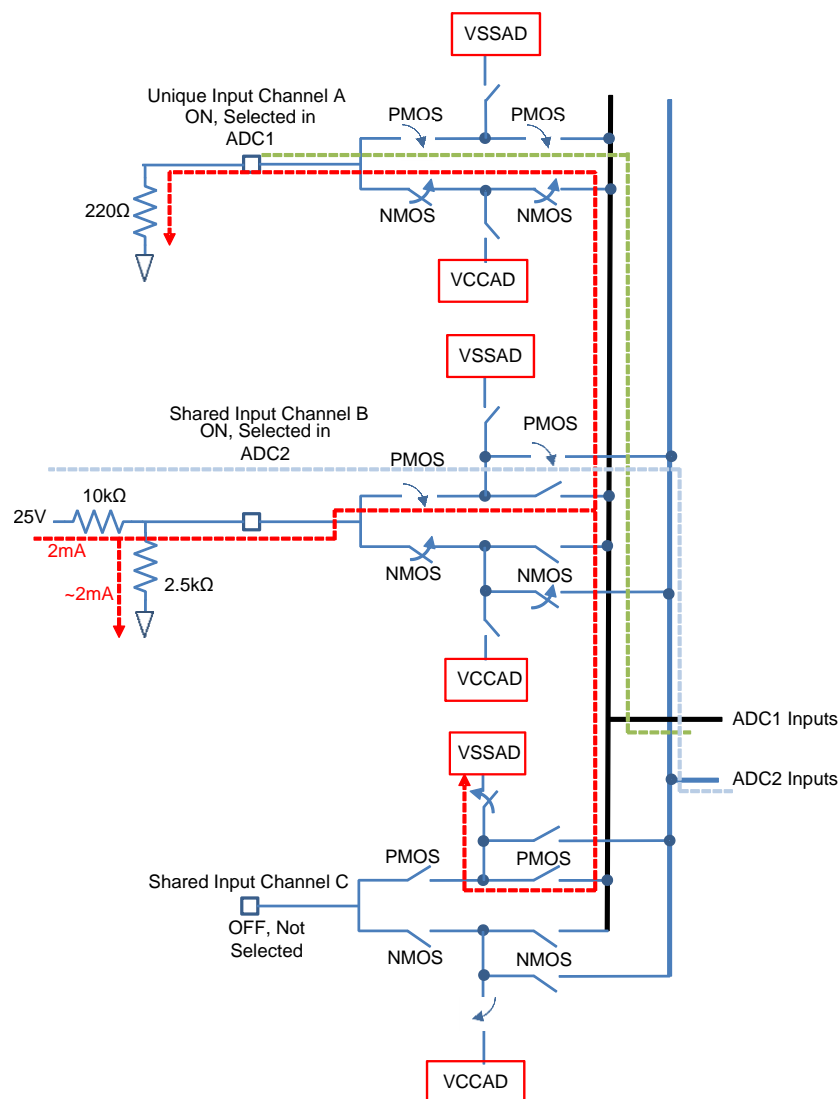
Figure 3. Example ADC1/ADC2 Channel Connection

Figure 3 shows an example where a ADC1 is sampling input channel A which is unique to ADC1, and ADC2 is sampling input channel B, which is a shared-input channel. This is shown by the dashed green and light blue current paths.

Another current path is shown in dashed dark red. This is a current injected into channel B as the input level on terminal B is greater than $V_{CCAD} - 0.3V$. This is a parasitic current that passes through the "open" PMOS switch, and a part of this current flows to ground through the external 220 ohm resistor connected to input channel A. This causes an offset in the conversion result of channel A being sampled by ADC1.

1. Configure the two ADC modules such that their sampling periods do not overlap, or
2. Limit the shared analog input upper limit to be lower than ($V_{CCAD} - 0.3V$). The PMOS leakage is reduced exponentially if the input is lower than $V_{CCAD} - 0.3V$.
