STM32WB55Cx/Rx/Vx device errata

Applicability

This document applies to the part numbers of STM32WB55Cx/Rx/Vx devices and the device variants as stated in this page. It gives a summary and a description of the device errata, with respect to the device datasheet and reference manual RM0434. Deviation of the real device behavior from the intended device behavior is considered to be a device limitation. Deviation of the description in the reference manual or the datasheet from the intended device behavior is considered to be a documentation erratum. The term “*errata*” applies both to limitations and documentation errata.

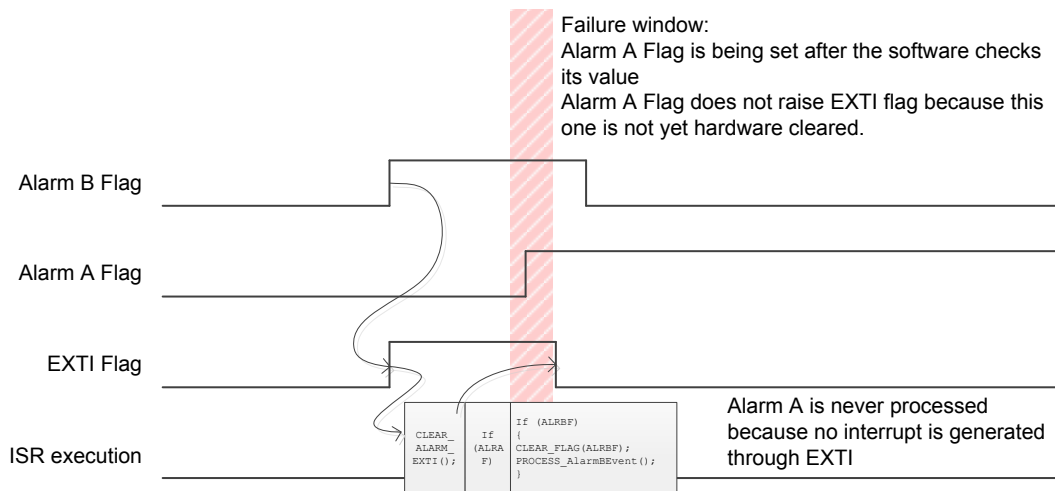
Figure 1. Masked RTC interrupt

The following code example and figure illustrate the failure mechanism: The Alarm A event is lost (fails to generate interrupt) as it occurs in the failure window, that is, after checking the Alarm A event flag but before the effective clear of the EXTI interrupt flag by hardware. The effective clear of the EXTI interrupt flag is delayed with respect to the software instruction to clear it.

In the interrupt service routine, apply three consecutive event flag checks - source one, source two, and source one again, as in the following code example:
