## KSZ9031MNX Silicon Errata & Data Sheet Clarification

This document describes known silicon errata for the Microchip KSZ9031MNX device, which include the following variants:

- KSZ9031MNXCA
- KSZ9031MNXCC
- KSZ9031MNXIA
- KSZ9031MNXIC

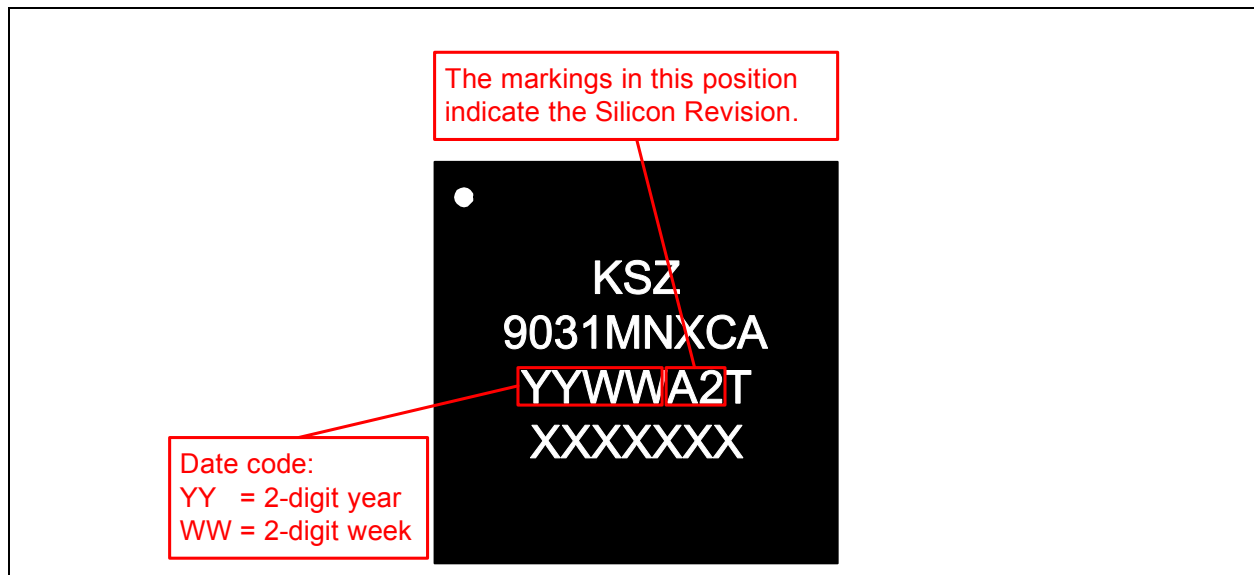
**FIGURE 1: TOP MARKING DATE CODE INDICATION**

The silicon errata discussed in this document are for silicon revisions as listed in [Table 1](#). The silicon revision can be determined by the device's top marking as indicated in [Figure 1](#). A summary of KSZ9031MNX silicon errata is provided in [Table 2](#).

**Note:** The purpose of [Figure 1](#) is to detail the top markings of an example part and highlight the location of the silicon revision code. Other top marking values may differ (lot codes, location of manufacture, etc.).

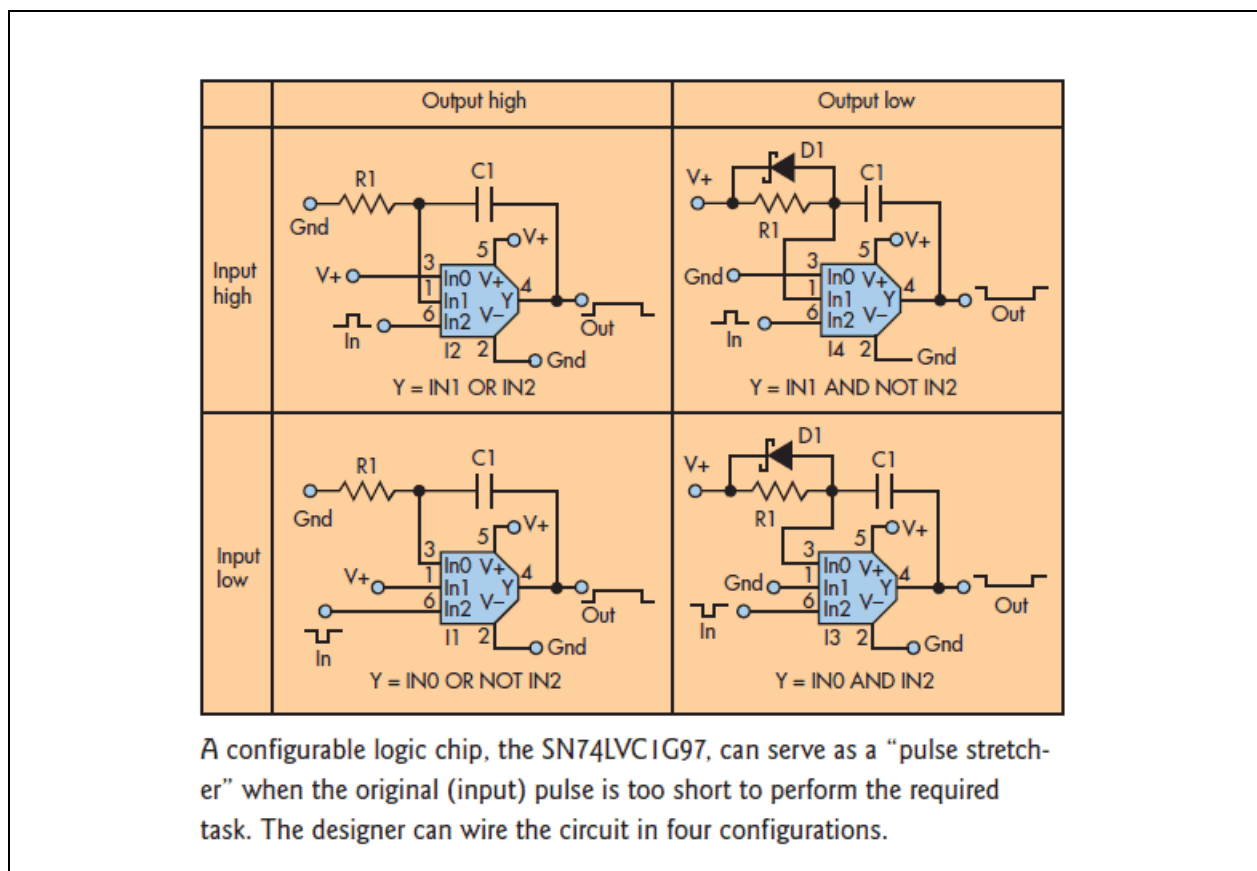
**FIGURE 2: LED CONFIGURATION**

In Tri-color Dual-LED mode, the LED[2:1] pin outputs toggle high pulses for transmit/receive activity indication. The high pulse width incorrectly tracks the activity data rate. At low data rate (e.g., one frame per second), the LED pin drives high (OFF) with a narrow high pulse width of about 640ns.

Typically, the LED toggle rate should be <10Hz (100ms clock period or 50ms high pulse width) to be visible to the human eye. A 640ns pulse is not visible.

If Tri-color Dual-LED mode must be used, use a pulse stretching circuit to detect high narrow pulse widths down to 500ns and stretch them to the visible width (e.g., >50ms). The following Electronic Design web link article has a sample pulse stretching circuit:

Use the Input high / Output high configuration, as shown in Figure 2 from the Electronic Design link. The output high stretch time is set by the time constant ( $R1 * C1$ ).

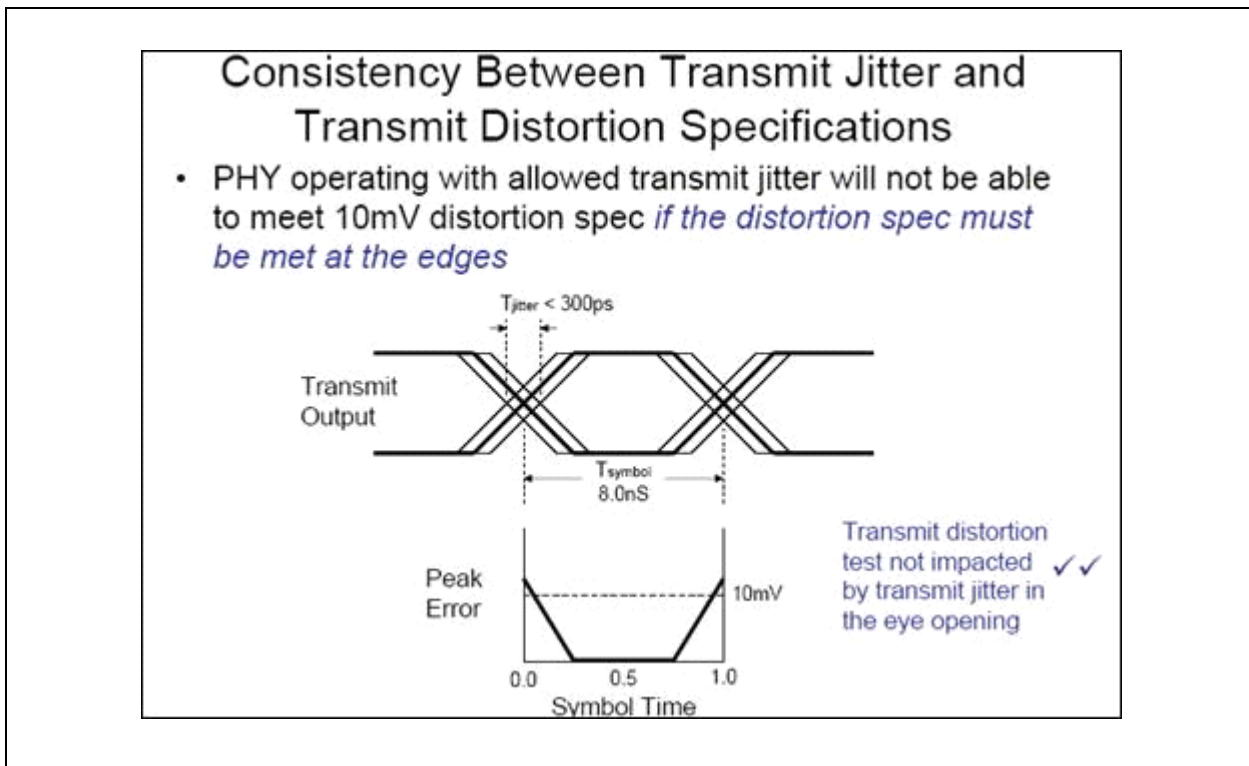
**FIGURE 3: IEEE DOCUMENT PAGE 6**

IEEE testing calls for <10mV peak transmitter distortion for at least 60% of the UI within the eye opening. However, this measurement might not be valid, as the transmit distortion test is sensitive to transmit jitter. Refer to the explanation below, taken from the aforementioned IEEE document.

- On page 6, a contradiction between Transmit Jitter and Transmit Distortion requirements:
