# ***AM574x, AM576x Sitara™ Processors***

## ***Silicon Revision 1.0***

## 1 Introduction

This document describes the known exceptions to the functional specifications for the device.

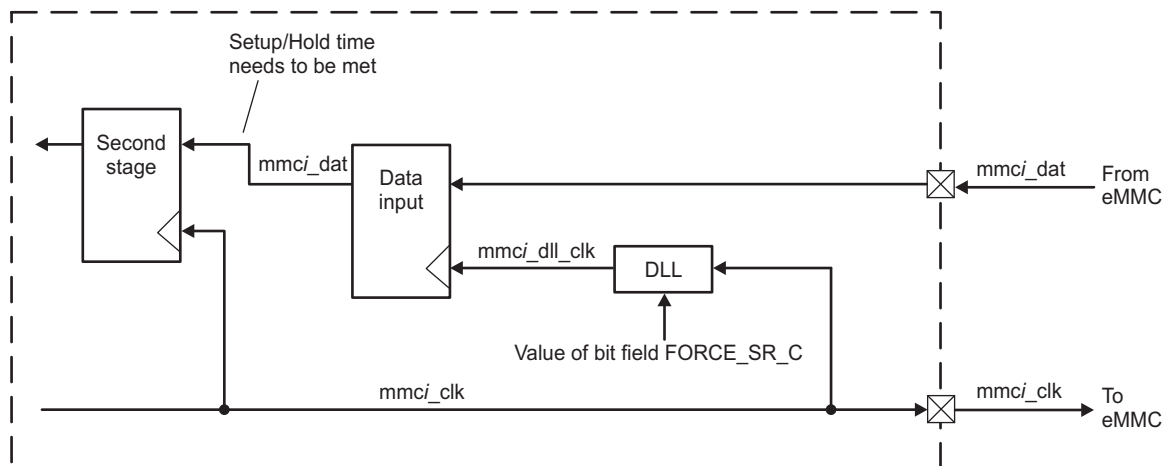
**Figure 1. Simplified SoC 192-MHz Mode DLL Block Diagram**

**DESCRIPTION** Internal to the MMC module, a second stage latch is used to recapture data captured by DLL delayed clock, `mmci_dll_clk`. The second stage latch captures with the original transmitting clock, `mmci_clk`.

`mmci_dll_clk` and `mmci_clk` both run at the same clock frequency. This results in a narrow range of tuning ratio elements, where the delayed `mmci_dll_clk` comes in phase with `mmci_clk`. If the clocks are in phase, the data captured by the first clock violates the setup and hold time requirements needed for the second stage latch, resulting in incorrectly read data. This is known as tuning re-timing errors.

For systems in which MMC DLL tuning algorithm\* chooses a ratio less than 40, which is sufficiently far from the lowest re-timing error ratio element, no workaround is necessary.

**WORKAROUND** A DLL tuning algorithm has been implemented that can avoid the tuning re-timing errors. More details on this can be found in App Note [SPRACA9](#). The following notes summarize the updated algorithm:
