## STM32L451xx device errata

This document applies to the part numbers of STM32L451xx devices and the device variants as stated in this page.

It gives a summary and a description of the device errata, with respect to the device datasheet and reference manual RM0394.

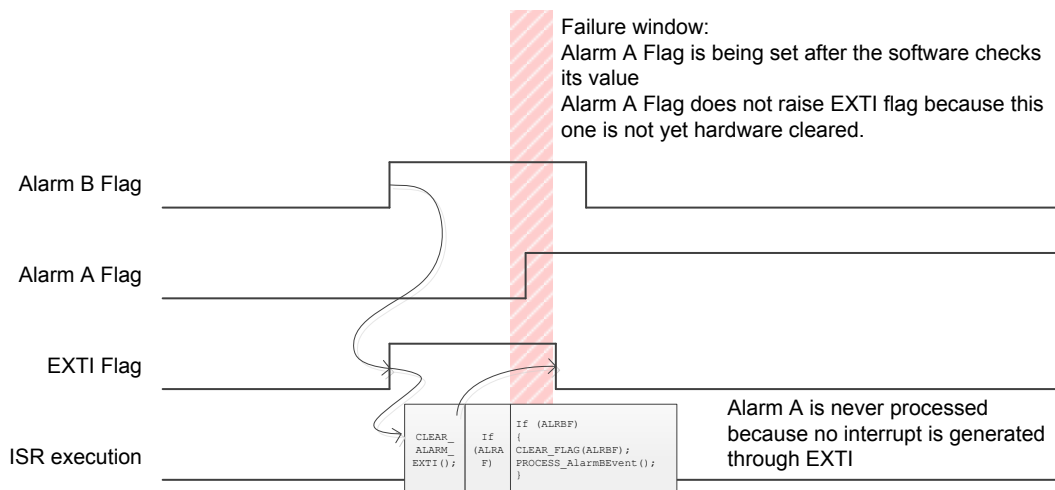
Figure 1. Masked RTC interrupt

The following code example and figure illustrate the failure mechanism: The Alarm A event is lost (fails to generate interrupt) as it occurs in the failure window, that is, after checking the Alarm A event flag but before the effective clear of the EXTI interrupt flag by hardware. The effective clear of the EXTI interrupt flag is delayed with respect to the software instruction to clear it.

In the interrupt service routine, apply three consecutive event flag checks - source one, source two, and source one again, as in the following code example:
