**TMS320C6712, TMS320C6712C, TMS320C6712D**  
**Digital Signal Processors**  
**Silicon Errata**

**C6712 Silicon Revisions 1.0, 1.2, 1.3**

**C6712C Silicon Revision 1.1**

**C6712D Silicon Revision 2.0**

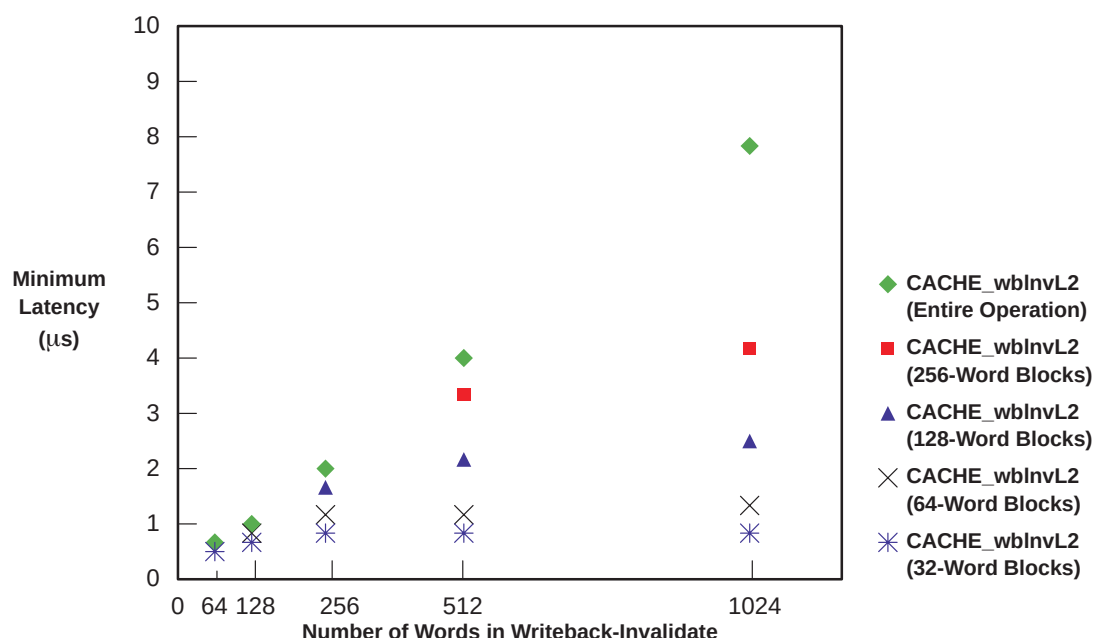
**Figure 2. Minimum Required Latency Between McBSP Events for a Successful Transfer with Concurrent L2 Writeback-Invalidates at 200-MHz CPU and 50-MHz EMIF, Using Entire Operations and Block Breakdown**

For example, if the CPU is running at 200 MHz with a 50-MHz EMIF and you have a McBSP hard real-time deadline of 5  $\mu$ s, Figure 2 shows that a 1024-word L2 writeback-invalidate may cause data loss since back-to-back McBSP events can only be serviced at  $\sim 8$   $\mu$ s. By breaking down the L2 writeback-invalidate into 256-word blocks, you can then meet the 5- $\mu$ s McBSP deadline. In other words, when performing a 1024-word L2 writeback-invalidate operation with the CPU and EMIF conditions cited above, the McBSP events can be serviced in  $\sim 8$   $\mu$ s for the entire operation (one whole block), in  $\sim 4$   $\mu$ s when breaking it into 256-word blocks, in  $\sim 2.5$   $\mu$ s when breaking it into 128-word blocks, etc.

1. Avoid placing real-time data in EMIF address range. Instead, real-time data should be placed in the L2 address range.
2. If data must be placed in the EMIF address range:
  - Avoid global cache operations in favor of block-based cache operations.
  - Block-based cache operations should be submitted in small blocks, such that the total amount of time that the EMIF is blocked is less than the amount of time between serial samples.

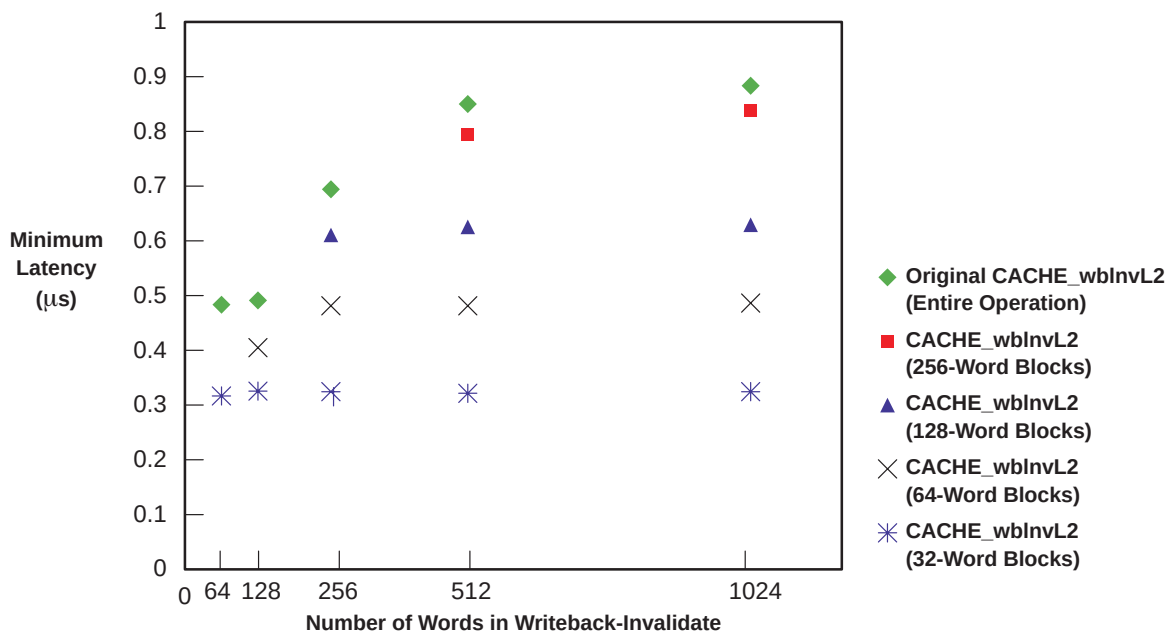
**Figure 3. Minimum Required Latency Between McBSP Events for a Successful Transfer With Concurrent Writeback-Invalidates at 225-MHz CPU and 100-MHz EMIF, Using Entire Operations and Block Breakdown**

When the CPU is set to 225 MHz and the EMIF is set to 100 MHz, breaking down the cache operations will still improve the block-out problem. Figure 3 shows the improvement in the McBSP's performance with this frequency ratio.

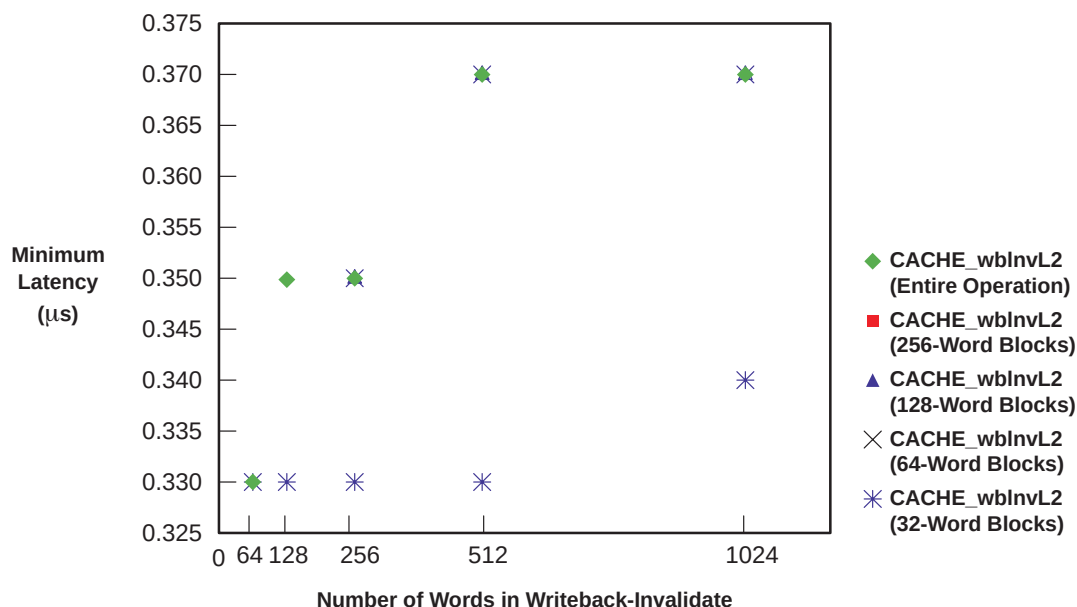
**Figure 4. Minimum Required Latency Between McBSP Events for a Successful Transfer With Concurrent Writeback-Invalidates at 150-MHz CPU and 100-MHz EMIF, Using Entire Operations and Block Breakdown**

When the CPU is set to 150 MHz and the EMIF is set to 100 MHz, there is virtually no benefit from breaking down the coherency cache operations. Figure 4 shows the McBSP's performance with this frequency ratio.

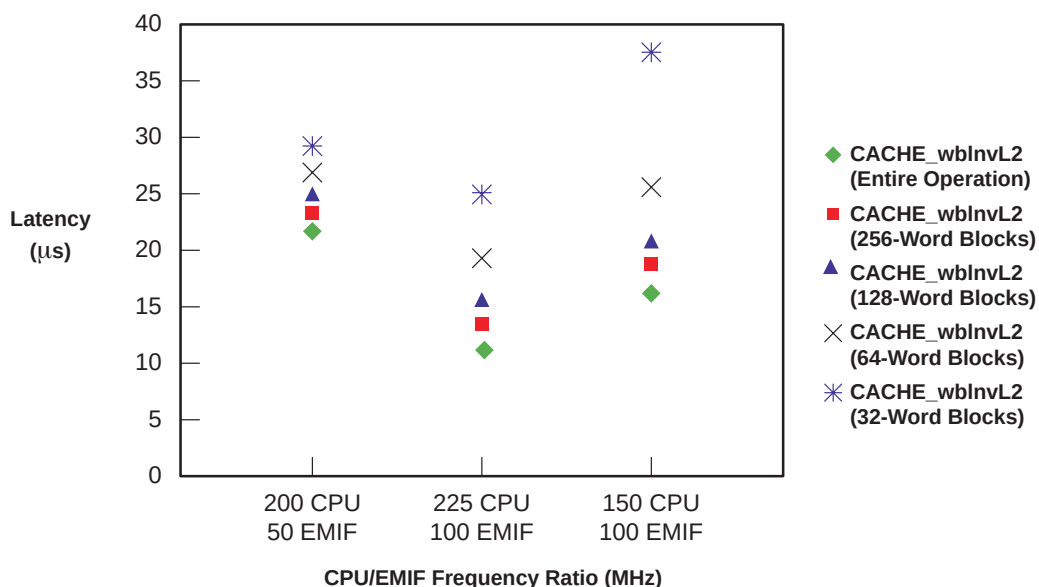
**Figure 5. 1024-Word L2 Writeback-Invalidate Performance at Various Frequency Ratios With Old and New CACHE\_wbInvL2()**

Breaking down the cache operations into smaller blocks takes longer to complete than performing the entire cache function as one large block. Figure 5 shows how much extra overhead is incurred by breaking down an L2 writeback-invalidate operation to transfer 1024 words with different sized blocks and at various frequency ratios. Notice that for the 200-MHz CPU and the 50-MHz EMIF frequency ratio, where the new functions are most critical for peripherals such as the McBSP, the least overhead is incurred.

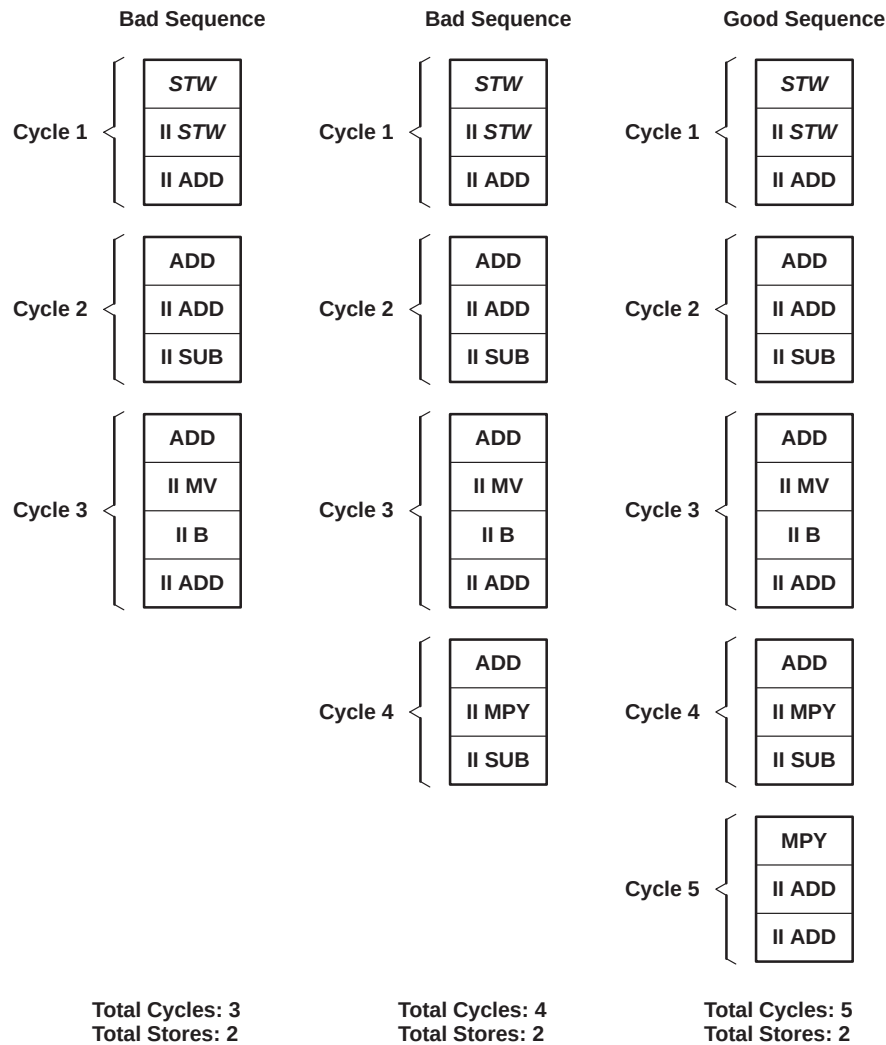
Figure 7. Pseudo Code Example With Parallel Stores (Criteria 2)

Figure 7 outlines this scenario. Note that the STW instruction represents a store of any word size (32-, 16-, or 8-bit).

In most looped code, more than one instruction would likely be executed on each cycle, i.e., instructions would be executed in parallel. In this case, as long as a store is one of the instructions being executed in parallel on a particular cycle, that cycle counts as a cycle on which a store occurs. Instructions with parallel bars (||) at the beginning of the line of assembly execute in parallel with instructions on the preceding line.

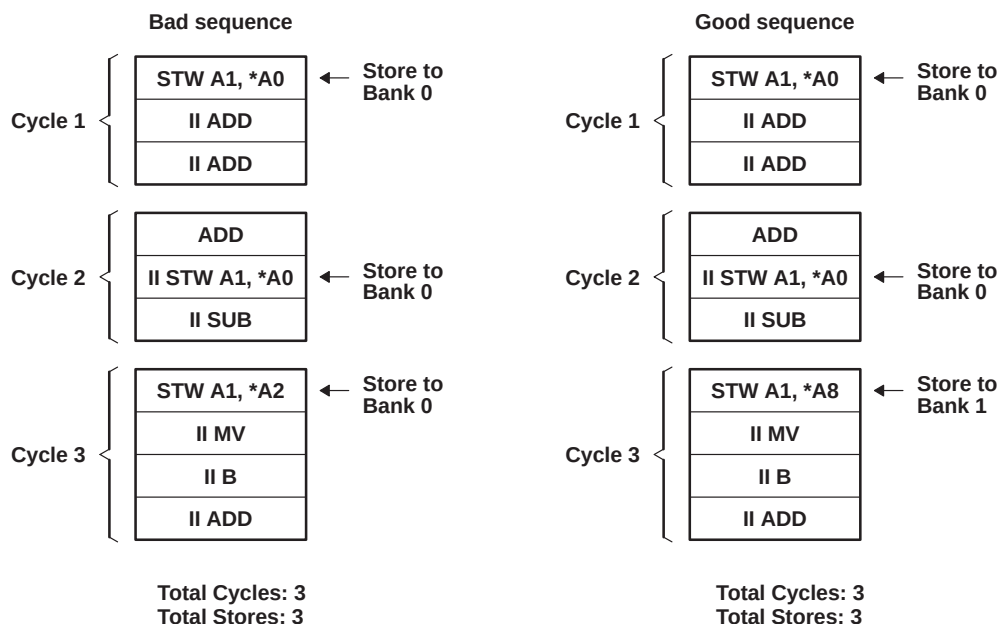
**Figure 8. Pseudo Code Example Stores to Specified Banks (Criteria 3)**

3. All stores in the loop must be to the same bank of L2. If there are any stores to another bank, this will free the first bank long enough for the EDMA access to get in (see Figure 8).

In the case of two stores occurring on the same cycle, in parallel, the same rules apply. If both stores are to the same bank (and there are no other stores in the sequence to a different bank), then a problem may occur. If each of the parallel stores is to a different bank, then the problem cannot occur.

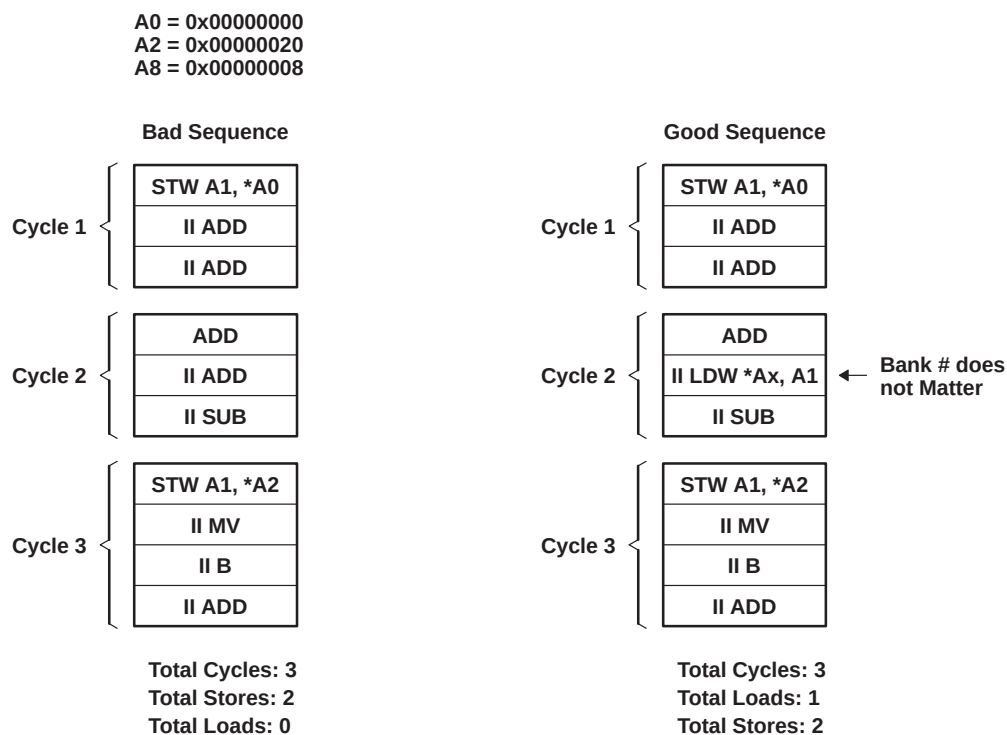
Figure 9. Pseudo Code Example Stores and Loads (Criteria 4)

A load from L2 provides enough of a gap to allow the EDMA to access L2. The good sequence would not cause a problem even if the load were executed in parallel with one of the stores, as long as the load occurred somewhere in the sequence. Notice that although the good sequence satisfies criteria 2 and 3, it would not cause a problem.

- A. Reduce the duration of the loop by breaking into smaller loops. If a particular problem loop has a length of 4 cycles (determined by looking at the software pipeline kernel in the assembly file), and the loop runs 200 times, then the total loop duration is ~800 cycles. If the deadline is 586 cycles, then loop could cause a problem (assuming the loop meets all the other criteria). The workaround is to break the loop into four smaller loops of 50 iterations each. Then any one loop will only run for 200 cycles allowing the EDMA transfer to complete between the smaller loops.

- B. Try to break criteria 2. The quickest way to do this is to turn off optimization for the file containing the problem loop (this is done in the File Specific Options for the file). Instead of using the compiler switch -o3, use the compiler switch -o1 for the particular problem file. This will cause the problem loop to not be software pipelined and less likely to meet criteria 2. The downside to this fix is that all the loops in the particular file will be un-optimized, not just the problem loop.

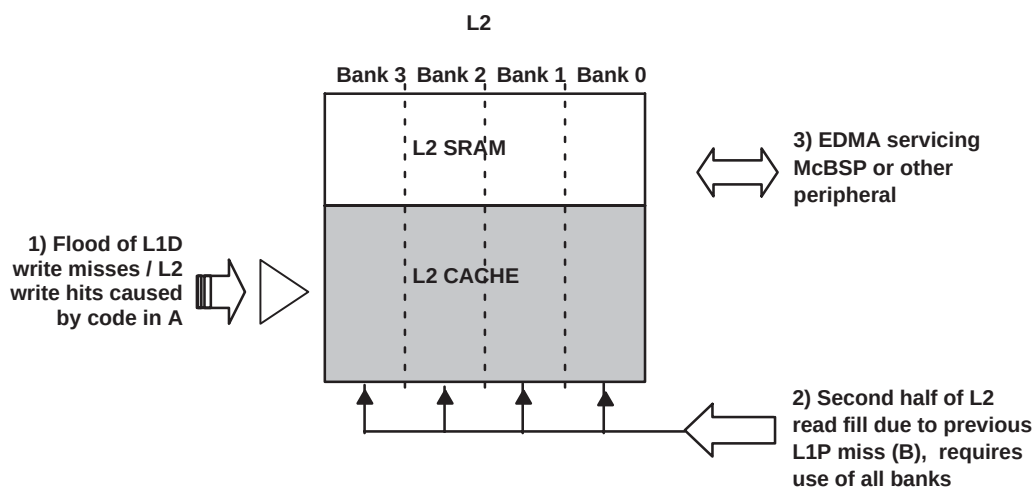
**Figure 10. Problem Scenario**

In this scenario, the next CPU fetch packet does not reside in either L1P or L2 cache; therefore, it causes an L1P and L2 miss. An L2 cache line (128 bytes, 4 fetch packets) must be fetched from external memory. The fetch from external memory is split into two requests (two halves) of 64 bytes, or two fetch packets each. In this document, the two halves are labeled A and B, respectively, as shown in Figure 10. The first half (A) to arrive in L2 is the half in which the missed fetch packet resides. This first half is immediately forwarded to L1P so that CPU can resume execution before the second half (B) is fetched from external memory. The second half of the L2 line (B) is to be fetched and written to L2 later.

The lockout condition occurs only when the second half (B) of the L2 cache line fill starts. When the B is ready, it attempts to write to L2. It will be unable to do so, however, because the line fill operation accesses all four banks of L2 whereas one bank is always busy servicing the higher priority L1D misses from the code in A. Thus, the line fill (B) cannot complete until the flood of writes from A has stopped. The line fill stays at the head of queue in the EDMA controller, so any other EDMA transfers that access L2 will also be blocked until the flood of stores has stopped *and* the L2 line fill (B) has completed.

The amount of time that an EDMA transfer is locked out of L2 is determined by the code running on the DSP (A), and ultimately by the amount of time that L1D write misses are happening in succession. When all of the conditions are met, the second half of the L2 line fill and the EDMA will be locked out of L2 as long as the flood of stores is sustained.

- Avoid the flood of L1D write misses. Pre-read all data locations prior to writing them. This will allocate them in L1D, preventing the L1D write misses from occurring. Recall that L1D read misses do not cause problems.
- Make sure that any algorithm or code segment that naturally produces a long string of writes inserts gaps in the write sequence such that writes occur at a frequency slower than 1 write miss every other cycle. The term "long" is based on the system requirements. Gaps in the L1D write misses means that the second half of the L2 read fill is given a chance to access L2.

- Run the algorithm or code segment that contains A from internal SRAM. There will not be L2 code read fill (A or B) coming into L2. The simulator can be used to detect such code segment. See the C6x1x Simulator section below for details.
- Ensure the problematic segment of algorithm or code is in cache. This can be accomplished by issuing any CPU read/load instruction from the beginning of the problematic code segment in external memory, that will cause both L1D and L2 miss. Assuming the code segment is not yet in L1/L2 cache, Performing CPU load instruction generates an L1D request, and CPU stalls until the code missed and data is returned from L2. After the load instruction, code segment will reside in the L2 cache, and an L2 read fill due to L1P miss will not occur.
