STM8S007xx and STM8S20xxx device limitations

This errata sheet applies to revisions X, Y/6, V, W/7 and 1 of the STMicroelectronics STM8S007xx and STM8S20xxx products.

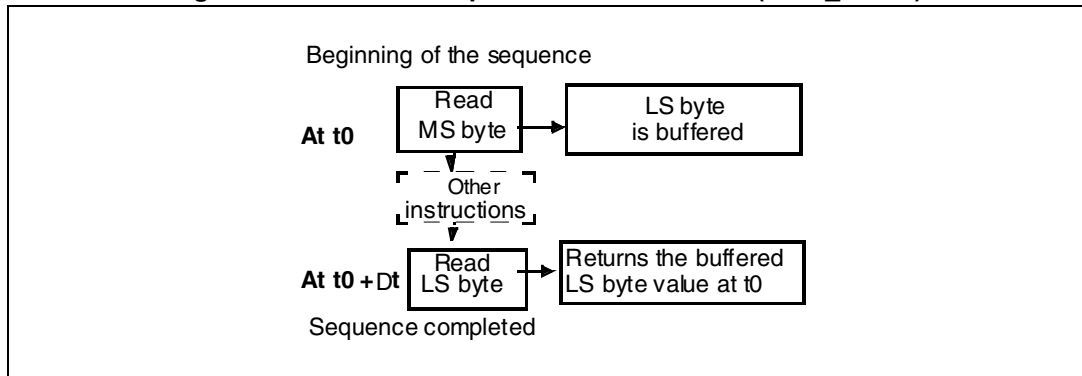
Figure 1. 16-bit read sequence for the counter (TIMx_CNTR)

An 8-bit buffer is implemented for reading the 16-bit counter registers. Software must read the MS byte first, after which the LS byte value is buffered automatically (see [Figure 1](#)). This buffered value remains unchanged until the 16-bit read sequence is completed.

When any multi-cycle instruction precedes the read of the LSB, the content of the buffer is lost and the second read returns the immediate content of the counter directly.

Do not use multi-cycle instructions before reading the LSB.
