# Chip Errata for the i.MX28

This document details all known silicon errata for the i.MX28. [Table 1](#) provides a revision history for this document.

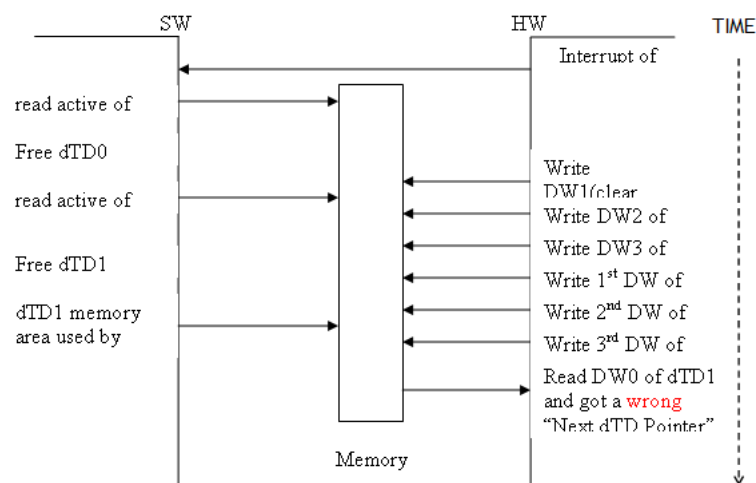
Figure 1. dTD Issue Sequence of Events

After step 1, if software finds the Active bit is cleared, then the dTD memory space is freed and may be allocated for another thread's use. In step 3, hardware may get a wrong dTD.

This issue only occurs in USB INCR8 mode, because steps 1 and 2 have 6 SINGLE AHB transfers in INCR8 mode, but only two burst AHB transfers in INCR mode.

This issue only occurs when the dTD list is used; because if only one dTD is used, the software only checks the Active bit after an interrupt is received (step 3). However, when the dTD list is used, the software may check the entire list after the interrupt for the first dTD is received, when the hardware has just finished the transfer of the second dTD.

USB Controller may hang if dTD is freed too quickly.

Postpone freeing the current dTD; free it when its next dTD can be freed, so the last completed dTD (followed by an ACTIVE dTD) is always freed when the next IOC irq comes.
