## **TMS320C2834x Delfino™ MCUs**

### **Silicon Revision 0**

## **1 Introduction**

This document describes the silicon updates to the functional specifications for the TMS320C2834x microcontrollers (MCUs).

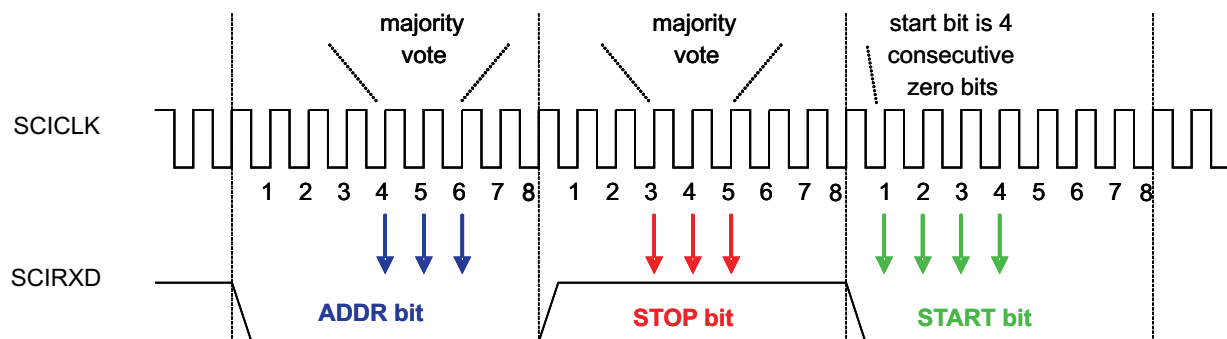
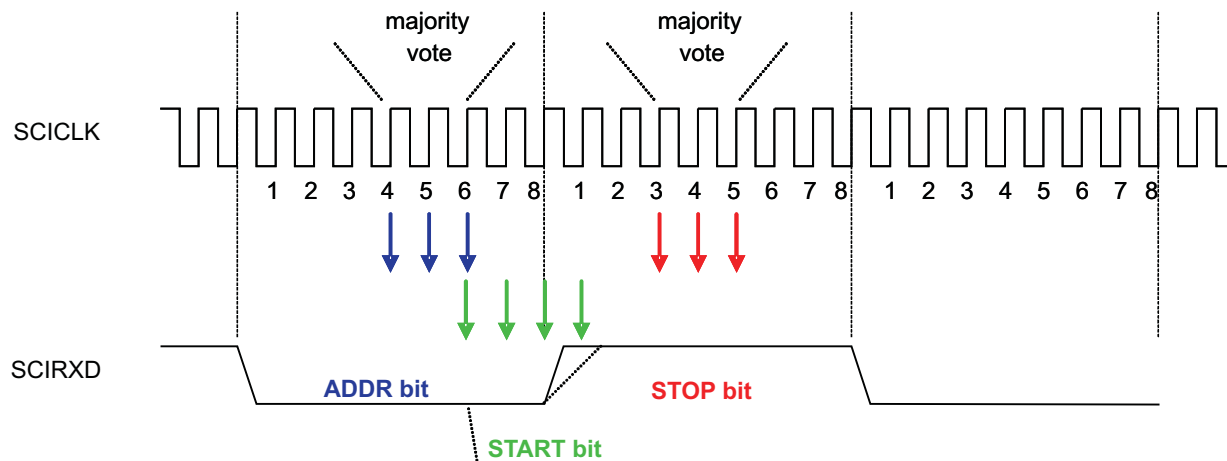
**Figure 3. Difference Between Expected and Erroneous Operation of START Bit**

SCI does not look for STOP bit after the ADDR bit. Instead, SCI starts looking for the start bit beginning on sub-sample 6 of the ADDR bit. Slow rise-time from ADDR to STOP bit can cause the false START bit to occur since the 4th sub-sample for the start bit may be sensed low.

Program the baud rate of the SCI to be slightly slower than the actual. This will cause the 4th sub-sample of the false START bit to be delayed in time, and therefore occur more towards the middle of the STOP bit (away from the signal transition region). The amount of baud slowing needed depends on the rise-time of the signal in the system. Alternatively, IDLE mode of the SCI module may be used, if applicable.
