# **AM3517, AM3505 Sitara™ Processors**

## **Silicon Revisions 1.1, 1.0**

# **Silicon Errata**

Literature Number: SPRZ306E  
October 2009–Revised September 2016

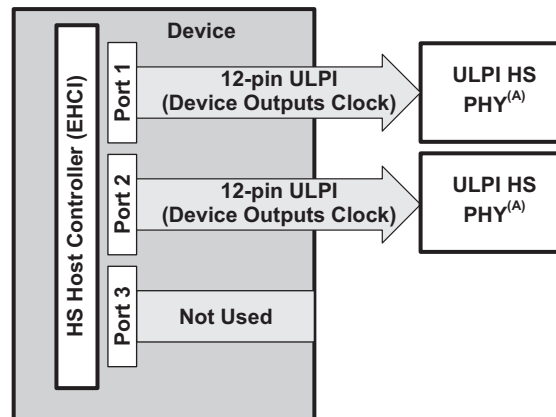
**Figure 4. Connecting to High-Speed PHYs Using USB Ports**

As shown in Figure 4, USB Port 1 and Port 2 can be used to connect to external high-speed PHYs which include a ULPI port. However, in this case, the external USB PHY must be able to accept a source clock generated by the high-speed USB controller. Also, in this usage model the USB ports cannot support full-speed and low-speed operation. Therefore, using this approach, USB Port 1 and Port 2 cannot provide a fully compliant USB 2.0 Type-A receptacle; a high-speed USB hub would be required in this case; please see Figure 5.

A. USB port 3 does not support ULPI mode.

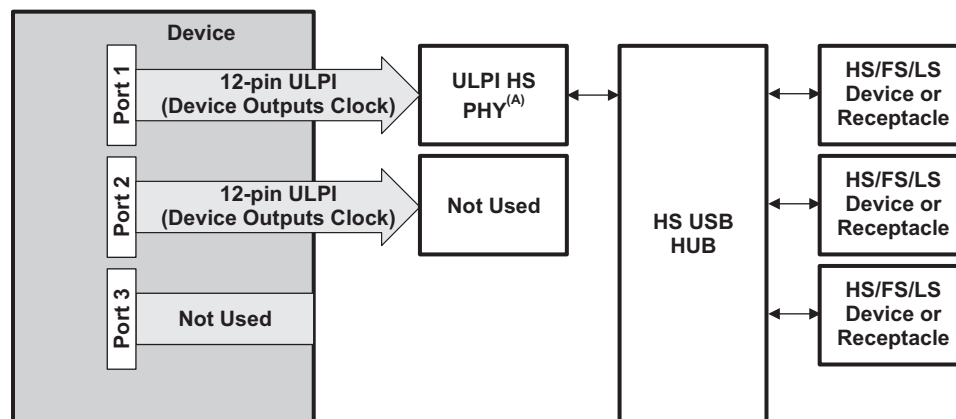
**Figure 5. Connecting to a High-Speed USB Hub**

A. USB port 3 does not support ULPI mode.

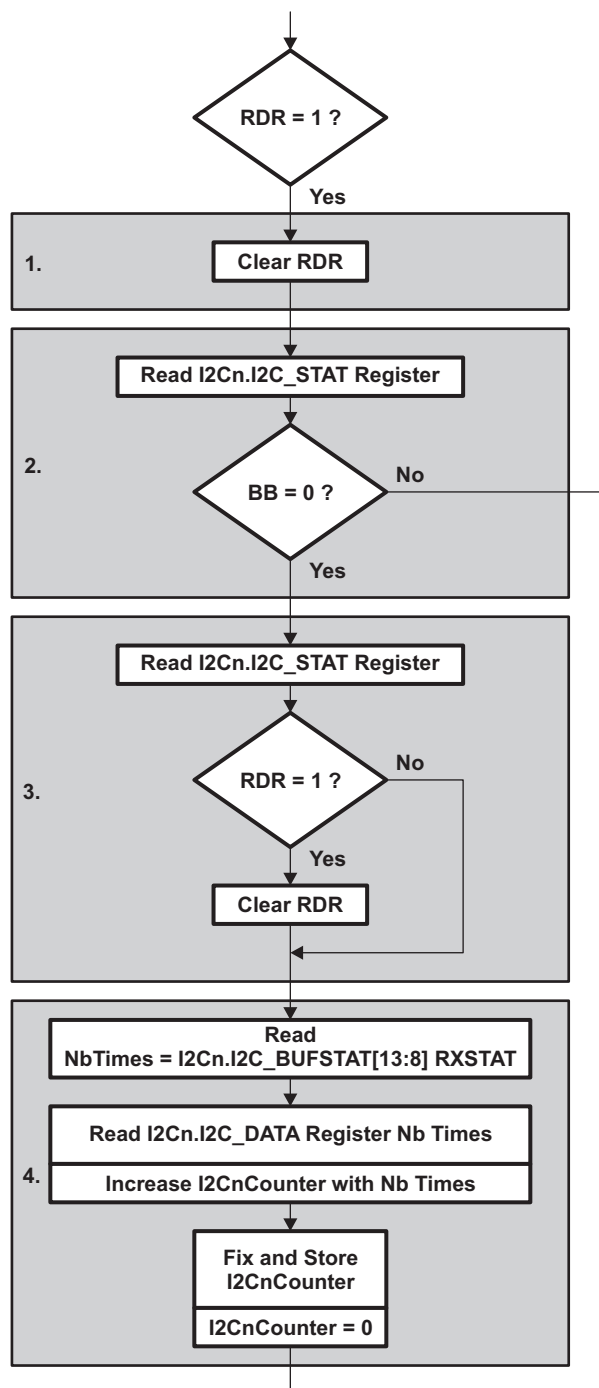
Figure 6. I2C Flowchart

**Details**      Under certain rare conditions, the I2C\_STAT[13].RDR bit may be set as well as the corresponding interrupt fire, even when there is no data in the receive FIFO, or the I2C data transfer is still ongoing. These spurious RDR events must be ignored by the software.

**Workaround(s)**      Software must filter out unexpected RDR pulses, using the flowchart illustrated in [Figure 6](#) when receiving an I2C RDR interrupt.

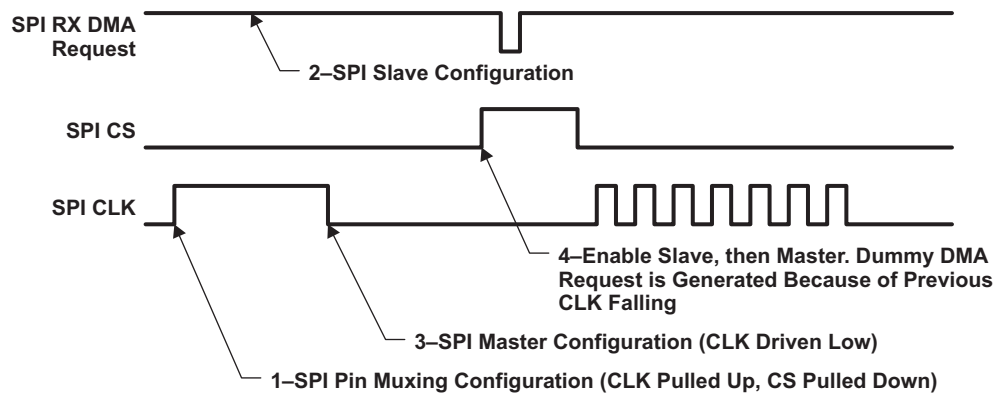
**Figure 7. SPI Dummy DMA RX Generation**

A dummy DMA RX request is generated as soon as the SPI is configured in *slave* mode and a SPI clock edge is detected. The dummy DMA RX request is generated during module configuration, when the module is not performing an SPI transfer. The dummy DMA RX request occurs as soon as the SPI interface signal sensitivity is changed compared to the default value.

The dummy DMA RX request is generated because the mechanism to avoid dummy data capture on a CS glitch is done regardless of channel activation.

**Workaround(s)** Avoid conditions where the SPI is in *slave* mode and the SPI clock toggles (see examples below).
