MSP430F438 Device Erratasheet

1 Functional Errata Revision History

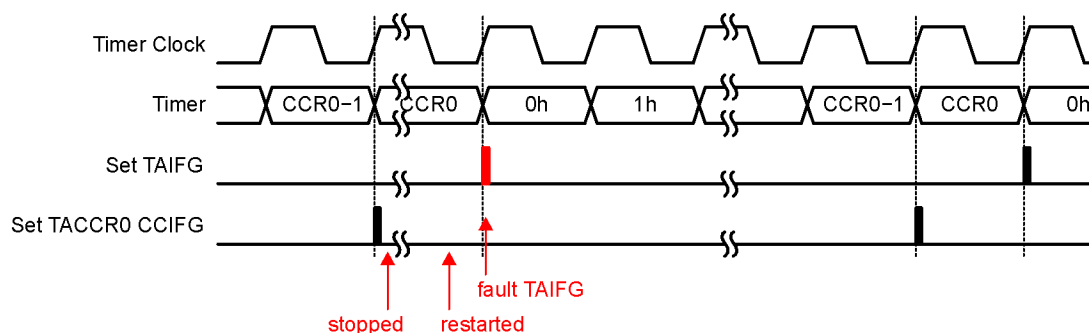
TA21

TAIFG Flag is erroneously set after Timer A restarts in Up Mode

In Up Mode, the TAIFG flag should only be set when the timer counts from TACCR0 to zero. However, if the Timer A is stopped at TAR = TACCR0, then cleared (TAR=0) by setting the TACLR bit, and finally restarted in Up Mode, the next rising edge of the TACLK will erroneously set the TAIFG flag.

None.
