*TMS320DM365*  
*Digital Media System-on-Chip (DMSoC)*  
**Silicon Revision 1.1 and 1.2**

## **Silicon Errata**

Literature Number: SPRZ294E  
March 2009—Revised July 2011

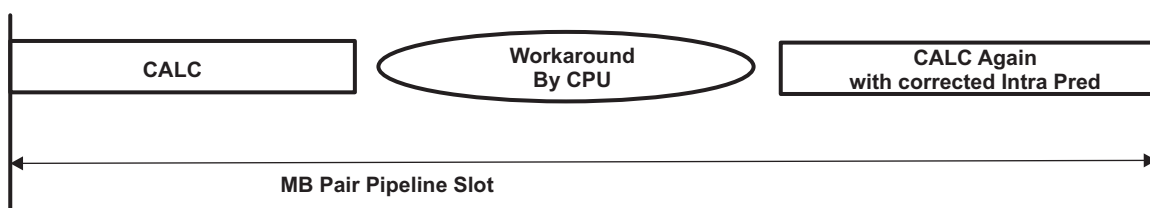
**Figure 3. MB Pair Pipeline Slot Example**

**Details:** During the calculation of the intra prediction block, pixel values can reach 512 or higher. However, the computation engine has precision only enough to hold values equal to 511 or less.

- H.264 Encode or Decode
- Intra\_16x16\_Plane mode MB
- Luma blocks *only*; it does not affect Chroma blocks
- If the prediction block generated using the Intra\_16x16\_Plane mode has a pixel value of 512 or higher

- In Encode, an incorrect (but legal) bitstream will be generated, and a mismatch will happen between the Encoder and Decoder resulting in significant quality degradation.
- In Decode, the reconstructed macroblock will be incorrect.
- If the following MBs are intra referring to this MB, the error is propagated spatially within the picture.
- If the following pictures refer to this MB, the error is propagated temporally to the following pictures.

During a MB pipeline slot, a CALC is done, a workaround by CPU, and CALC again with corrected intra prediction macroblock (see [Figure 3](#)).

If the MB is of intra 16x16 plane mode, perform the following steps:

1. Let CALC run.
2. Wait for CALC to complete
3. After CALC completes, switch BFSW for iprdbuf : CALC → DMA
4. Check and correct Intra Prediction (for more details, see the *Check and Correct Intra Prediction* section below)
5. Switch BFSW for iprdbuf : DMA → CALC
6. Switch BFSW for calcmbuf : CALC → DMA
7. Set up CALC commands with intra mode for IQ/IT and inter mode for prediction (for more details, see the *Set up CALC Commands with Intra mode for IQ/IT and Inter Mode for Prediction* section below)
8. If MBAFF, retrigger DMA for upper row data
9. Switch BFSW for calcmbuf : DMA → CALC
10. Switch BFSW for reconbuf : LPF → DMA
11. Read left reconstructed column
12. Switch BFSW for reconbuf : DMA → LPF
13. Switch BFSW for calcsbuf : CALC → DMA
14. Set back left reconstructed column
15. Switch BFSW for calcsbuf : DMA → CALC
16. Re-run CALC
17. Wait for CALC to complete
