## MEC170x Silicon Errata and Data Sheet Clarification

## Silicon Errata Issues

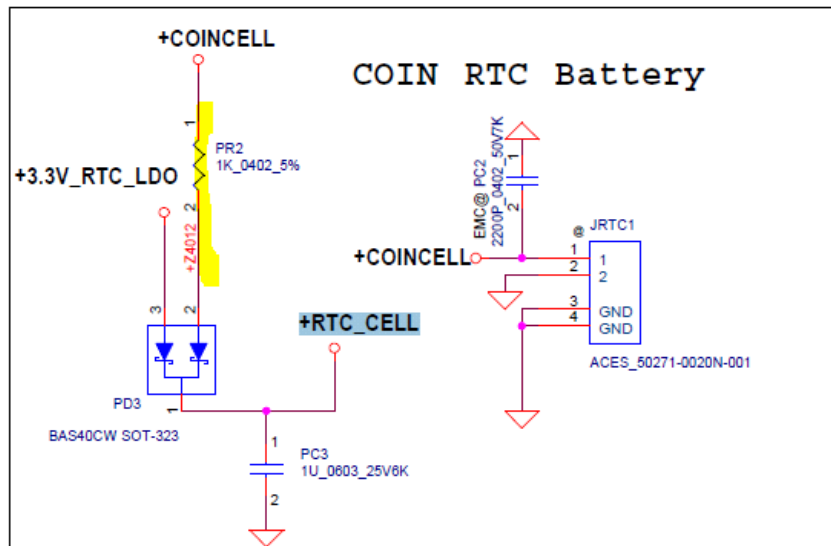
FIGURE 1: HIGH IBAT CURRENT DURING COIN CELL INSERTION

There could be a high  $I_{BAT}$  current on new coin cell insertion. During initial VBAT power rising, the VBAT circuit can enter a high current state causing a voltage drop across the 1K UL resistor. This affects all 128 and 144 pin packages. This issue is not present in the 169 pin packages.

- Under these conditions, the VBAT power on can stall in this high current state, with the VBAT on device pin between 0.7 and 1.2V.

Referring to the RTC Battery circuit shown in [Figure 1](#), applying VTR via the +3.3V\_RTC\_LDO signal, powers RTC\_Cell (which is connected to VBAT of MEC5105/6) directly (without a series 1k resistor and hence no IR drop from the applied VTR), raising VBAT (RTC\_Cell) to greater than 2.0 volts. This takes VBAT out of the "high current" region discussed above enabling normal VBAT low power operation.

Insert the coin cell and then apply VTR (i.e +3VALW). This enables VBAT low-power operation. A high  $I_{BAT}$  will not return on subsequent VTR power cycles.
