## PIC18F87J11 Family Silicon Errata and Data Sheet Clarification

The PIC18F87J11 family of devices that you have received conform functionally to the current Device Data Sheet (DS39778E), except for the anomalies described in this document.

## Silicon Errata Issues

## Data Sheet Clarifications

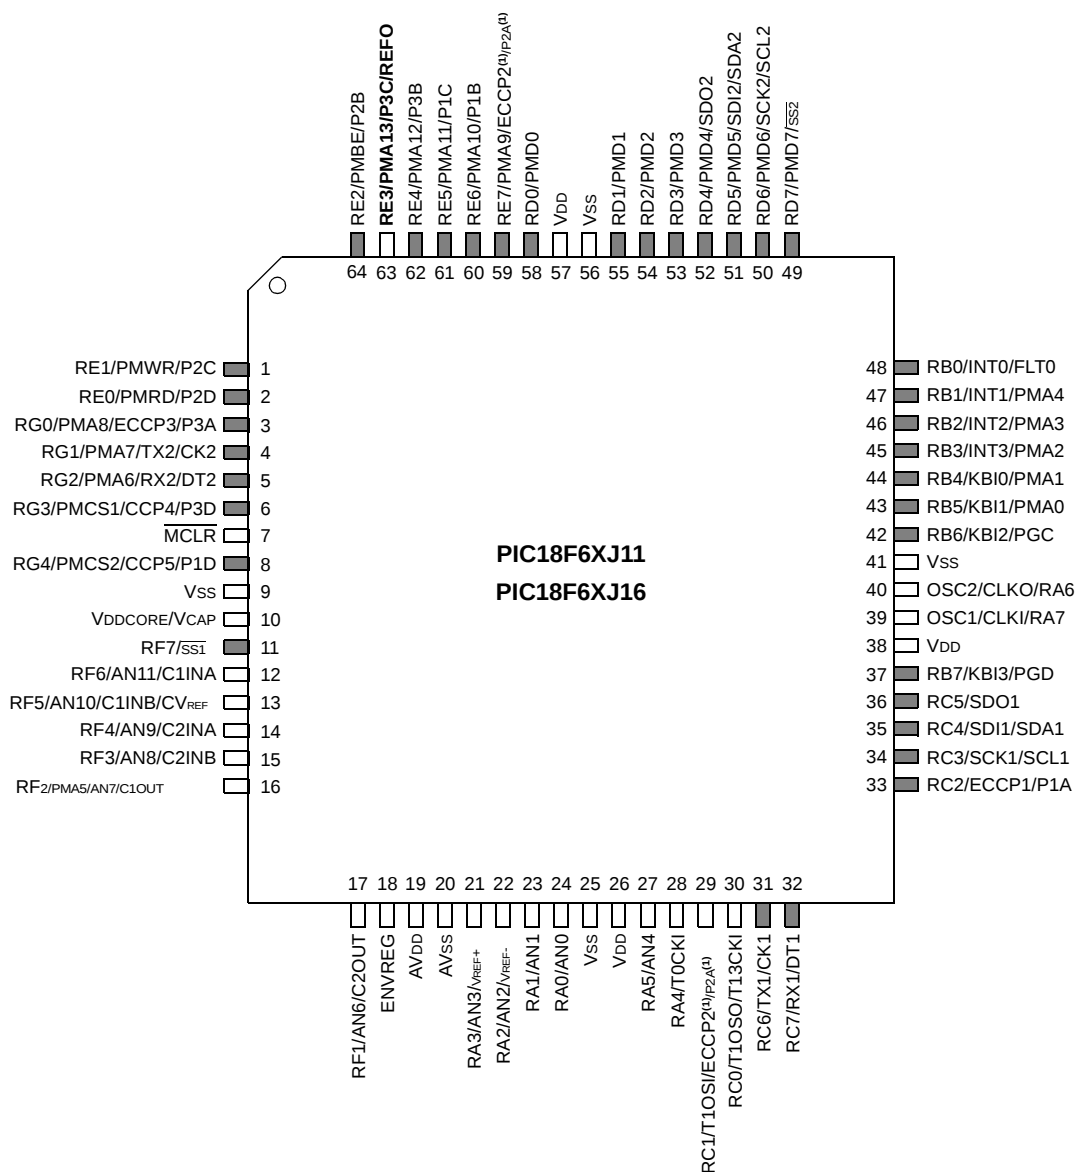
## 64-Pin TQFP

PORTE pin RE3 is not +5.5V tolerant as indicated in the data sheet. The pin diagrams should be corrected to read as follows:
