## ERRATA NOTES

### CC2500

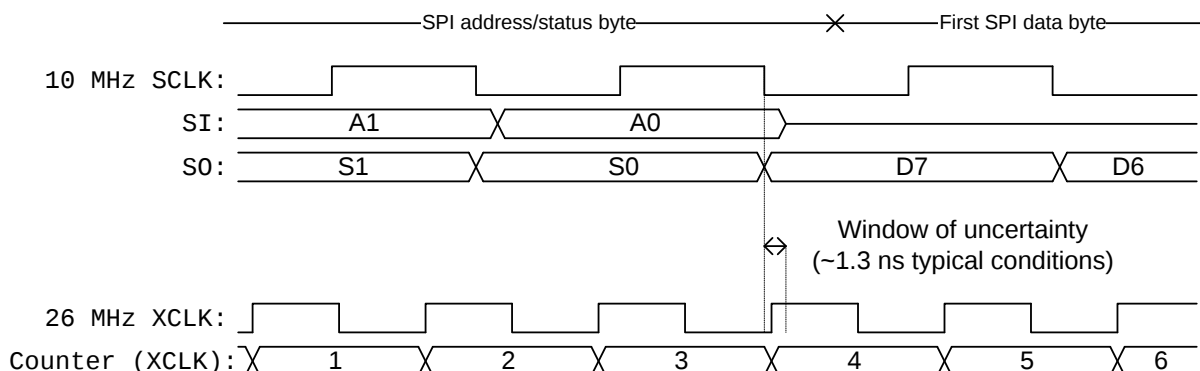
**Figure 1 Window of uncertainty (drawing not to scale)**

Due to this synchronization issue, if the register being read changes value (synchronously with XCLK) during a certain period of time after this falling edge of SCLK then some of the bits in the read value will come from the **previous** value and some from the **next** value. This so-called window of uncertainty is about 1.3 ns for typical conditions and increases to about 2.0 ns for worst-case conditions (1.8 V VDD, 85 °C).

Figure 1 shows a timing diagram of an SPI read that fails when reading a fictitious counter being updated internally each **XCLK**. Since the counter update from value 3 (011b) to 4 (100b) within the window of uncertainty, the read value could be any one of 0-7 (000b, 001b, 010b, 011b, 100b, 101b, 110b, 111b) depending on exactly when the positive edge of **XCLK** falls within the window of uncertainty.

If it is important to **ensure** that read values are not corrupted, reading of one of the affected registers should be done repeatedly until the same value is read twice in succession. If the rate at which the register is read is guaranteed to be at least twice as fast as the expected register update rate, then an upper bound on the number of required reads is four and the average number of reads slightly more than two.
