**TMS320VC5421**  
**Digital Signal Processor**  
**Silicon Errata**

*SPRZ170C*  
April 2000  
Revised October 2001

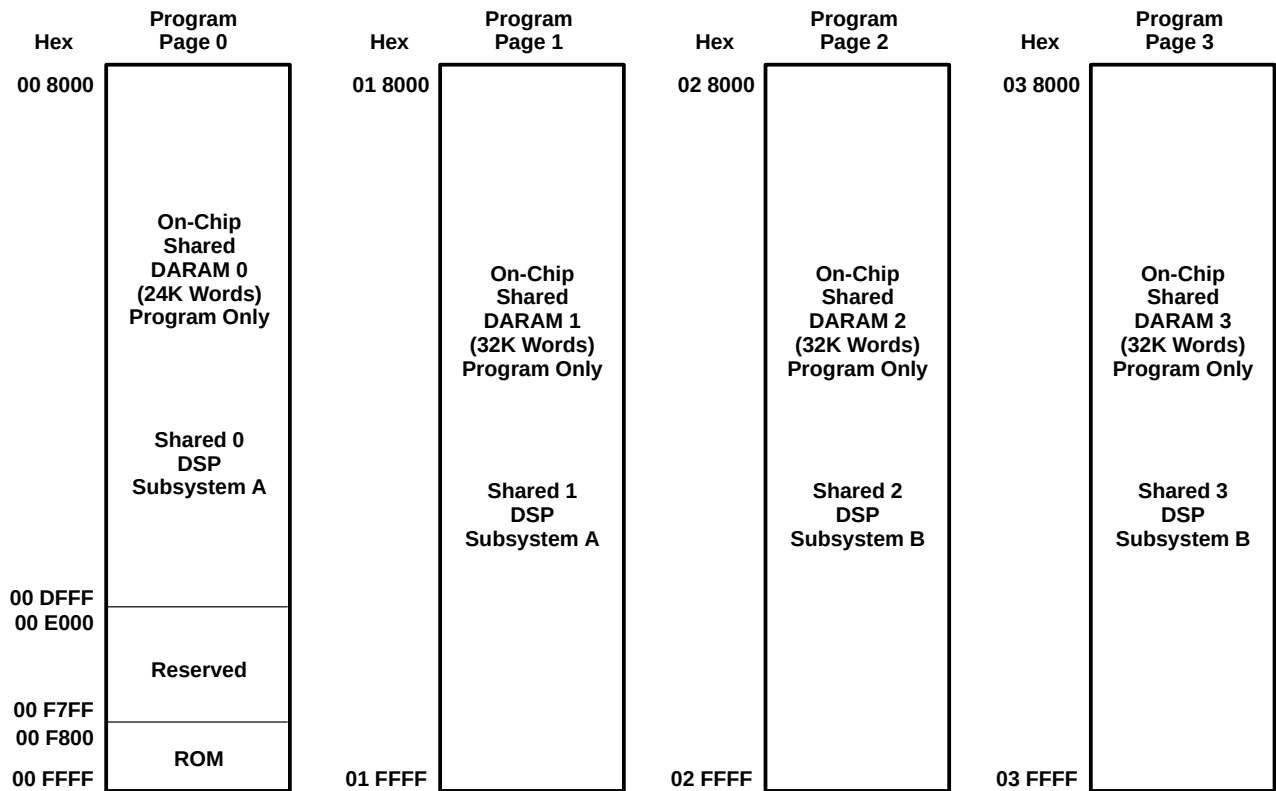
Figure 3. Shared-Memory Map

**Details:** When a 5421 subsystem is halted in emulation mode, the other subsystem is unable to access the shared memory associated with the halted subsystem (see Figure 3 for the shared-memory map). This also affects the use of software and hardware breakpoints in the shared memory. Note that this issue only affects the TMX320VC5421 during emulation, and there are no issues with shared memory accesses during normal functional mode.

**Workaround:** None. This problem is corrected in Revision A silicon.
