## MSP430G2755 Device Erratasheet

### 1 Functional Errata Revision History

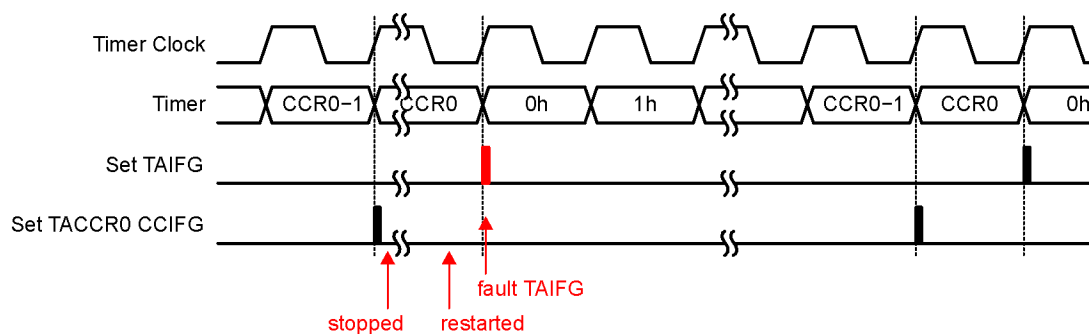
## TA21 *TIMER\_A Module*

**Function** TAIFG Flag is erroneously set after Timer A restarts in Up Mode

**Description** In Up Mode, the TAIFG flag should only be set when the timer counts from TACCR0 to zero. However, if the Timer A is stopped at TAR = TACCR0, then cleared (TAR=0) by setting the TACLR bit, and finally restarted in Up Mode, the next rising edge of the TACLK will erroneously set the TAIFG flag.

**Workaround** None.

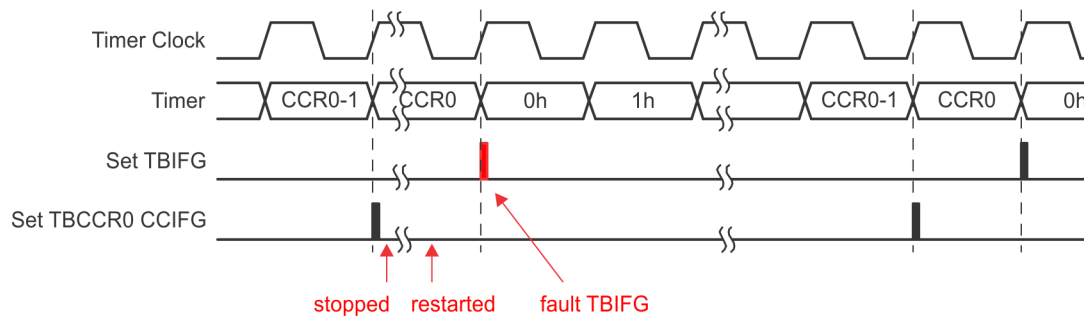
**TB24** ***TIMER\_B Module***

**Function** TBIFG Flag is erroneously set after Timer B restarts in Up Mode

**Description** In Up Mode, the TBIFG flag should only be set when the timer resets from TBCCR0 to zero. However, if the Timer B is stopped at TBR = TBCCR0, then cleared (TBR=0) by setting the TBCLR bit, and finally restarted in Up Mode, the next rising edge of the TBCLK will erroneously set the TBIFG flag.

None.
